School Crossings on State Highways:

Improving Safety Near New Jersey's Schools

Prepared by:
Leigh Ann Von Hagen, Nicholas K. Tulach,
Catherine Bull, & Dan Chibbaro
New Jersey Safe Routes to School Resource Center
Alan M. Voorhees Transportation Center

Date:
April 2016

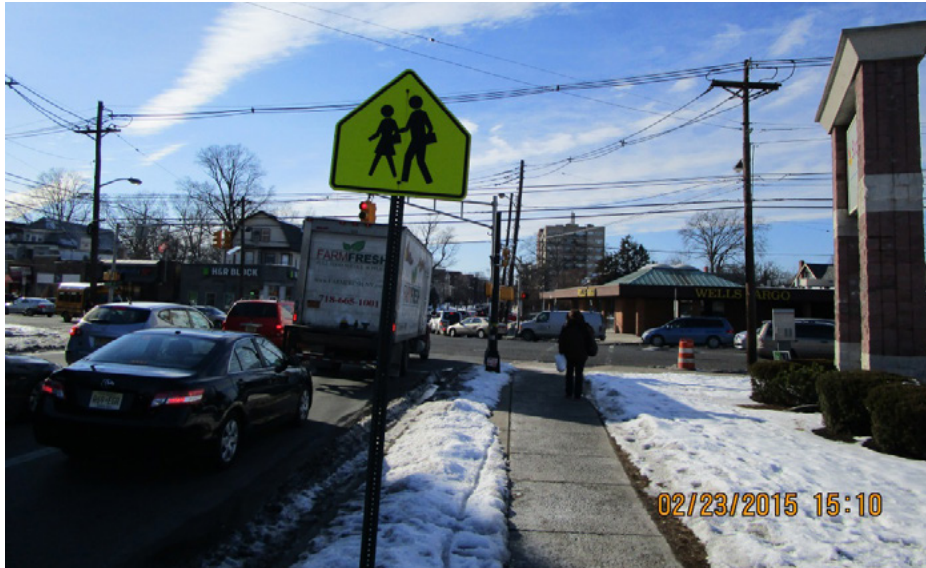
Figure 2: Route 27 (Newark Avenue) and County Road 439 (North Avenue), Elizabeth, NJ, looking west – A school sign is visible at the intersection, which features various commercial activities such as banks and a supermarket that may pose a hazard to pedestrians.

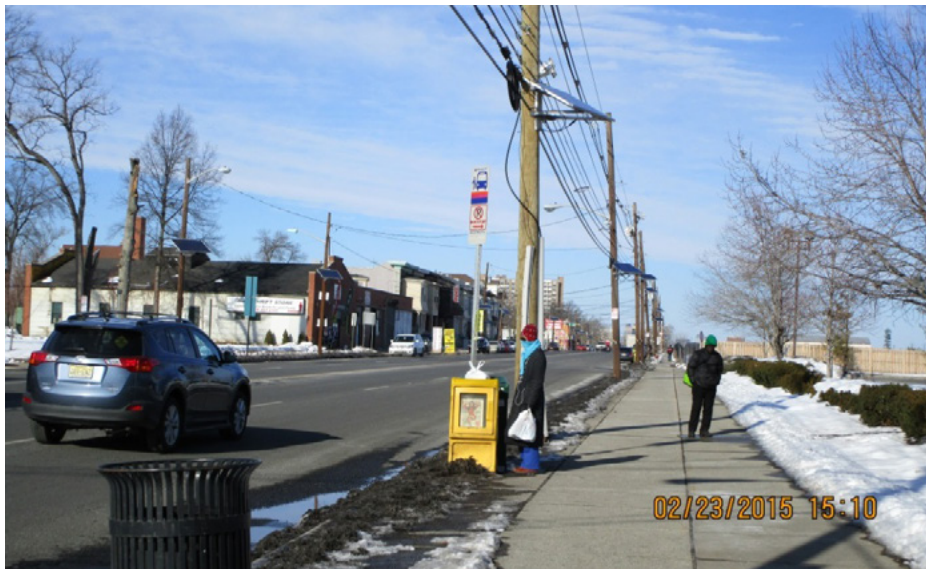
Figure 3: State Route 27 (Newark Avenue) and County Road 439 (North Avenue), Elizabeth, NJ, looking northeast – The intersection features a nearby NJ Transit bus stop, but no bus shelter and inadequate sidewalk lighting.

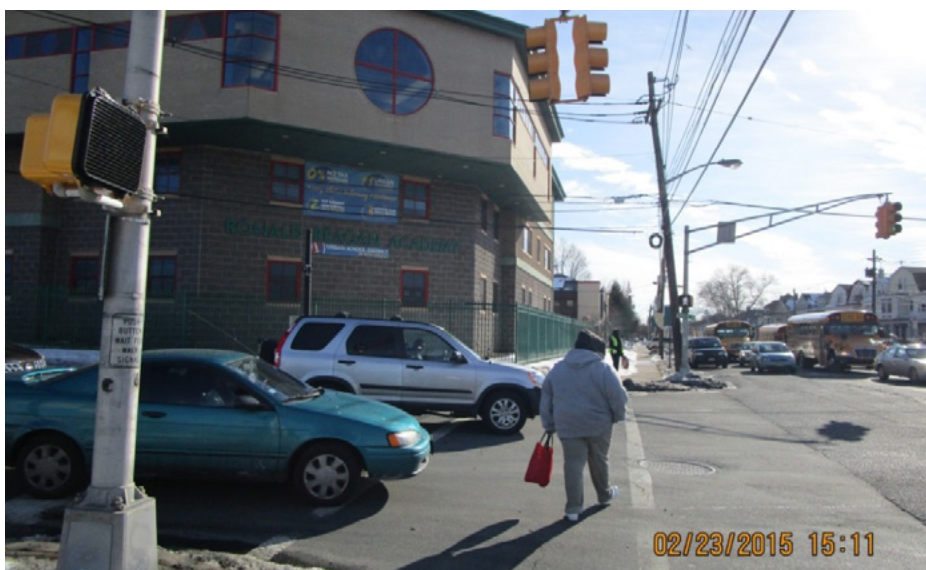
Figure 4: Route 27 (Newark Avenue) and County Road 439 (North Avenue), Elizabeth, NJ, looking southwest – Cars block the crossing path in anticipation of right and left turns. Ronald Reagan Elementary School is adjacent to this intersection (visible straight ahead).

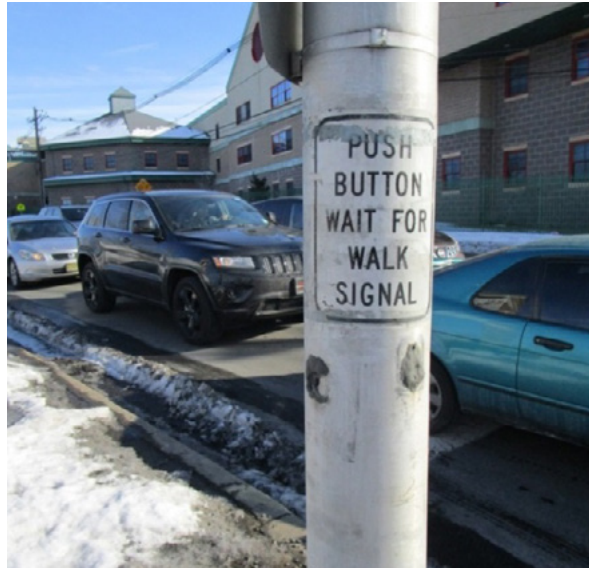
Figure 5: Route 27 (Newark Avenue) and County Road 439 (North Avenue), Elizabeth, NJ, looking south – Pedestrian buttons have been removed at this intersection; further research is needed to determine the reason.

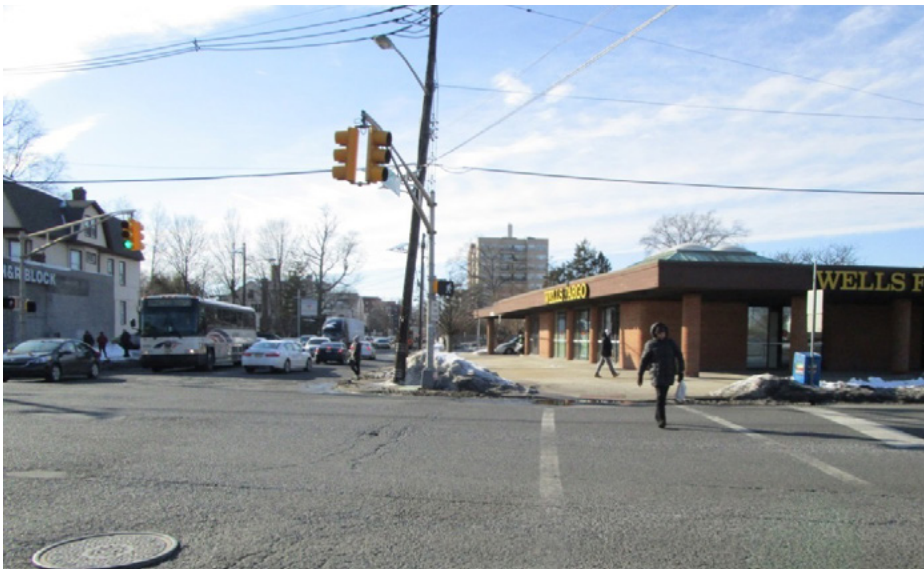
Figure 6: Route 27 (Newark Avenue) and County Road 439 (North Avenue), Elizabeth, NJ, looking west – Faded striping is evident at some parts of the intersection.

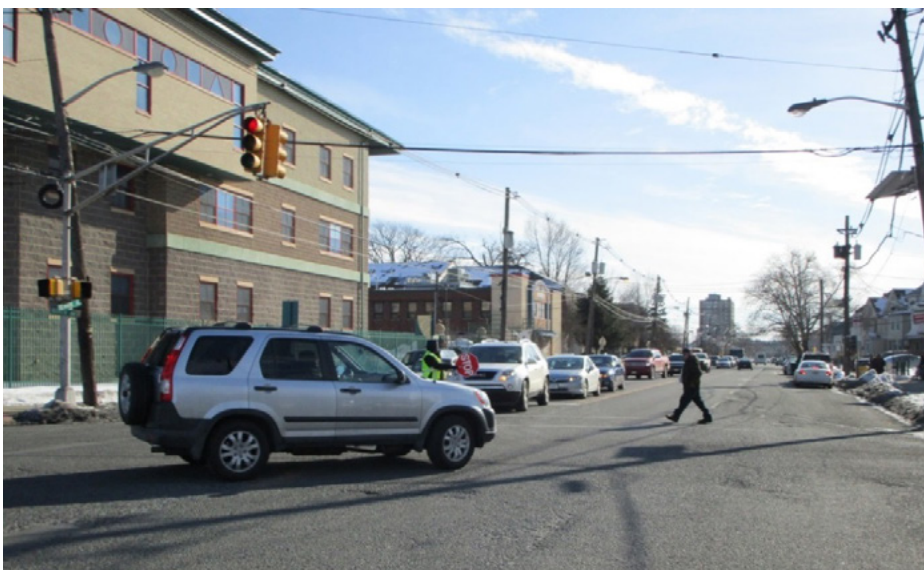
Figure 7: Route 27 (Newark Avenue) and County Road 439 (North Avenue), Elizabeth, NJ, looking southwest – At school dismissal time, a crossing guard assists pedestrians crossing Rt. 439.

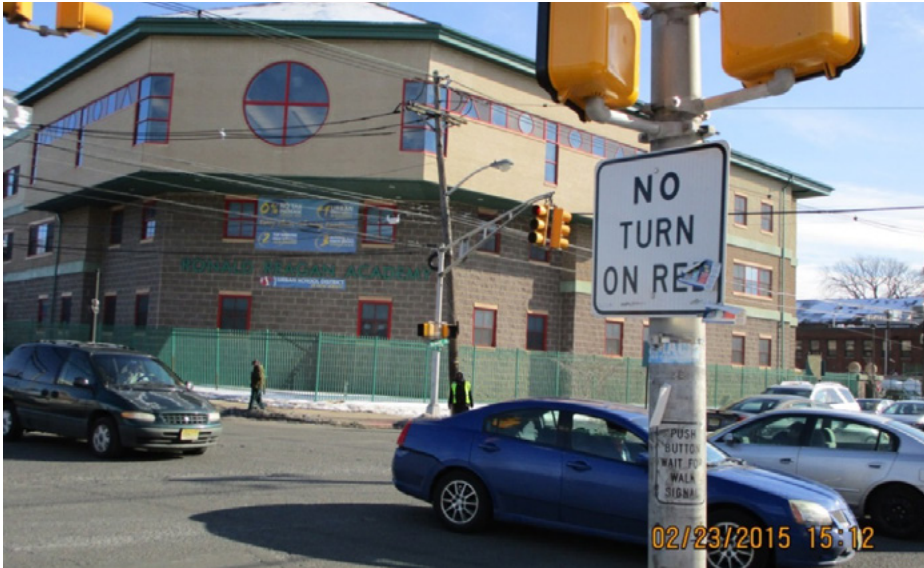
Figure 8: Route 27 (Newark Avenue) and County Road 439 (North Avenue), Elizabeth, NJ, looking southeast – No right turns on red are permitted here onto Rt. 439.

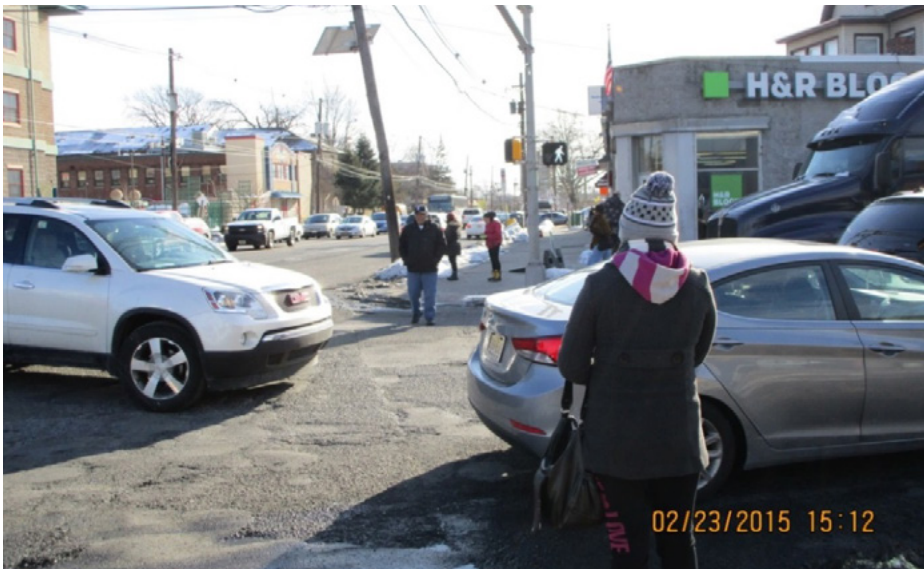
Figure 9: Route 27 (Newark Avenue) and County Road 439 (North Avenue), Elizabeth, NJ, looking southwest – The congestion of the busy intersection often reduces the space for pedestrians to safely cross.

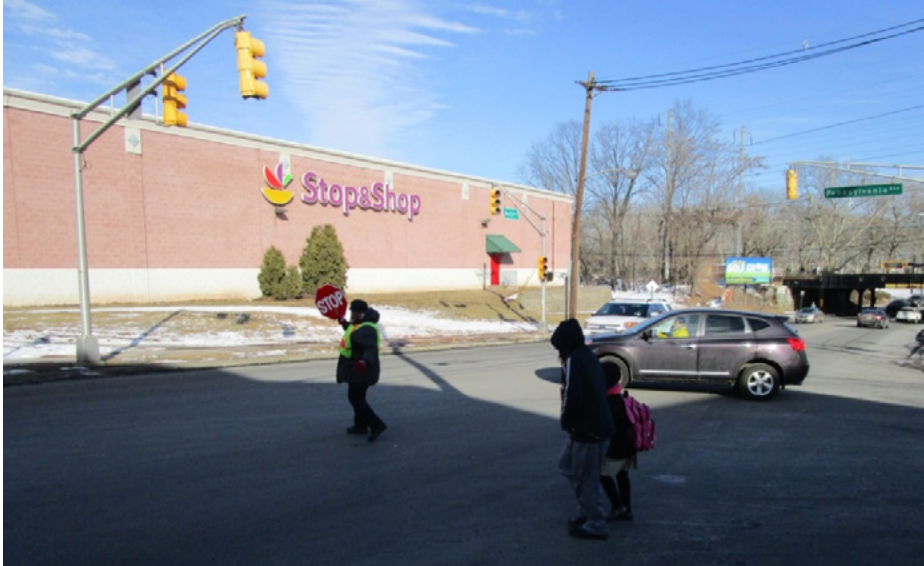
Figure 11: County Road 439 (North Avenue) and Pennsylvania Avenue, Elizabeth, NJ, looking east – A second crossing guard assists students at the school's second adjacent intersection of Rt. 439 and Pennsylvania Avenue. The busy, three-way intersection has crosswalk striping on only two of its three crossing points.

- » On North Avenue, one block east of Route 27, the crossing guards pointed out problems with jaywalking at the signalized intersection of North Avenue and Pennsylvania Avenue as a result of inadequate crossing striping. This intersection includes heavy traffic at the entrance to the supermarket parking lot.
- » Improvements could be made to right turns from North Avenue onto Pennsylvania Avenue. Changes to the turn radius, high visibility markers for crosswalks, and curb extensions could be evaluated at this crossing.
- » A mid-block crosswalk could be considered to improve safety at the entrance of the supermarket parking lot, acknowledging that people want to cross to access the shopping center.

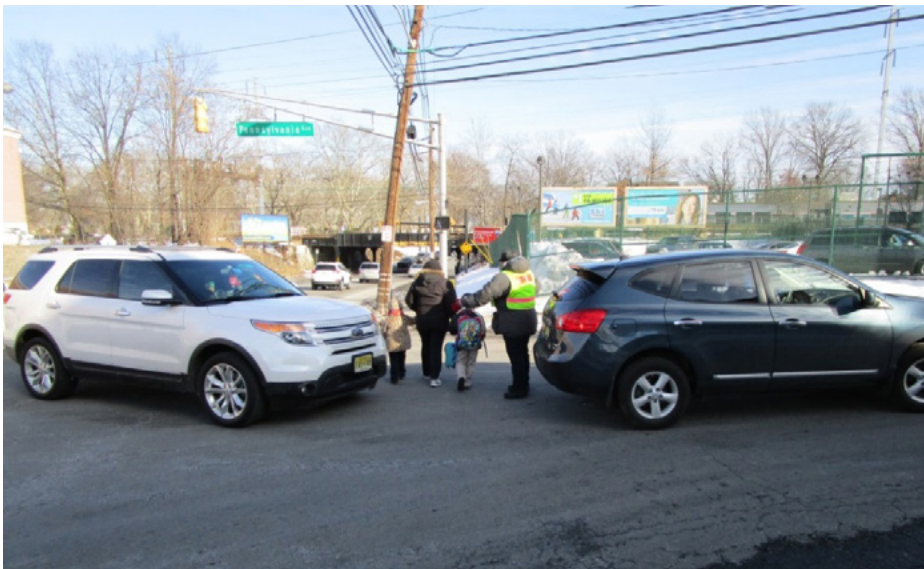
Figure 12: County Road 439 (North Avenue) and Pennsylvania Avenue, Elizabeth, NJ, looking east – Congestion poses hazards to pedestrians at this intersection.

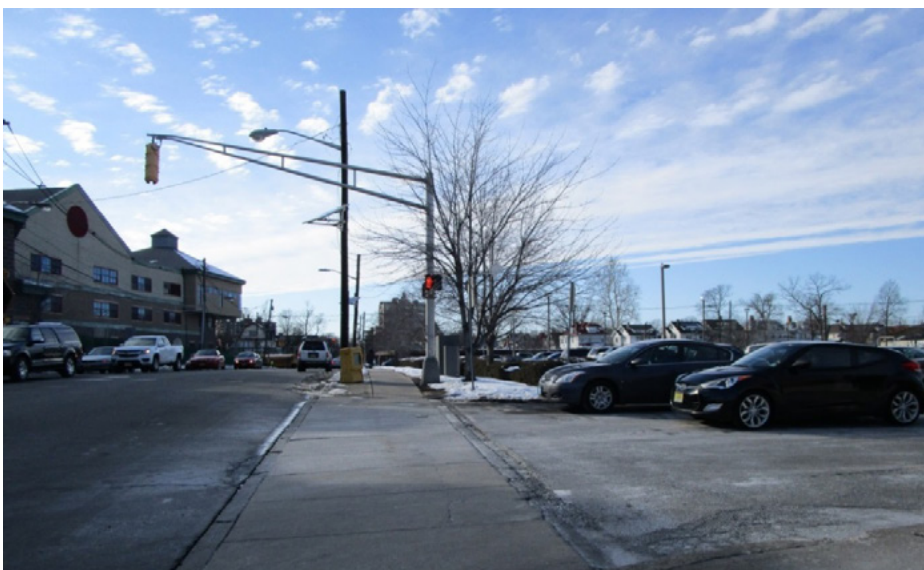
Figure 13: County Road 439 (North Avenue) and Pennsylvania Avenue, Elizabeth, NJ, looking west – The supermarket across the street from the school features a driveway wide enough to require a pedestrian signal.

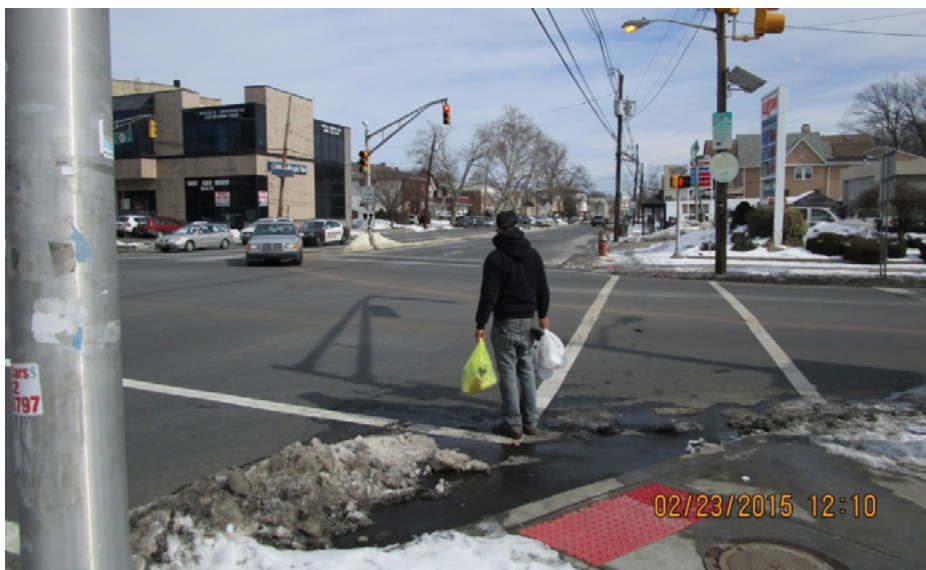
Figure 15: State Route 28 (Westfield Avenue) & County Route 439 (Elmora Avenue), Elizabeth, NJ, looking east – A pedestrian prepares to cross the intersection. The intersection features truncated domes with textured plates that are inconsistently in compliance with the ADA. Crosswalk striping, visual pedestrian signals, and signal buttons are absent.

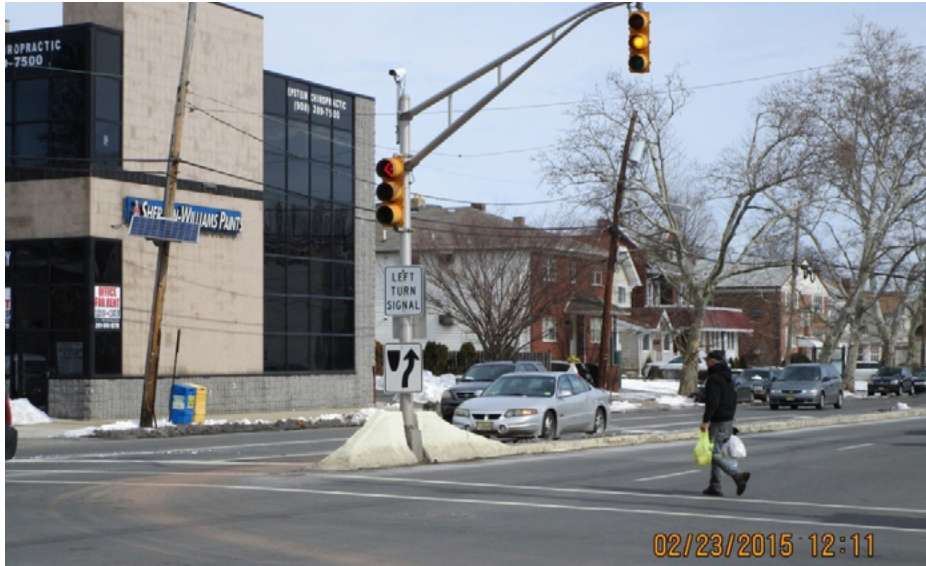
Figure 16: State Route 28 (Westfield Avenue) & County Route 439 (Elmora Avenue), Elizabeth, NJ, looking northeast – Central median provides insufficient protection for pedestrians who cannot complete the crossing during the signal phase.

Other observations at the intersection revealed a hazardous environment for pedestrians. Crossing Route 28 is a particularly long endeavor, and the central median provides insufficient protection for pedestrians who cannot complete crossing during the signal phase. Right turns on red are not permitted at this intersection, but some right turns during the pedestrian signal phase were observed. Some pedestrians were observed crossing outside of the crosswalks and using the narrow median as a pedestrian island for safe refuge from traffic. This behavior suggests that the current conditions do not encourage safer crossing at the intersection itself and that the crossing takes too long. A cyclist could also be seen attempting to cross this intersection despite the lack of facilities for bicycles in the area around the intersection. The smaller intersections along Route 439 nearest to the Jewish Educational Center are also consistently unsafe. While some crossings had adequate striping, elsewhere the striping was faded and some textured plates at the curbs were in need of repair.

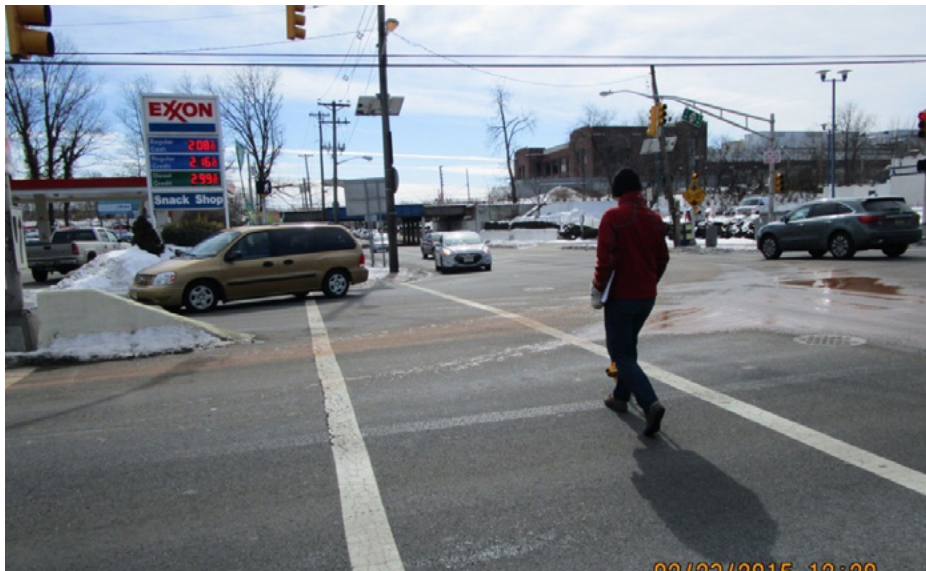
Figure 17: State Route 28 (Westfield Avenue) & County Route 439 (Elmora Avenue), Elizabeth, NJ, looking south – The crossing of Route 28 features the longer crossing distance as well as various commercial activities, such as this gas station, that pose a hazard to pedestrians. Right turns on red are not permitted during the pedestrian signal phase.

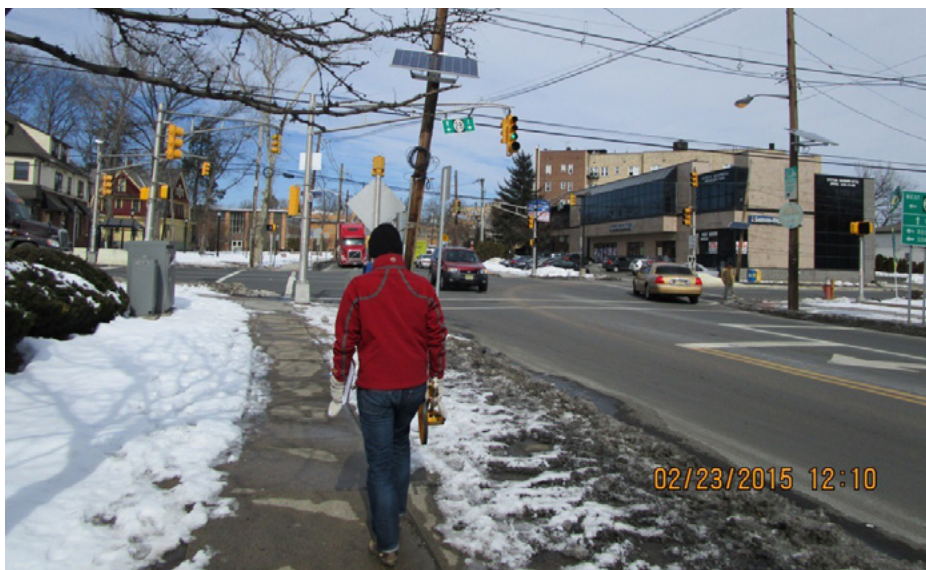
Figure 18: State Route 28 (Westfield Avenue) & County Route 439 (Elmora Avenue), Elizabeth, NJ, looking north – The sidewalks are somewhat narrow near the intersection.

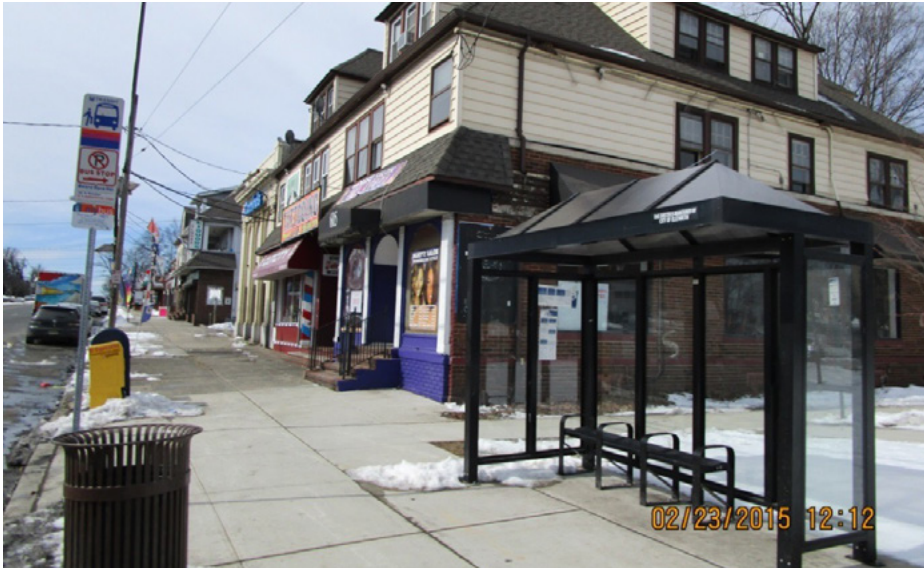
Figure 19: State Route 28 (Westfield Avenue) & County Route 439 (Elmora Avenue), Elizabeth, NJ, looking east – A NJ Transit bus stop is located near the intersection in addition to additional commercial activity.

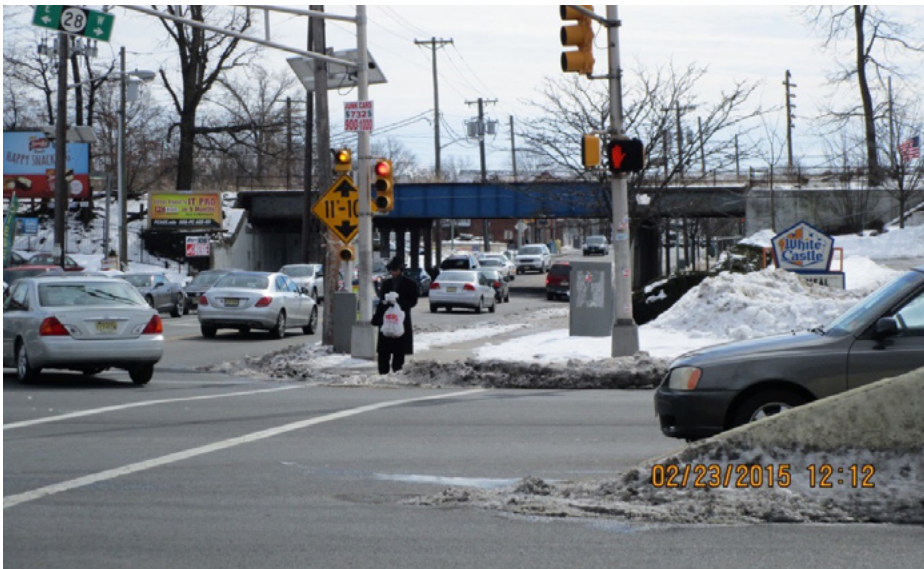
Figure 20: State Route 28 (Westfield Avenue) & County Route 439 (Elmora Avenue), Elizabeth, NJ, looking south – High volume traffic through the intersection is apparent at mid-day.

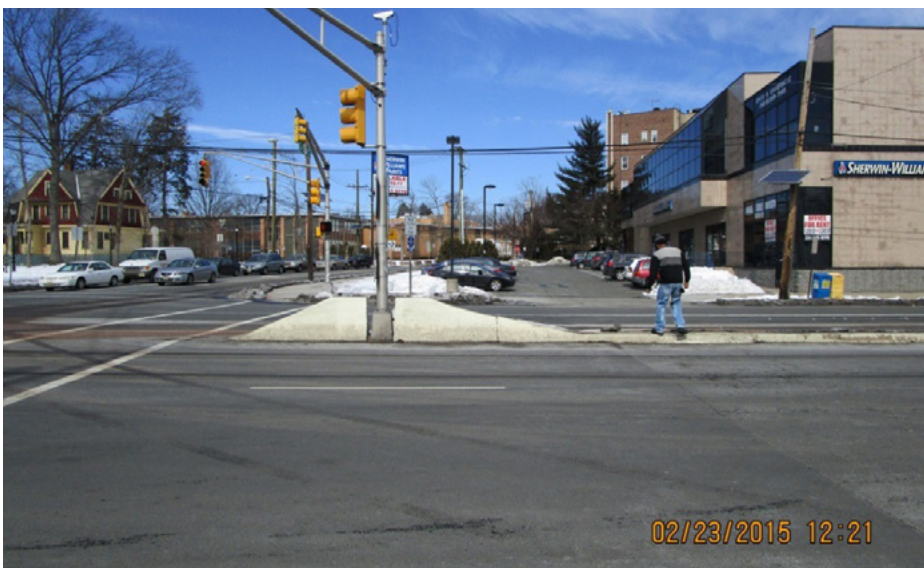
Figure 21: State Route 28 (Westfield Avenue) & County Route 439 (Elmora Avenue), Elizabeth, NJ, looking north – A pedestrian was observed waiting on the raised median in absence of a pedestrian refuge island.

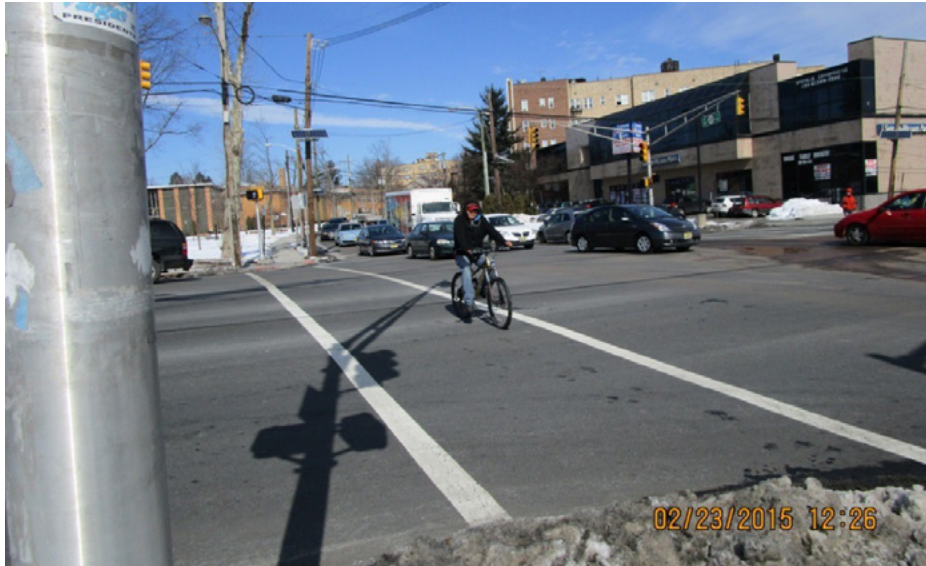
Figure 22: State Route 28 (Westfield Avenue) & County Route 439 (Elmora Avenue), Elizabeth, NJ, looking north – Cyclists also attempt to cross this intersection despite the lack of facilities for bicycles.

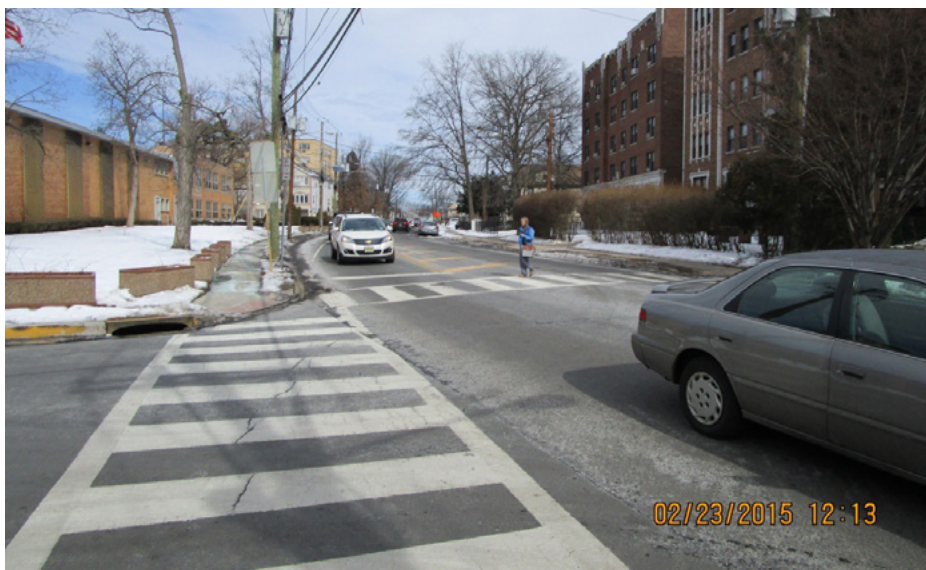
Figure 24: County Route 439 (Elmora Avenue), Elizabeth, NJ, looking north – The Jewish Educational Center (pictured on the left) is a brief walk from the intersection. Ladder striping can be observed here.

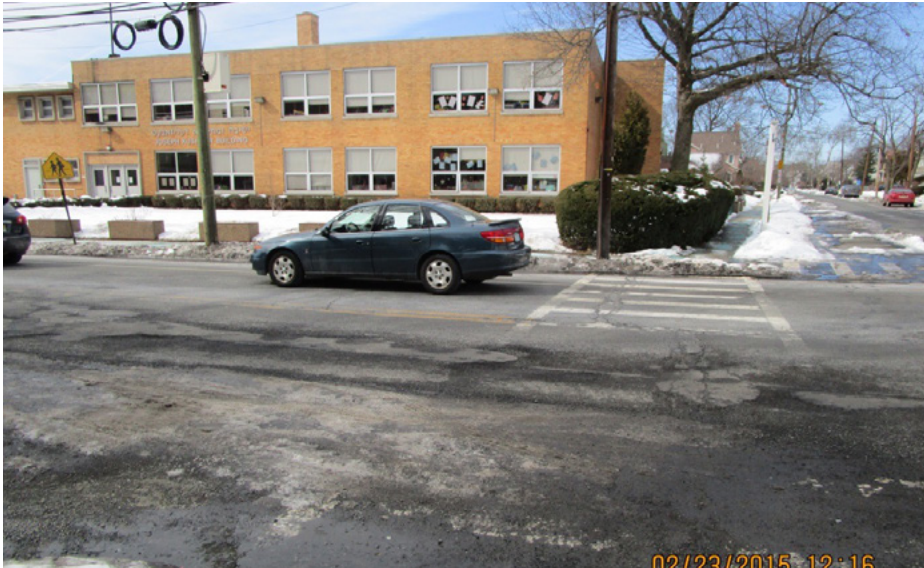
Figure 25: County Route 439 (Elmora Avenue), Elizabeth, NJ looking north – The striping adjacent to the school is faded in some sections.

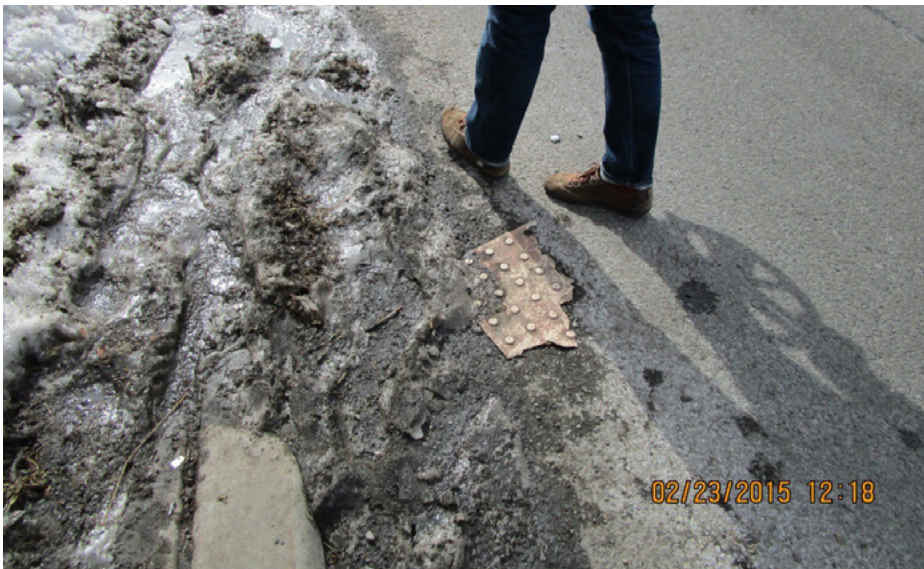
Figure 26: County Route 439 (Elmora Avenue), Elizabeth, NJ, looking south – Some of the textured plates leading to the school are in disrepair.

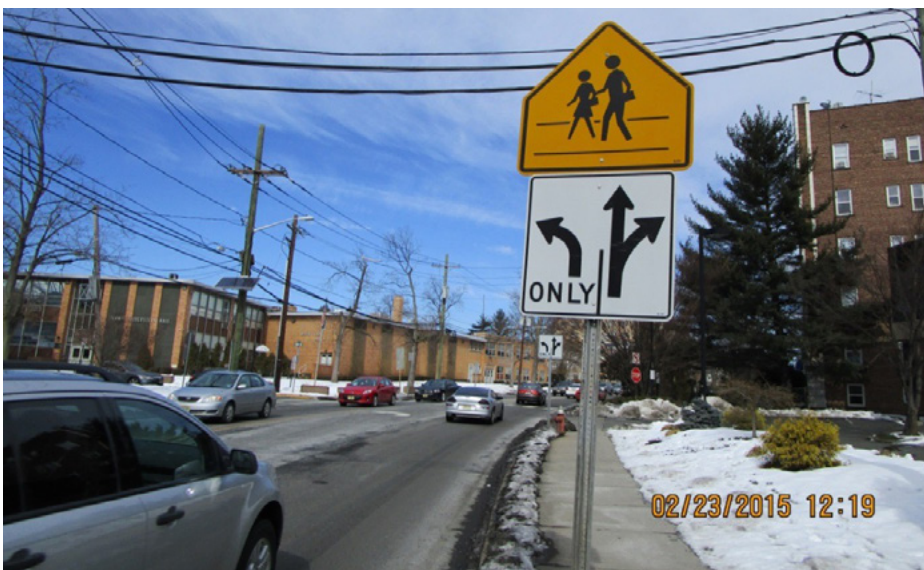
Figure 27: County Route 439 (Elmora Avenue), Elizabeth, NJ, looking north – School crossing sign on Rt. 439 with the Jewish Educational Center pictured on the left. There was no school crossing sign on Rt. 28.

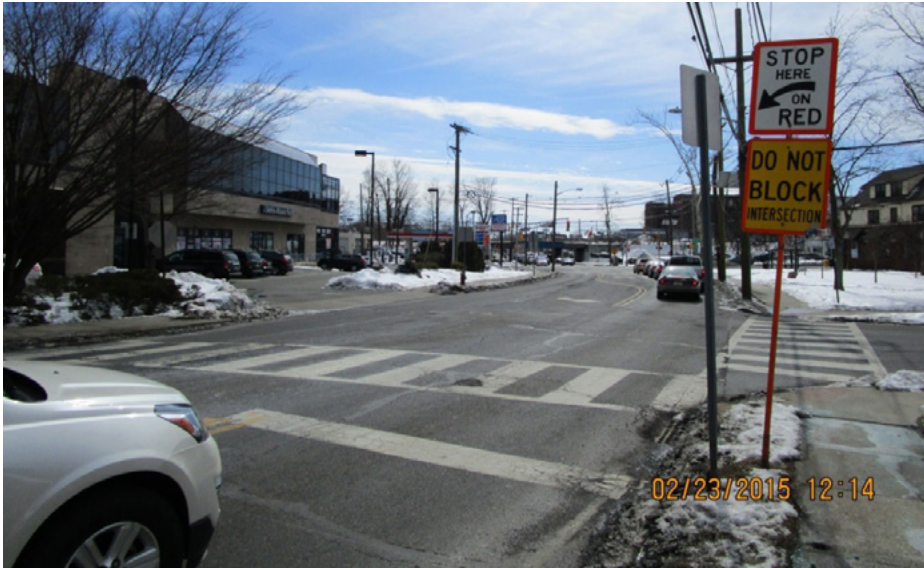
Figure 28: County Route 439 (Elmora Avenue), Elizabeth, NJ, looking south – A “Do Not Block Intersection” sign adjacent to the school is highly visible.

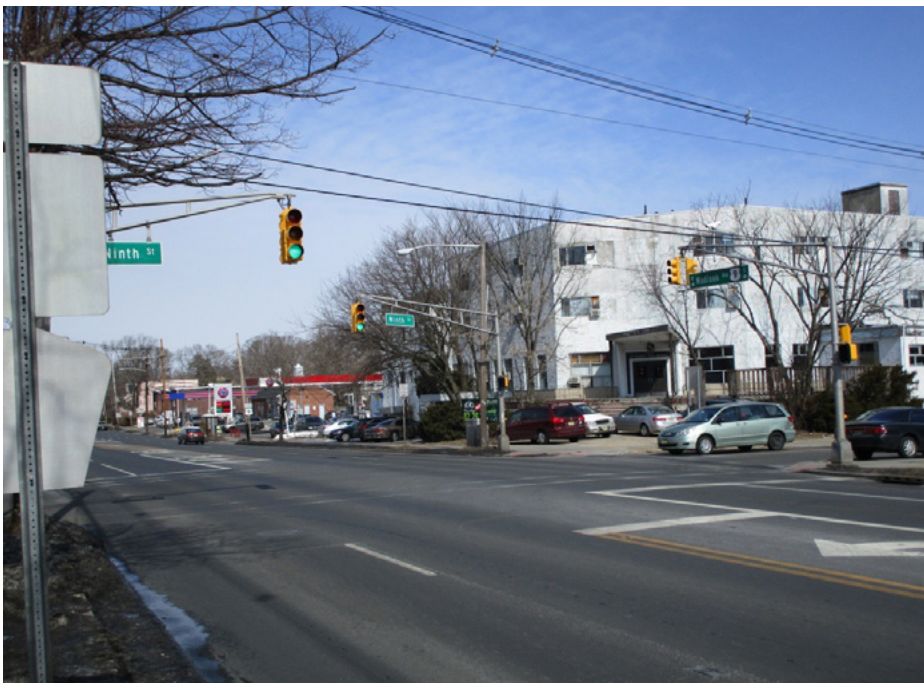
Figure 31: Route 9 (Madison Avenue) & 9th Street, Lakewood, looking northeast – Route 9 (Madison Avenue) & 9th Street is a primary intersection of concern. Various commercial activity is located nearby, including a gas station, supermarket and parking lots.

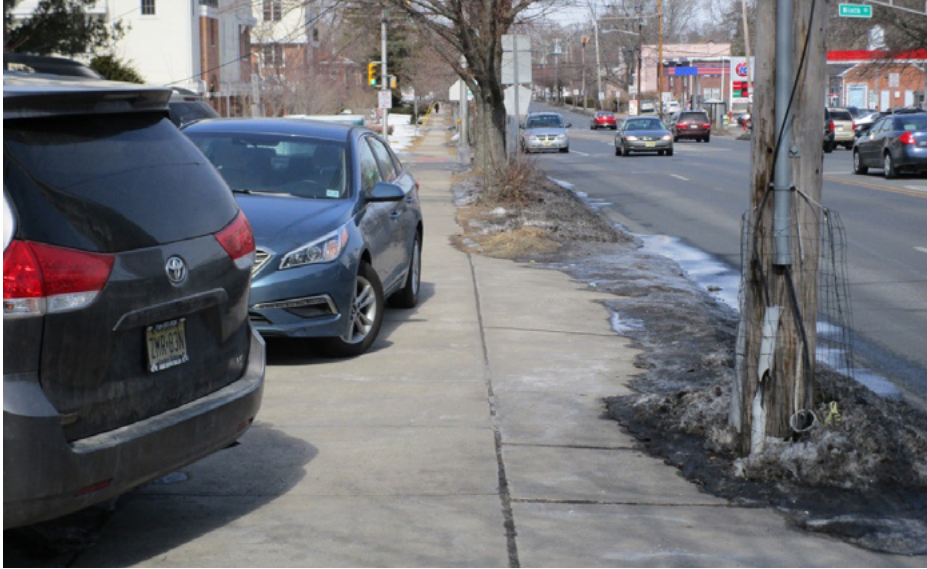
Figure 32: Route 9 (Madison Avenue) & 9th Street, Lakewood, looking north – Parking on the sidewalk near Route 9 (Madison Avenue) & 9th Street.

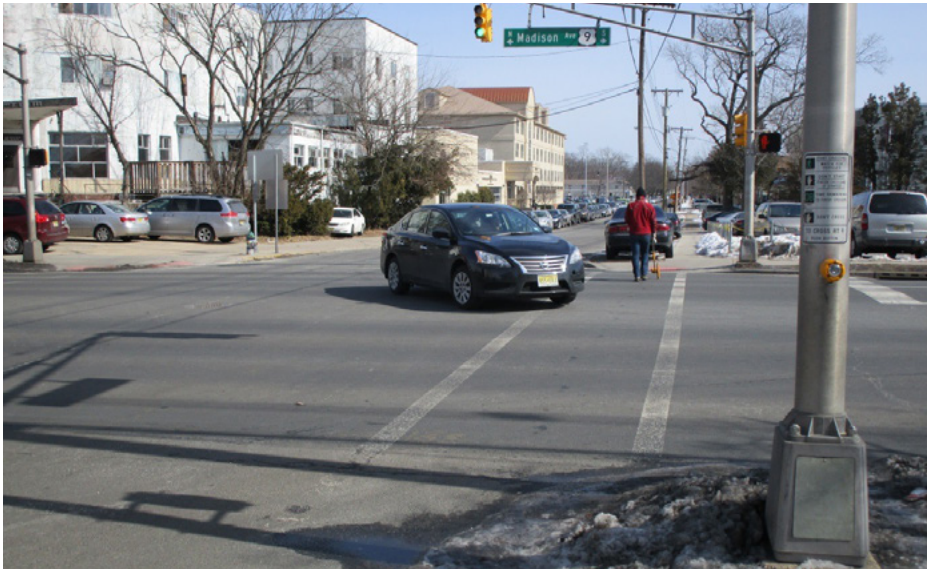
Figure 33: Route 9 (Madison Avenue) & 9th Street, Lakewood, looking east – The intersection features visual pedestrian signals, instructions and buttons but an insufficient number of ramps for ADA compliance. Striping is faded in some sections.

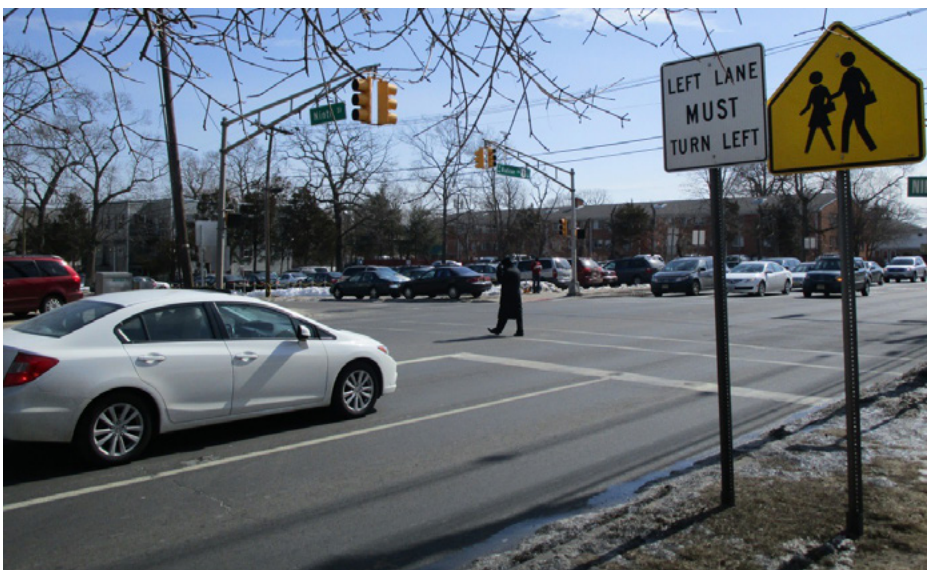
Figure 34: Route 9 (Madison Avenue) & 9th Street, Lakewood, looking southeast – A school sign is visible at the intersection on Route 9 (Madison Avenue).

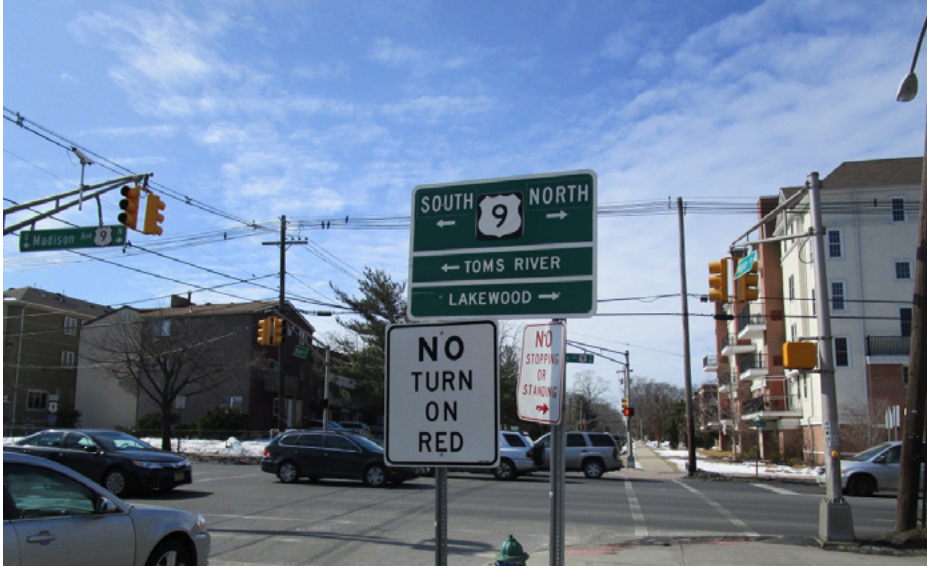
Figure 35: Route 9 (Madison Avenue) & 9th Street, Lakewood, looking north – No right turns on red are permitted onto Route 9 (Madison Avenue) from 9th Street.

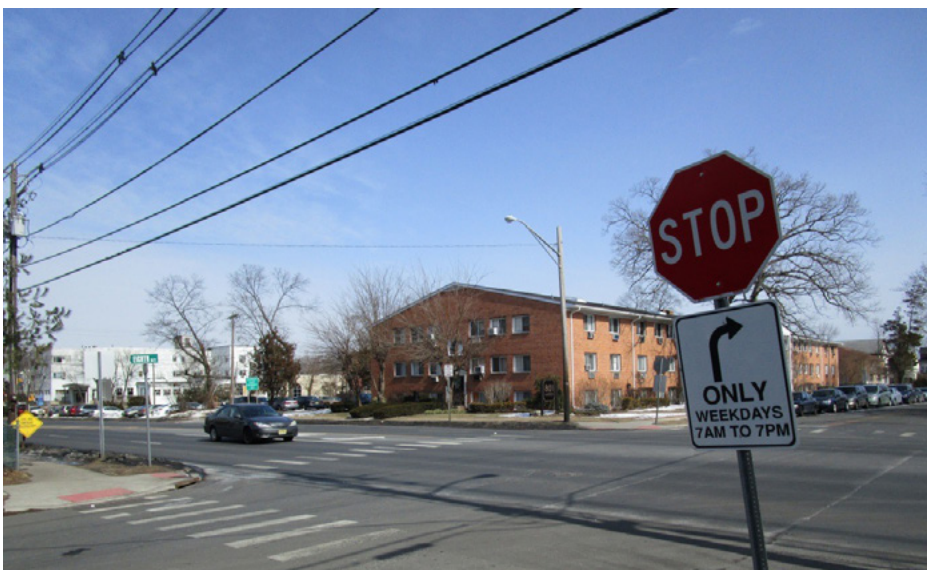
Figure 37: Route 9 (Madison Avenue) & 8th Street, Lakewood, looking northeast – Faded striping was evident at the intersection of Route 9(Madison Avenue) & 8th Street.

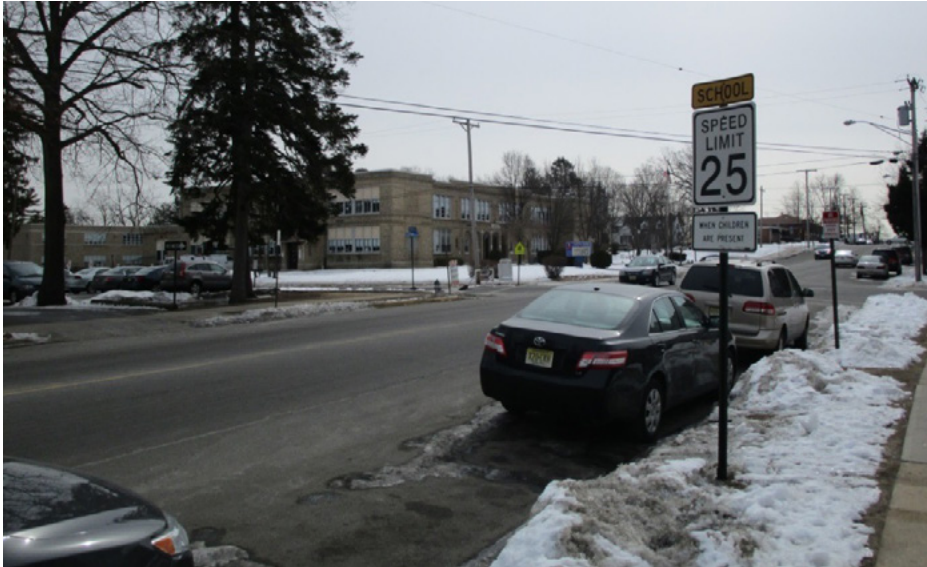
Figure 39: 7th Street & Clifton Avenue, Lakewood, NJ, looking southeast – School signs are visible just outside Clifton Avenue Grade School.

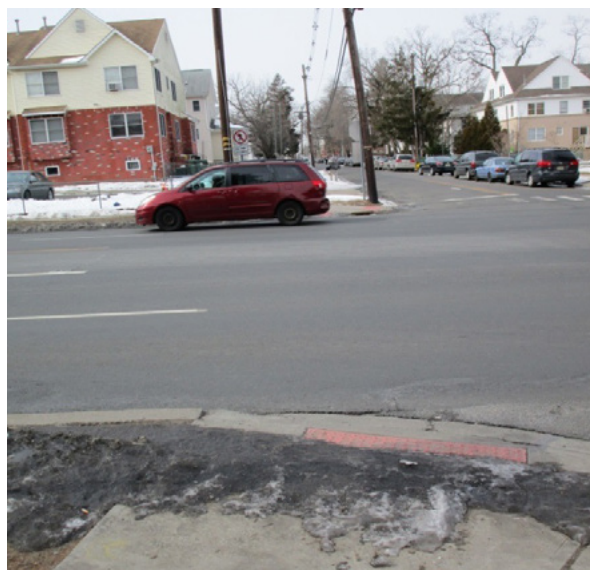
Figure 40: Route 9 (Madison Avenue) & 7th Street, Lakewood, NJ, looking west – Striping is absent at one particular crossing near Clifton Avenue Grade School.

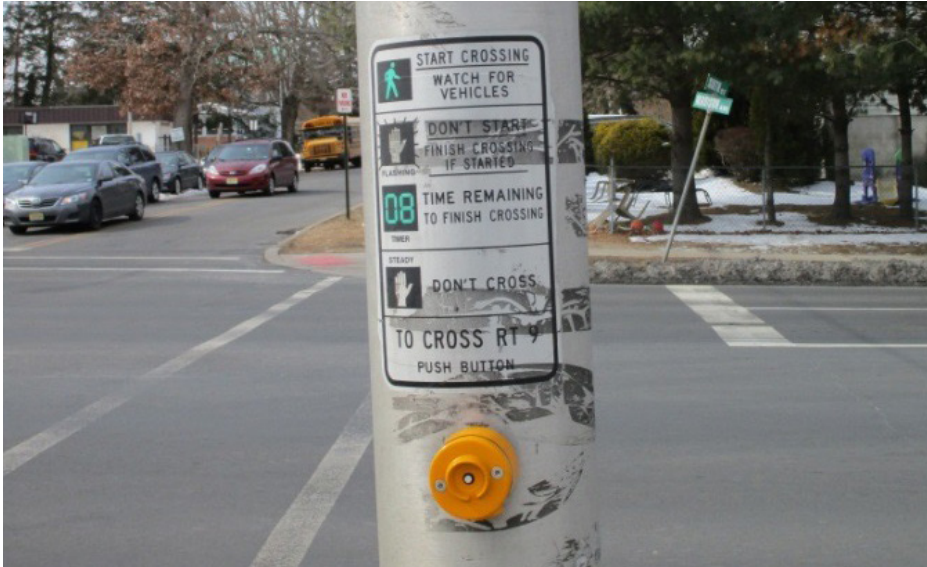
Figure 42: Route 9 (Madison Avenue) & 6th Street, Lakewood, NJ, looking east – Route 9 (Madison Avenue) & 6th Street features visual pedestrian signals, buttons, instructions and school signage.

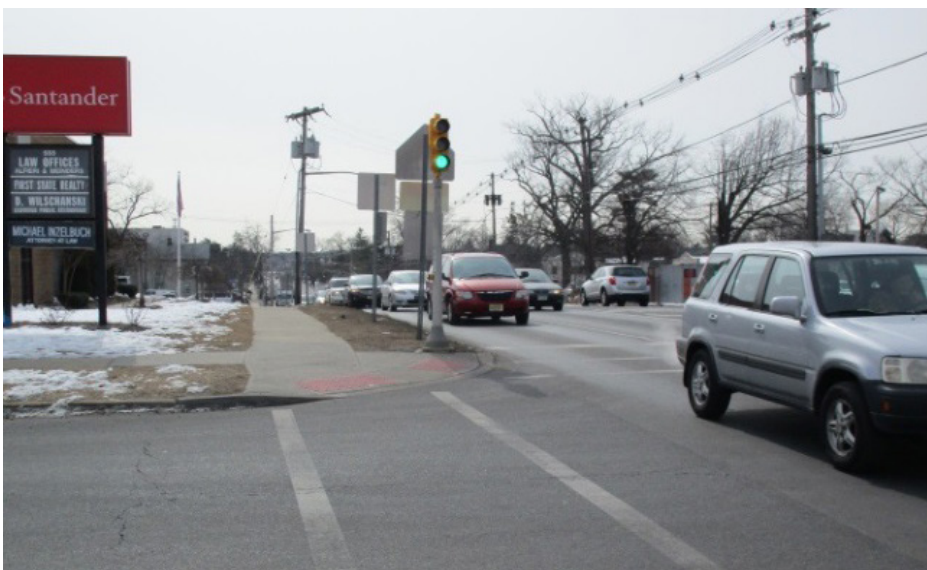
Figure 43: Route 9 (Madison Avenue) & 6th Street, Lakewood, NJ, looking south – Faded striping at Route 9 (Madison Avenue) & 6th Street. Commercial activity was evident in the area.

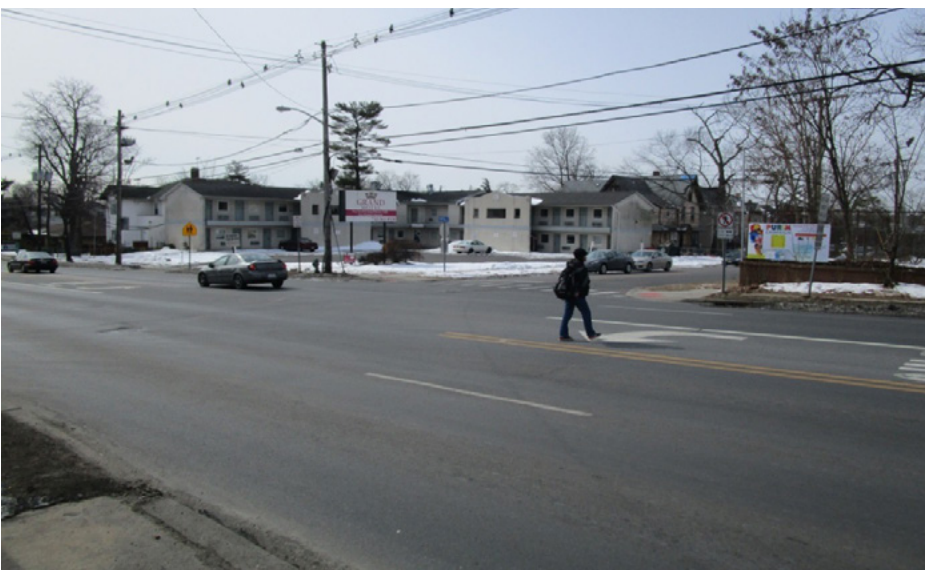
Figure 46: Route 9 (Madison Avenue) & 5th Street, Lakewood, NJ, looking southwest – The current conditions do not always encourage crossing at the crosswalk.

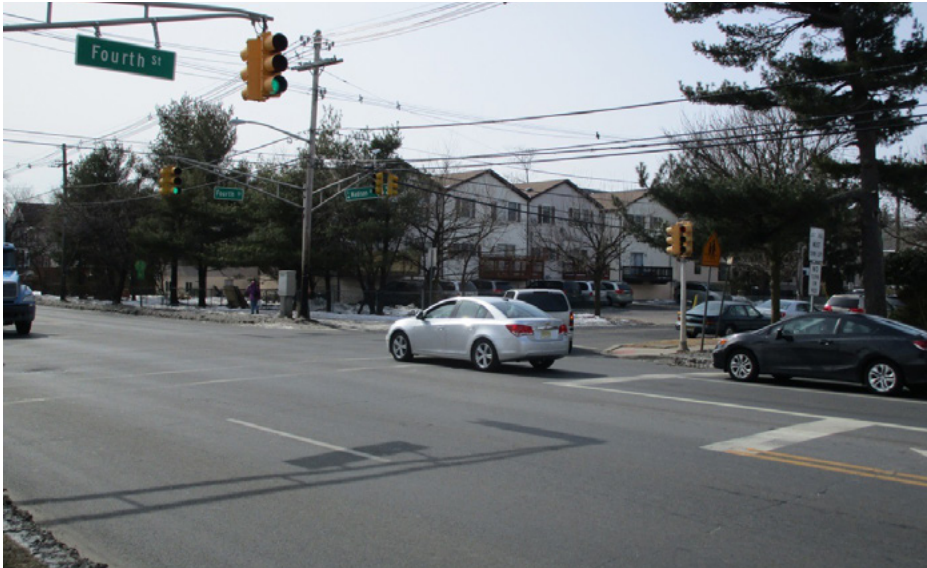
Figure 47: Route 9 (Madison Avenue) & 4th Street, Lakewood, NJ, looking southwest – Route 9 (Madison Avenue) and 4th Street is a primary intersection of concern and is similar in configuration to Madison Avenue & 6th Street.

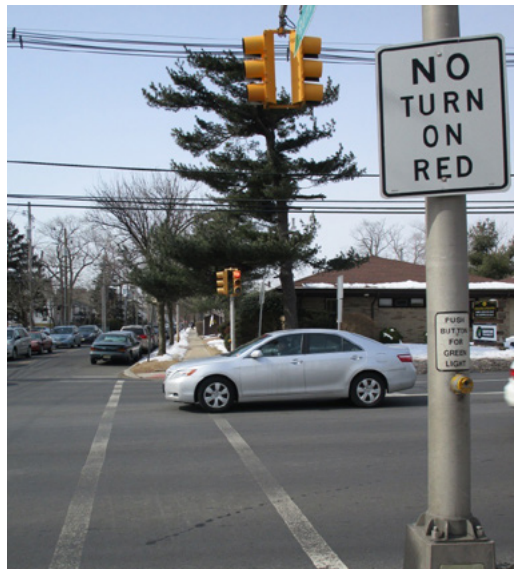
Figure 48: Route 9 (Madison Avenue) & 44h Street, Lakewood, NJ, looking west – No right turns on red are permitted onto Route 9 (Madison Avenue) from 4th Street.

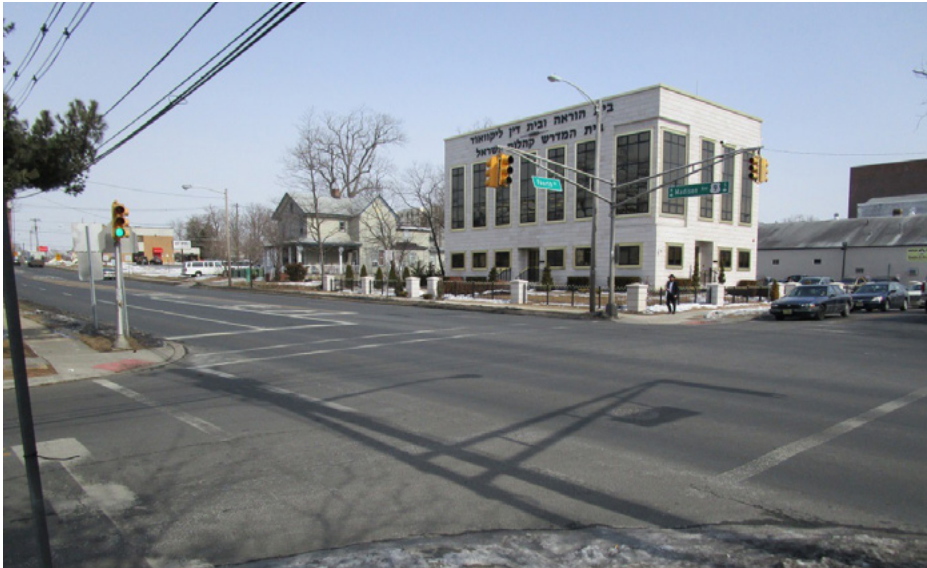
Figure 50: Route 9 (Madison Avenue) & 4th Street, Lakewood, NJ, looking northeast – Visual pedestrian signals are evident at Route 9 (Madison Avenue) & 4th Street but the striping is fading. Various commercial activities were observed near this intersection, such as banks and doctor’s offices.

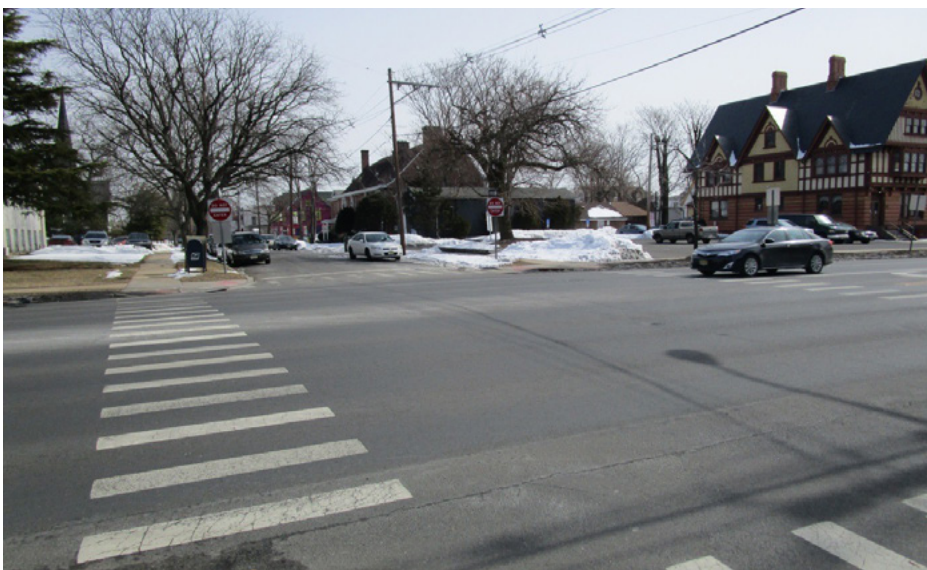
Figure 52: Route 9 (Madison Avenue) & 3rd Street, Lakewood, NJ, looking east – Ladder striping is utilized at Route 9 (Madison Avenue) & 3rd Street, but visual pedestrian crossing signals were absent.
