School Crossings on State Highways:

Improving Safety Near New Jersey's Schools

Prepared by:
Leigh Ann Von Hagen, Nicholas K. Tulach,
Catherine Bull, & Dan Chibbaro
New Jersey Safe Routes to School Resource Center
Alan M. Voorhees Transportation Center

Date:
April 2016

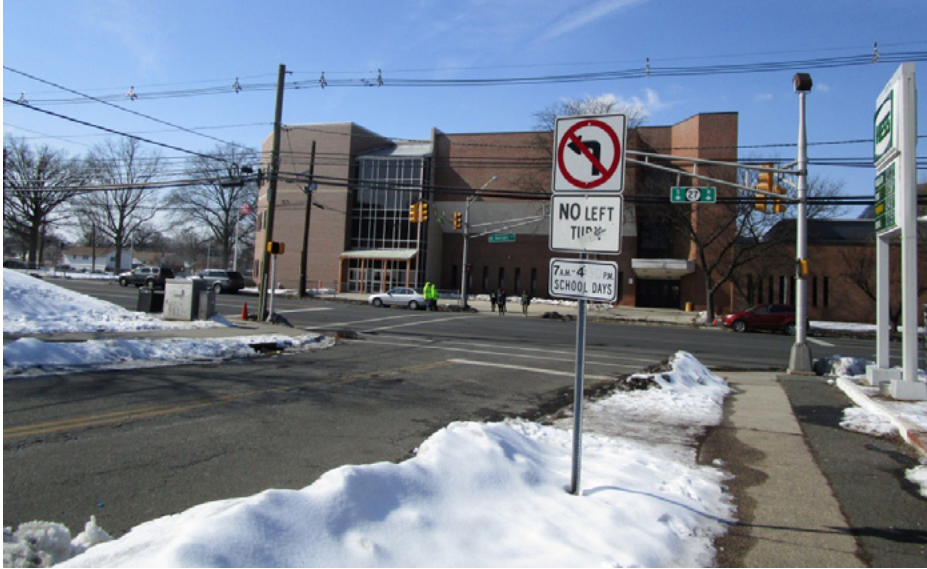
Figure 54: Route 27 (W St. Georges Avenue) & Ainsworth Street, Linden, NJ, looking northwest – The intersection features nearby school signage, crosswalk striping, visual pedestrian signals and crossing guards throughout the day. There is only striping for crossing at two out of the three sections of the intersection. Linden High School has a building on each side of the intersection.

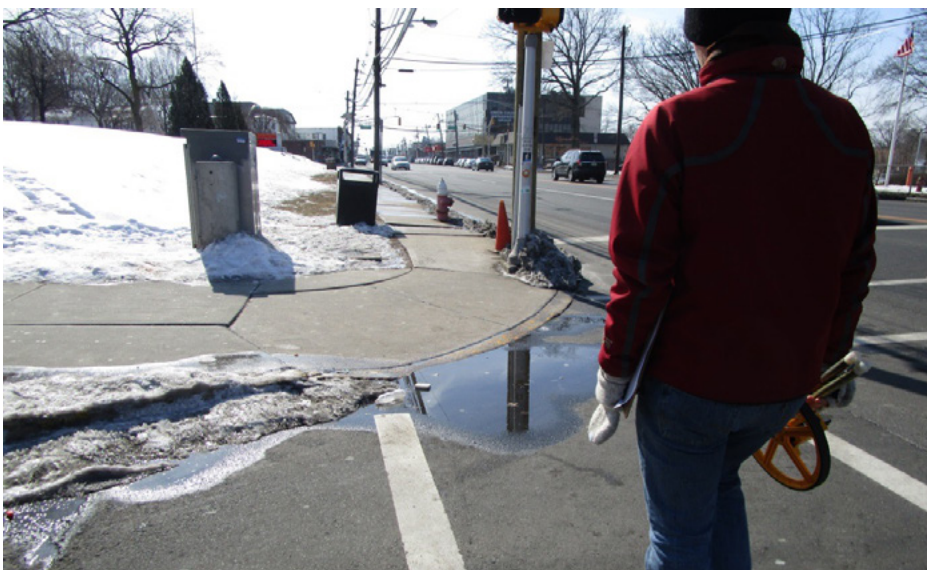
Figure 56: Route 27 (W St. Georges Avenue) & Ainsworth Street, Linden, NJ, looking southwest – The curbs at the intersection lack truncated domes for ADA compliance.

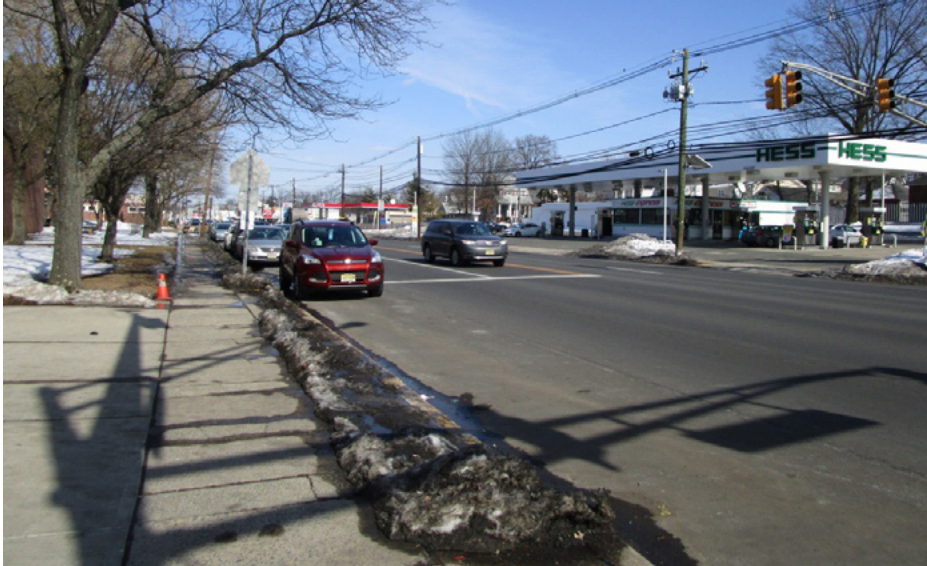
Figure 57: Route 27 (W St. Georges Avenue) & Ainsworth Street, Linden, NJ, looking northeast – Commercial activity at the intersection includes a gas station that poses a hazard for pedestrians.

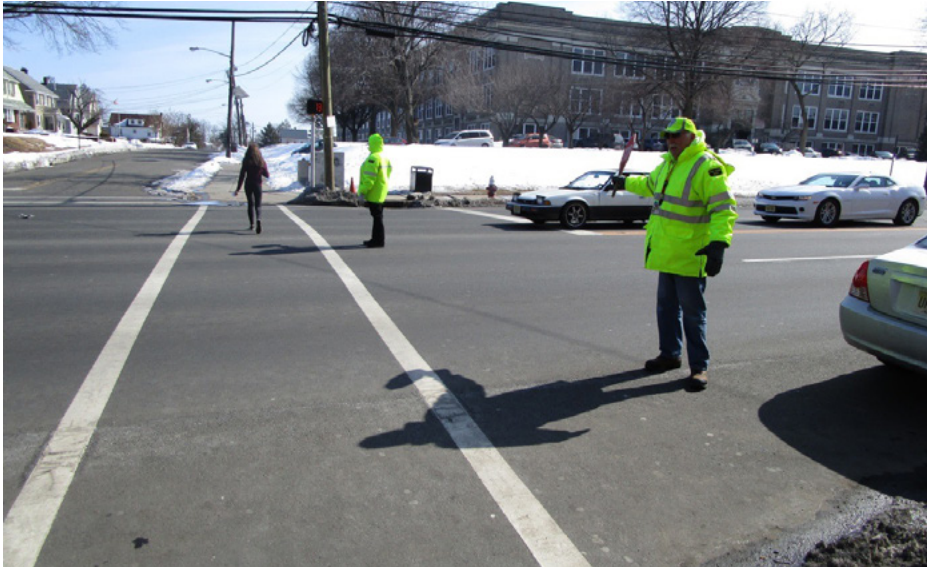
Figure 58: Route 27 (W St. Georges Avenue) & Ainsworth Street, Linden, NJ, looking southeast – The crossing guards assist a pedestrian across Route 27 (W St. Georges Ave).

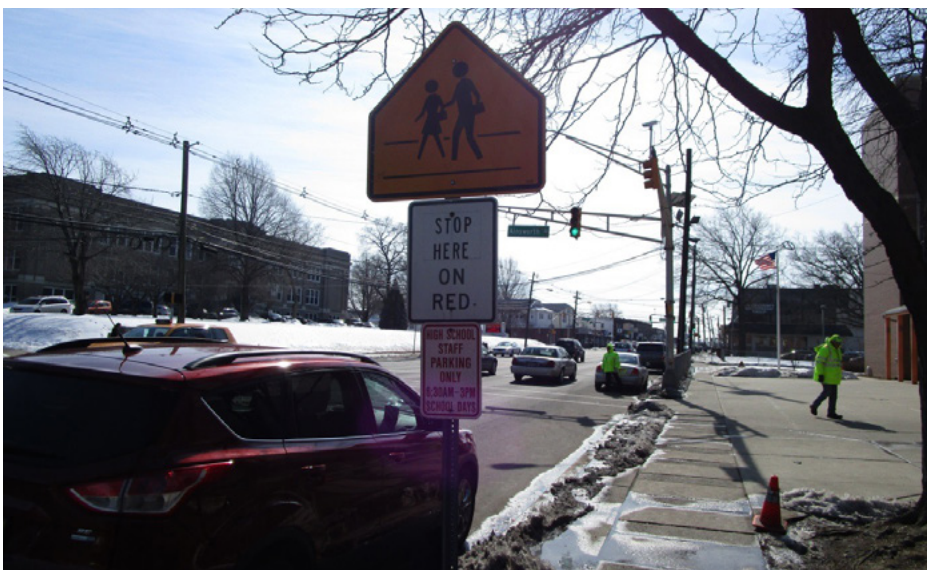
Figure 59: Route 27 (W St. Georges Avenue) & Ainsworth Street, Linden, NJ, looking southwest – A school sign on Route 27 (W St. Georges Ave)

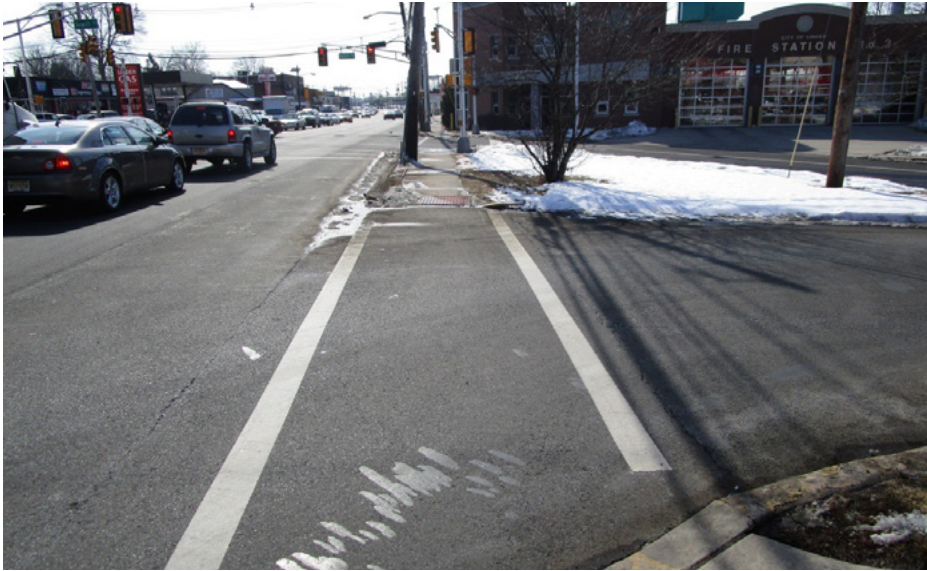
Figure 60: Route 27 (W St. Georges Avenue) & Dewitt Terrace, Linden, NJ, looking southwest – The nearby intersection of Route 27 and Dewitt Terrace features a pedestrian island.

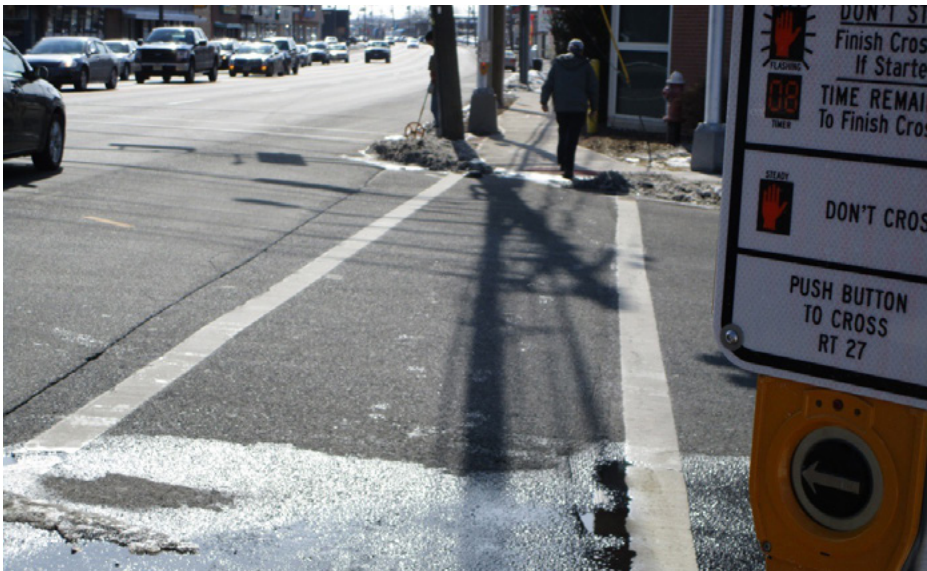
Figure 61: Route 27 (W St. Georges Avenue) & Dewitt Terrace, Linden, NJ, looking southwest – The pedestrian island at the intersection of Route 27 and Dewitt Terrace features visual and audible pedestrian signals and instructions for crossing.

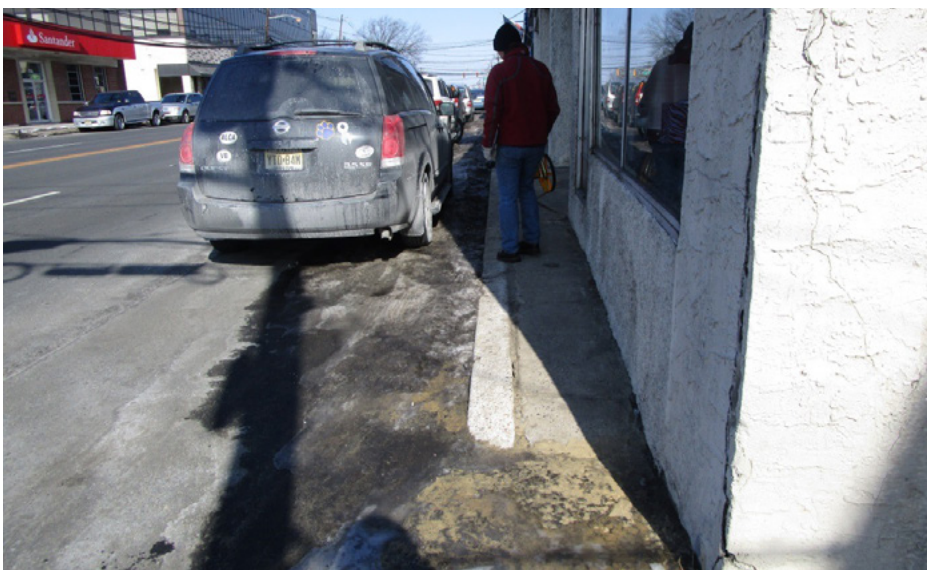
Figure 62: Route 27 (W St. Georges Avenue) & Dewitt Terrace, Linden, NJ, looking northeast – Very narrow sidewalks near the school.

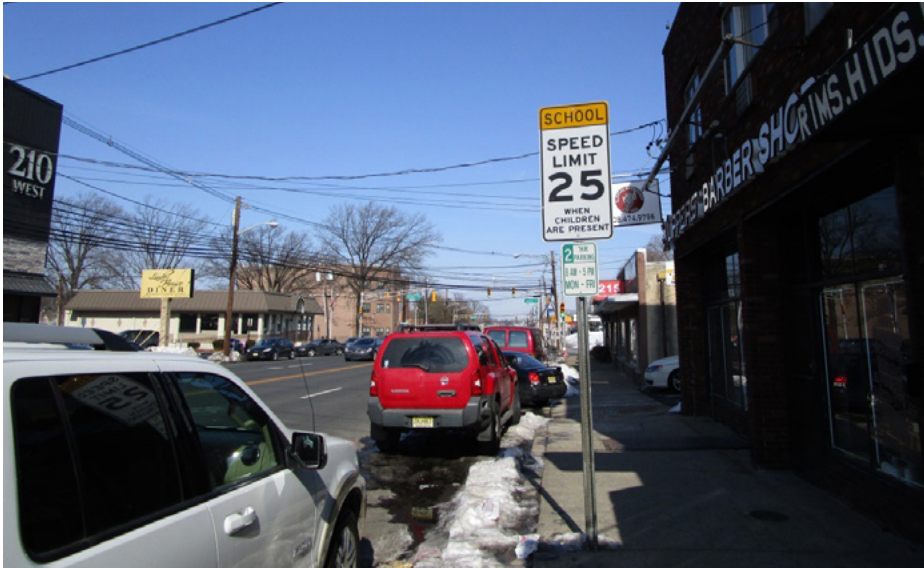
Figure 63: Route 27 (W St. Georges Avenue) & Dewitt Terrace, Linden, NJ, looking southwest – Additional school signs are observable in the area near Linden High School.

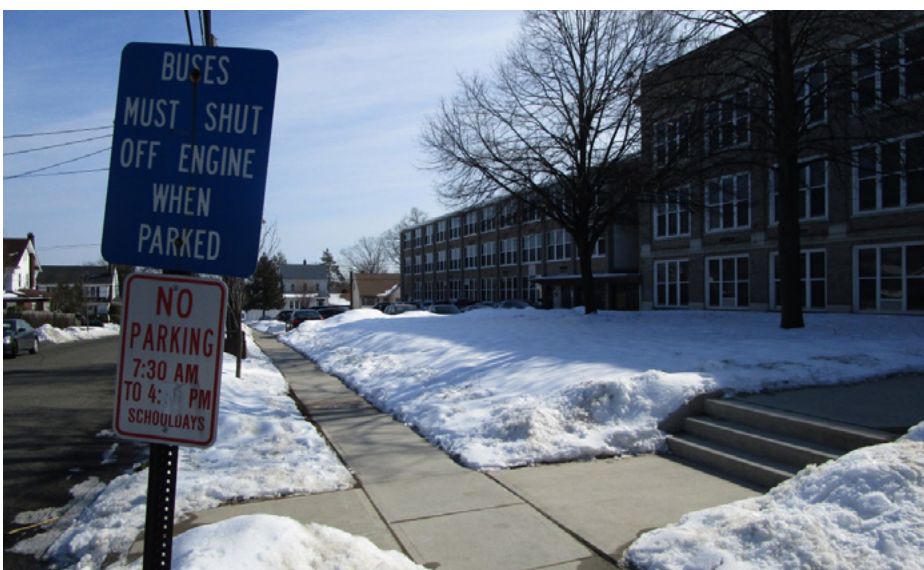
Figure 65: Summit Street, Linden, NJ, looking southeast – No parking during school hours sign in the driveway directly in front of the school.

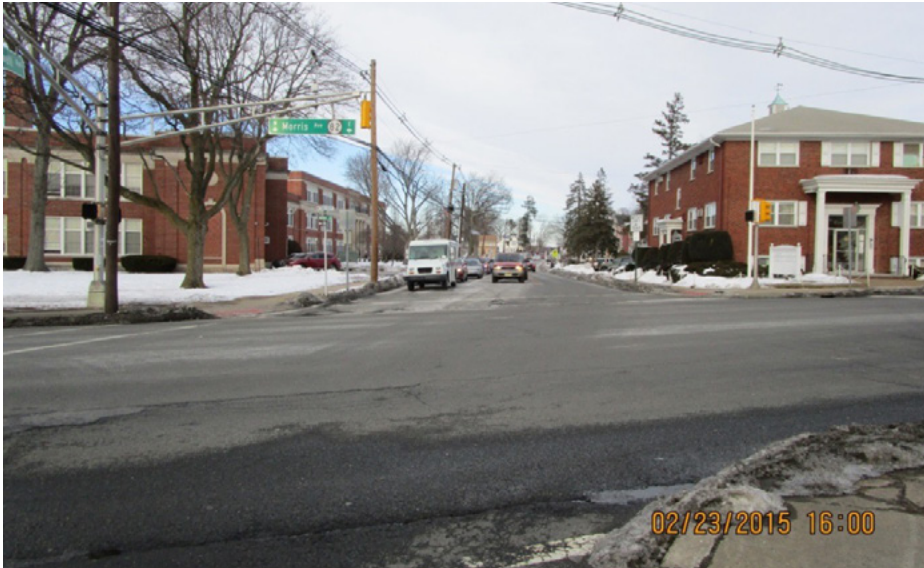
Figure 67: State Route 82 (Morris Avenue) & Caldwell Avenue, Union, NJ, looking northeast – Crosswalk striping is only present at three of the four crossings of the intersection.

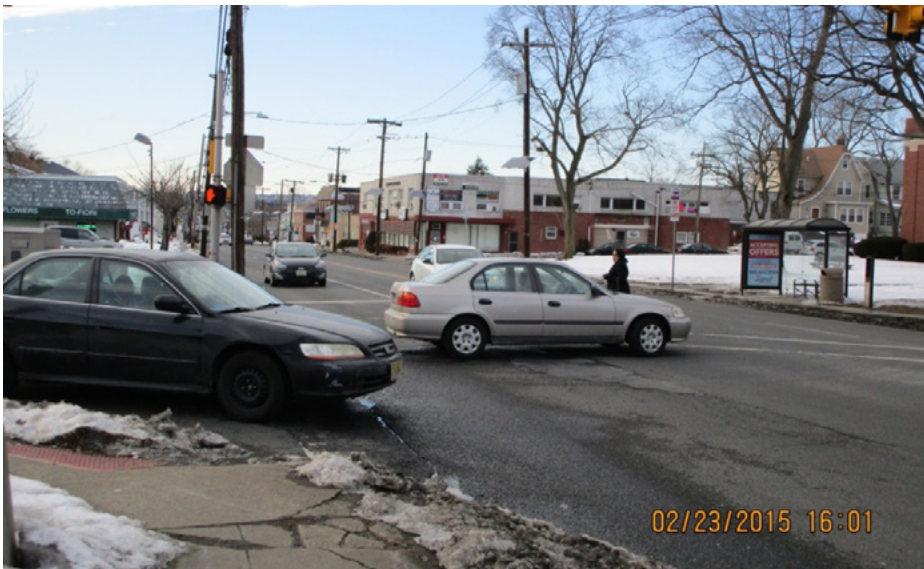
Figure 68: State Route 82 (Morris Avenue) & Caldwell Avenue, Union, NJ, looking northwest – This long, diagonal crossing is the only way to safely cross Rt. 82. Burnet Middle School is just visible on the right. The crosswalk striping is faded. School signage needs to be updated to current federal standards.

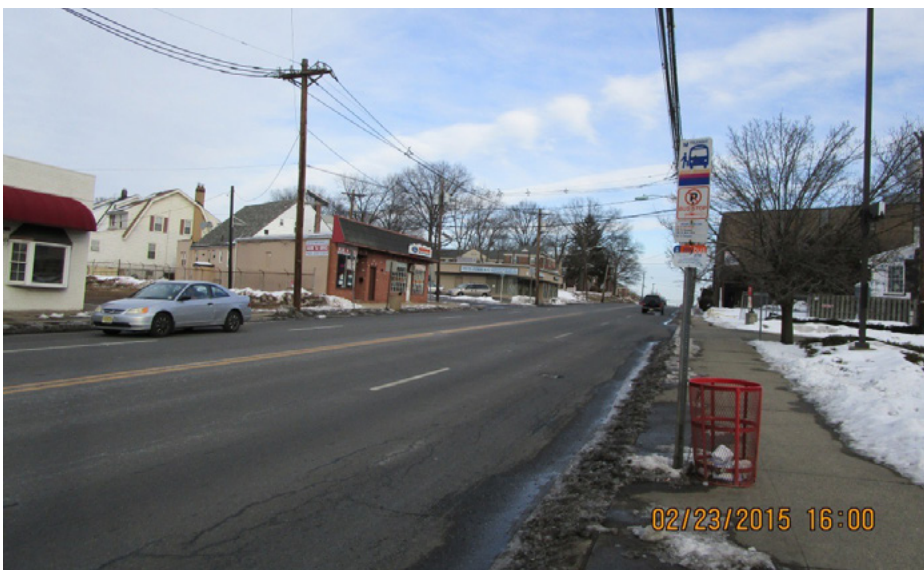
Figure 69: State Route 82 (Morris Avenue) & Caldwell Avenue, Union, NJ, looking southeast – A NJ Transit Bus stop is situated near the intersection.

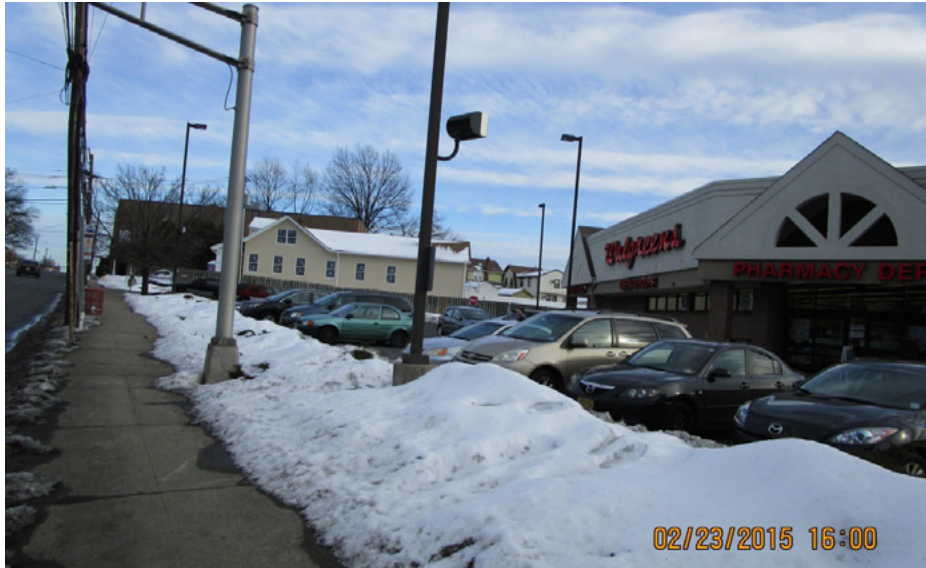
Figure 70: State Route 82 (Morris Ave) & Caldwell Ave, Union, NJ, looking south – There is commercial activity at the intersection, particularly a Walgreens that features a parking lot that could lead to conflicts between vehicles and pedestrians.

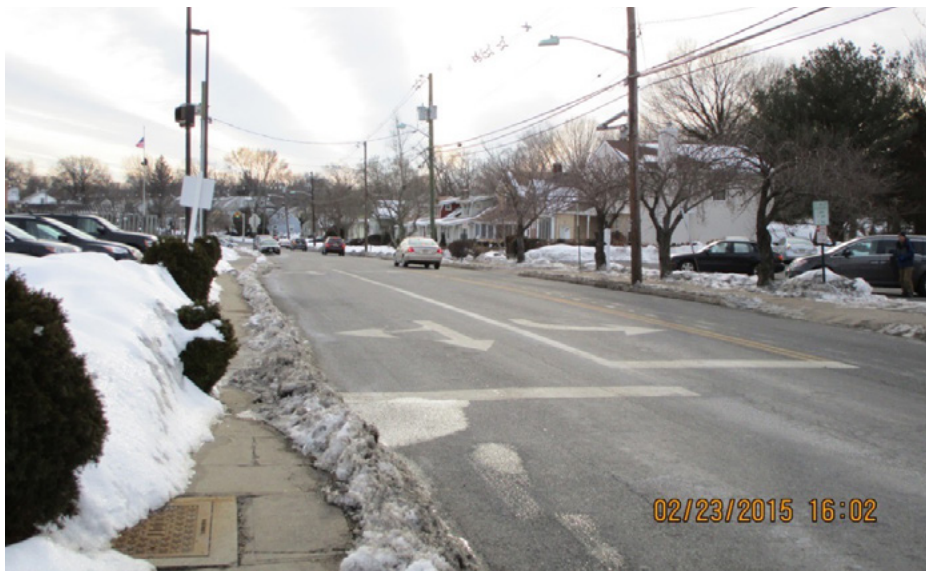
Figure 71: State Route 82 (Morris Avenue) & Caldwell Avenue, Union, NJ, looking southwest – The intersection features narrow sidewalks on certain points of Rt. 82 and Caldwell Avenue.

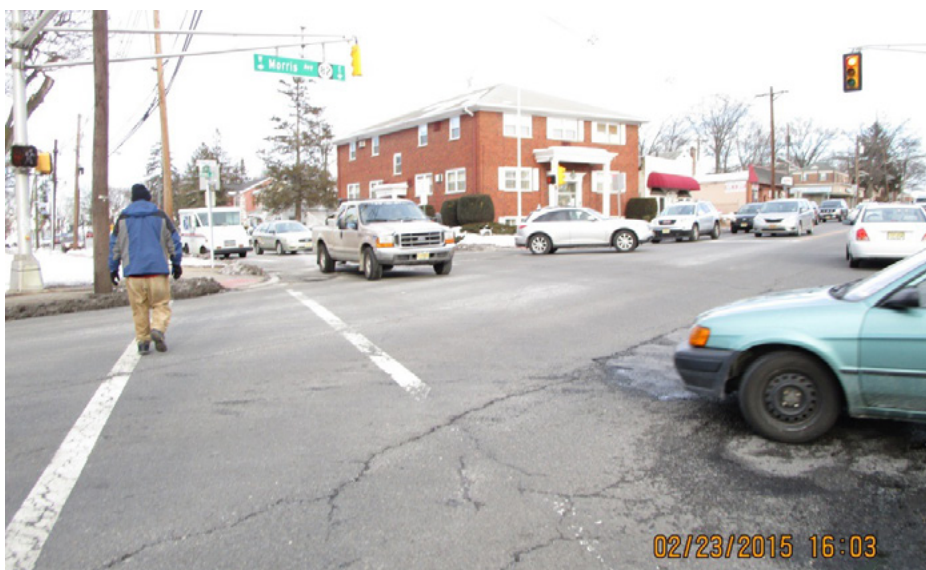
Figure 72: State Route 82 (Morris Avenue) & Caldwell Avenue, Union, NJ, looking northeast – A pedestrian crosses Rt. 82 towards Burnet Middle School.

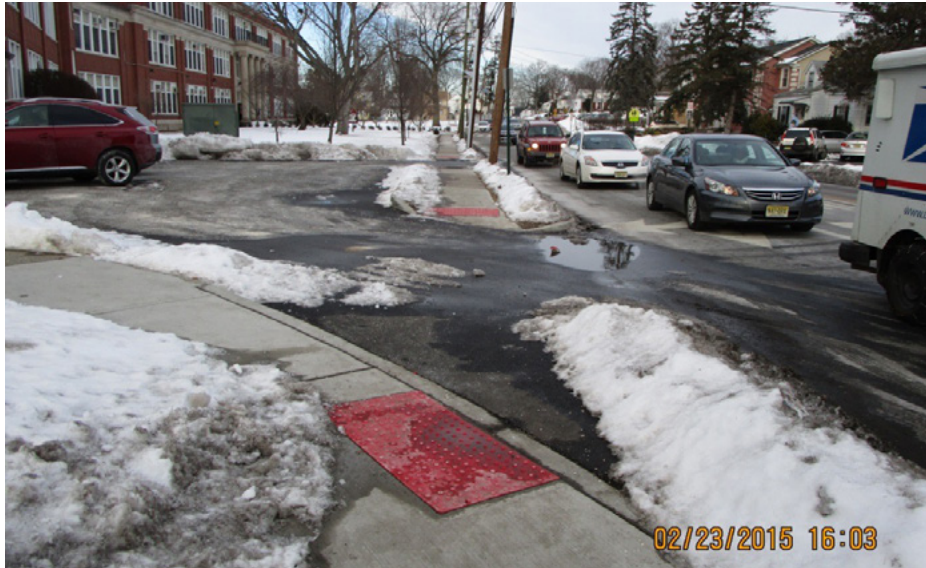
Figure 73: State Route 82 (Morris Avenue) & Caldwell Avenue, Union, NJ looking northeast – Crosswalk striping and other pedestrian signals or signage were missing in front of this parking lot adjacent to Burnet Middle School (visible on the left).

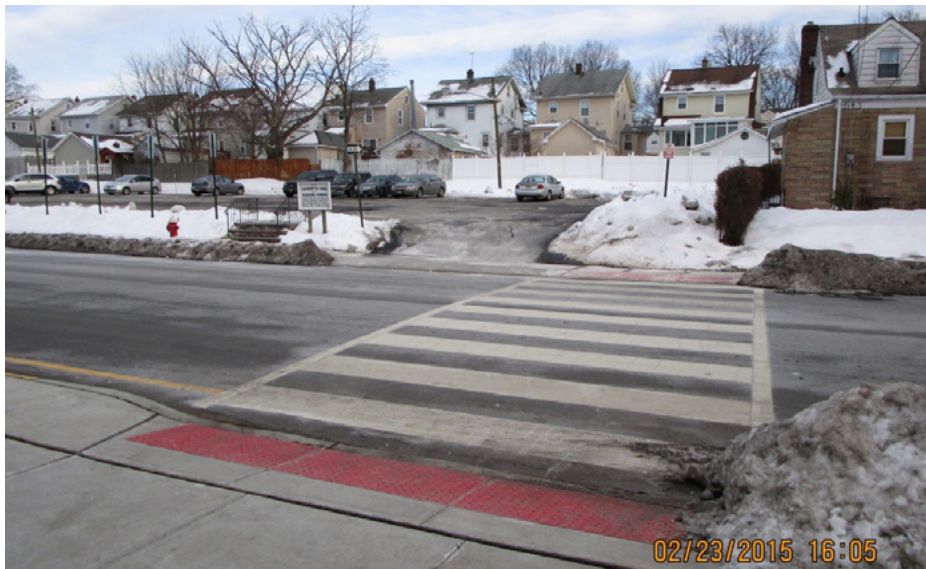
Figure 74: Caldwell Avenue, Union, NJ looking southeast – Caldwell Avenue features a visible pedestrian crossing adjacent to the school.

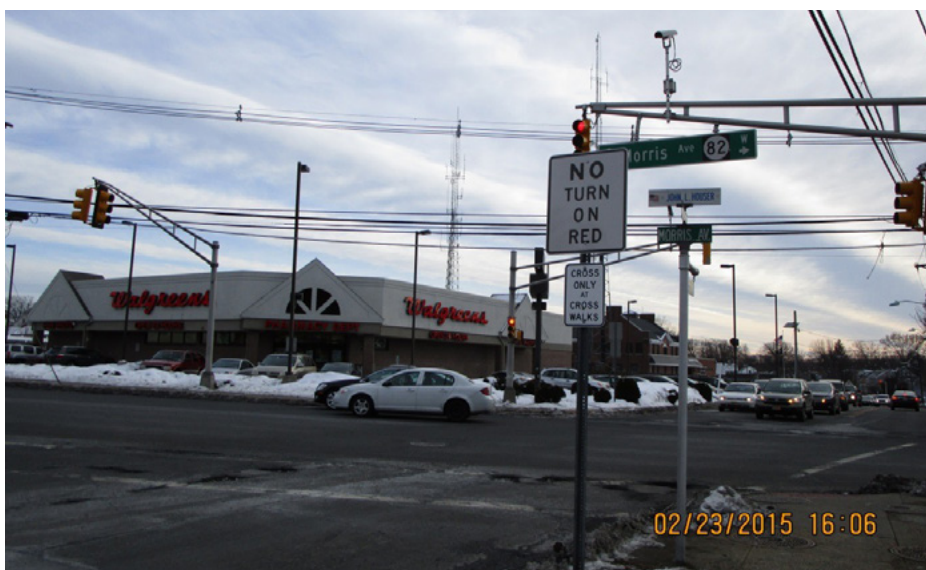
Figure 75: State Route 82 (Morris Avenue) & Caldwell Avenue, Union, NJ looking south – Right turns on red are not permitted at the intersection.

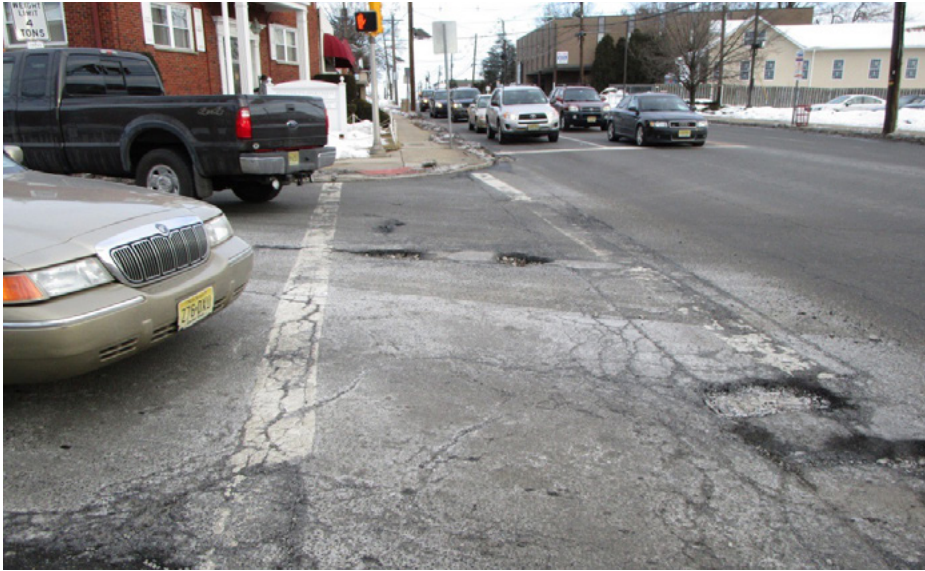
Figure 76: State Route 82 (Morris Avenue) & Caldwell Avenue, Union, NJ looking southeast – Potholes in the intersection are hazardous to pedestrians and may encourage crossing outside of the crosswalks.
