Walkability & Bikeability Assessment

Bound Brook Borough

Walkability & Bikeability Assessment Route

Borough of South Bound Brook Walkability & Bikeability Asssessment

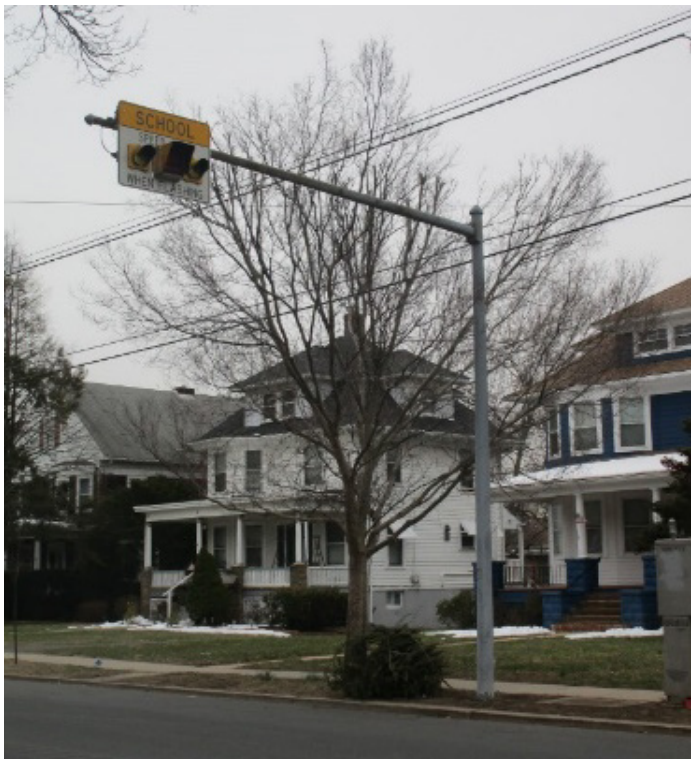
Speed Limit Signs

Bound Brook High School fronts a very busy state road, NJ-28. Many vehicles exceed the posted speed limit despite overhead flashing beacons warning of lower speed limits during school arrival and dismissal. School speed zone lights and signage (West Maple Ave) are limited and begin well within the school zone.

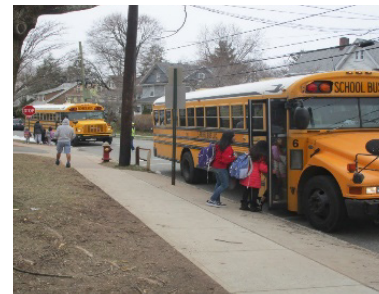
Ineffective No Parking Signs

Illegal parking around all schools is a common issue. At LaMonte School, a two-way street is converted into one-way during school hours which is an effective way to improve safety. However, parked vehicles line the road into the no parking zones up to and sometimes blocking the crosswalks. At Lafayette Elementary School, no parking signs did not stop parents from parking in front of the school causing the school buses to park further from the school. At both LaMonte and Lafayette, drivers without disability parking placards parked illegally in the spaces reserved for people with disabilities.

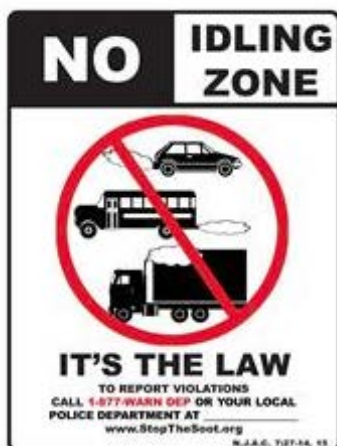
English Universal

No Idling Signs can be ordered from the NJ Department of Environmental Protection, but should also include an education component to parents and other residents.

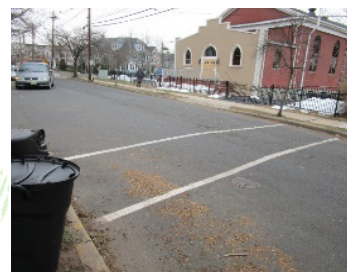
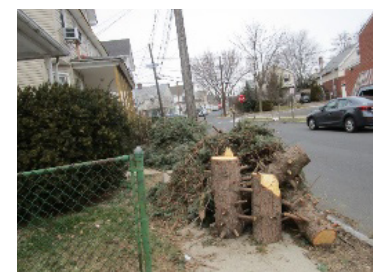
Blocked Sidewalks

Residents should be reminded that even temporary sidewalk obstructions (garbage cans, snow, tree limbs and leaves) can be hazardous for pedestrians.

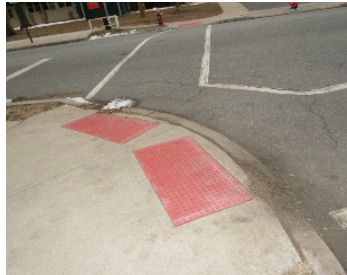
Incorrectly Placed Truncated Domes

Incorrectly placed truncated dome pad directs pedestrians into the middle of the street, not into crosswalks.

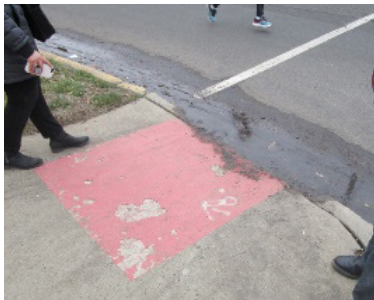
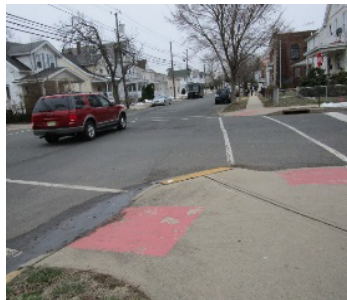
Painted Truncated Domes

Painted truncated domes are not in ADA compliance. Also, poor drainage around the curb is unfriendly to pedestrians, especially when frozen in winter.

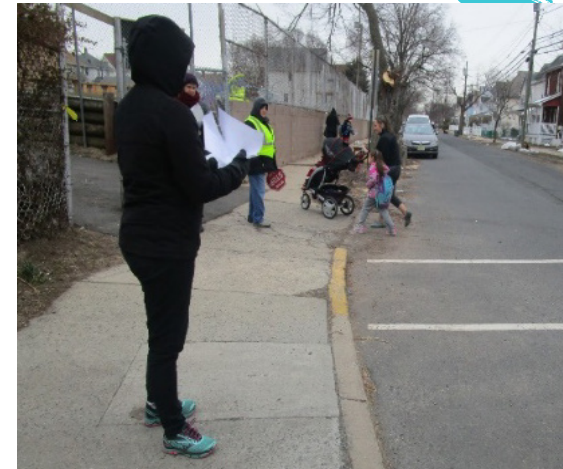
Disconnected Curb Cut and Crosswalk

Curb cuts and crosswalks are disconnected forcing pedestrians with strollers or in wheelchairs to cross outside the crosswalk directly behind Lafayette School.

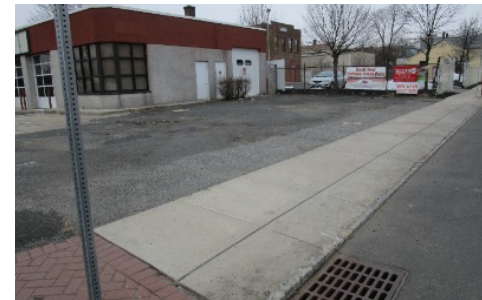
Excessively Wide Driveways

Extremely wide driveways were found at some downtown blocks.

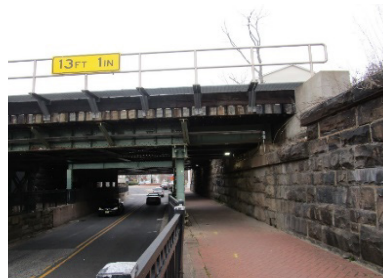
Uninviting Entrance

A dark and uninviting entrance to Bound Brook from South Bound Brook could be made friendlier with brighter, concrete sidewalks, better lighting and hanging planters.

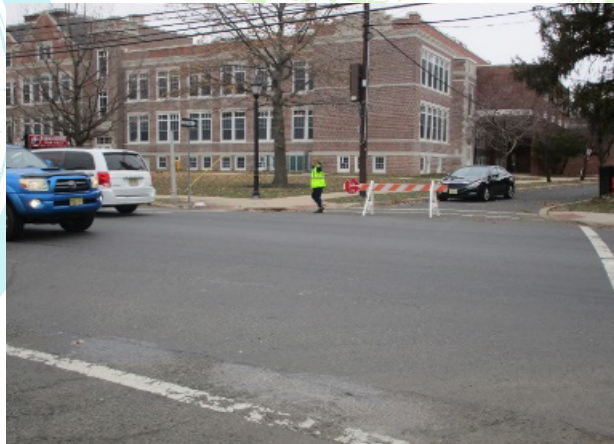
Fast Traffic at the front of Bound Brook High School

There is speeding traffic at the intersection closest to Bound Brook High School (NJ-28 and Winsor St) with no traffic signals. Wide crossings along this straight, flat stretch could be safer with pedestrian refuge island(s) or other treatments that include plantings.

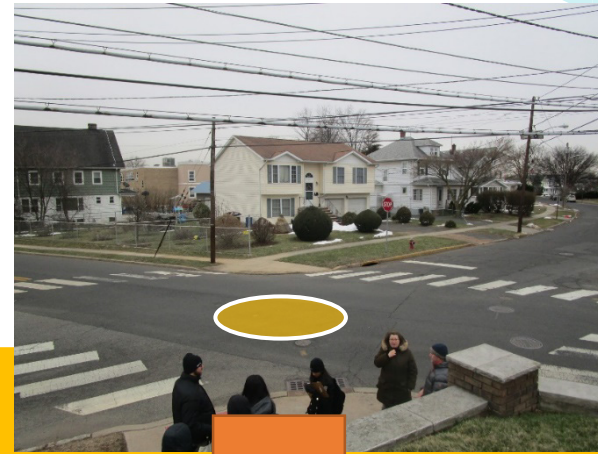
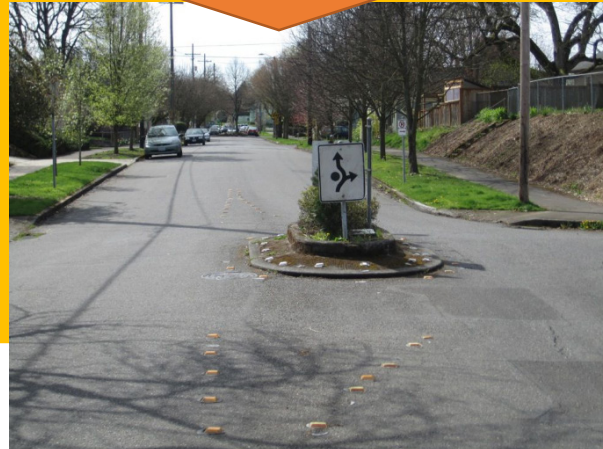
Intersection with Frequent Speeding

Frequent speeding along Vosseller Ave can be mitigated with traffic calming techniques such as a mini-roundabout which can include plantings and mountable curbs. Other options include curb extensions and/or narrowing travel lanes.

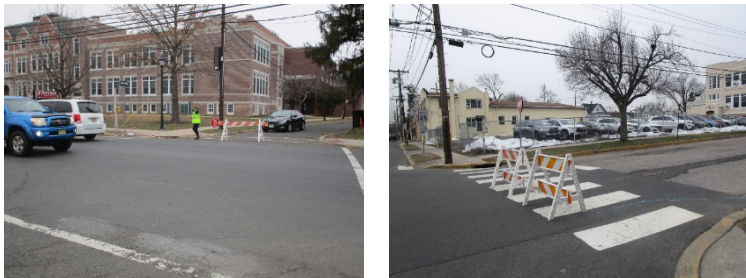
Good Examples in Bound Brook Closed Streets Provide Better Safety

One side of street is closed for safety during school hours. (Left: Bound Brook High School; Right: LaMonte School)

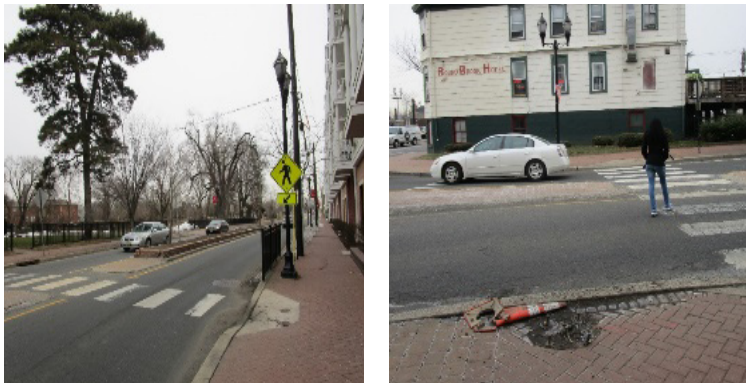
Need for Maintenance

Decorative brick pavers may look great when newly installed, however, can get beat up quickly and can cause uneven surfaces and tripping hazards. Brick pavers are better used for buffer areas between the sidewalk and road while using smooth, more durable concrete for sidewalk surfaces. Crosswalks should be striped on all four corners of the roundabout.

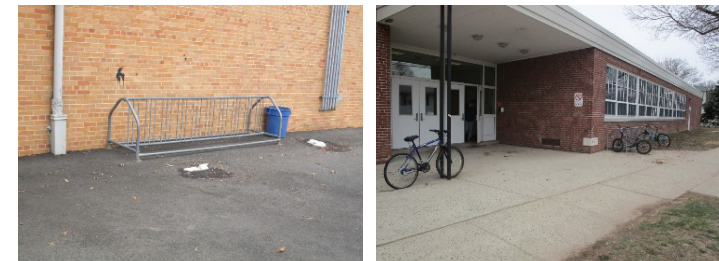
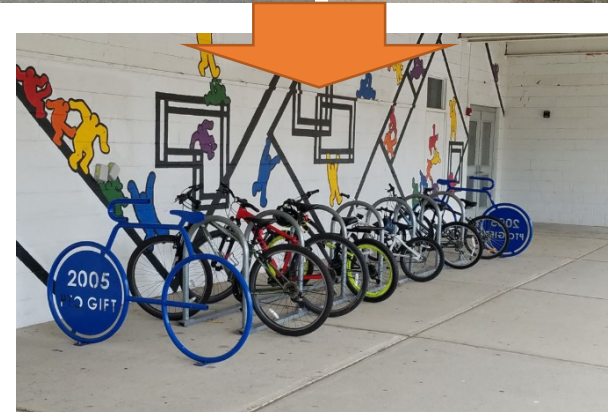
Poor Bike Rack Placement at Schools

The bike parking rack at Lafayette School is intended to be double-sided but only one side is available since the rack is placed against the wall. The position should be changed to make both sides accessible. In addition, it is located in an area with no windows or oversight from the school putting bikes at risk for theft.

At Bound Brook High School, pillars at entrances are used to lock bikes which may partially block entrances/exits during an emergency. More secure inverted U-racks are recommended to be placed in high visibility, sheltered areas to deter theft.

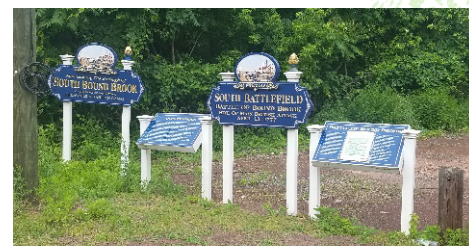
Access Points and Historic Significance

The Queens Bridge is an excellent opportunity for wayfinding and placemaking to help visitors connect with history and access the D&R Canal, the Raritan River, and downtown shops and amenities on either side. The entry points to the bridge are not well signed to alert users to the historic significance or river and canal access points. Partnering with the D&R Canal State Park, Crossroads to the American Revolution, and Somerset County Cultural and Historical Commission to improve wayfinding, additional historic informational signs along the bridge, landscaping at entry points, seasonal flags and decorations, and additional lighting could help make the bridge a primary destination for history buffs and visitors accessing land and water trails while providing information about downtown food and shopping destinations in both towns.

Signs provide historic information but lack landscaping and wayfinding to trail and downtown destinations.

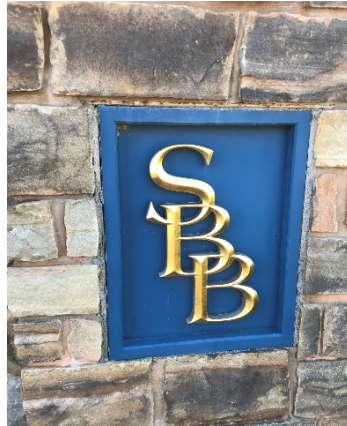
Color and Design

The street signs on Main Street are attractive, historic-looking and share the same blue theme-color with other street furniture and infrastructure in the downtown area.

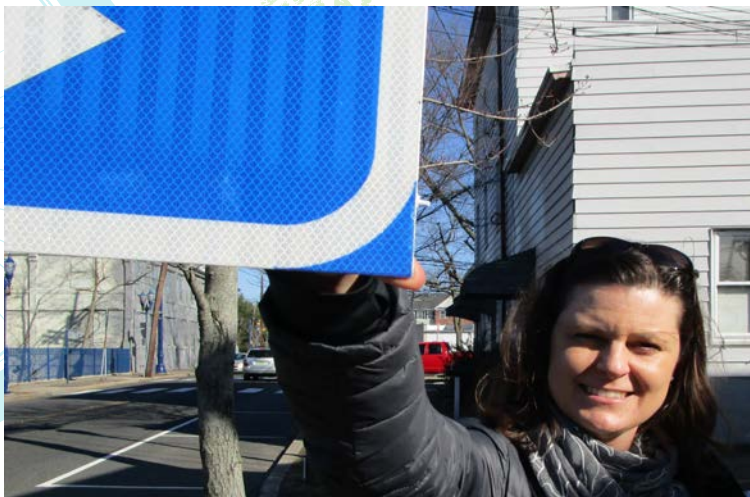
Sharp corner of sign at head height poses risk to pedestrians.

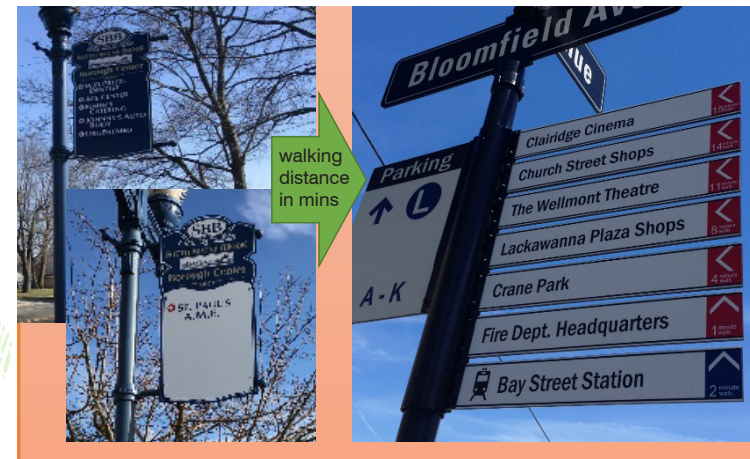
Difficult to read wayfinding signs

There are nice wayfinding signs but many are difficult to see as they are oddly placed high above the street. The signage placement is primarily oriented towards motorists not pedestrians, yet the smaller font size would suggest they are more likely to be seen at slower walking and bicycling speeds. Walking distance can be added to encourage foot-traffic and increase healthy behaviors.

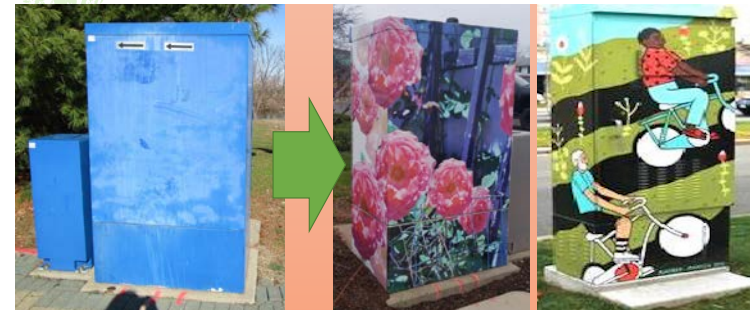
Plain Utility Box

Utility boxes are an opportunity for adding wayfinding and placemaking. For example, this box could be wrapped in a sign providing historic information or used to identify an entry point to the canal walk and potential kayak access point.

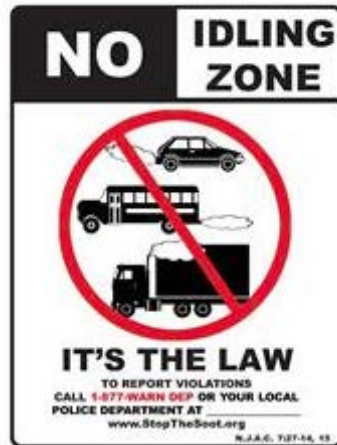
English Universal

No Idling Signs can be ordered from the NJ Department of Environmental Protection, but should also include an education component to parents and other residents.

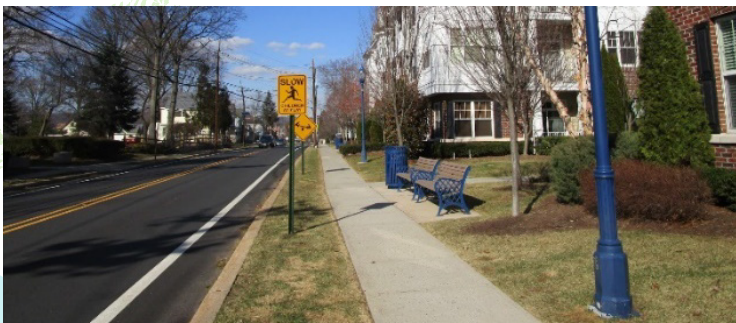
Quality Sidewalk and Street Furniture

Newer residential development on Elizabeth Ave across from the Robert Morris School features quality sidewalk and street furniture which is inviting to pedestrians.

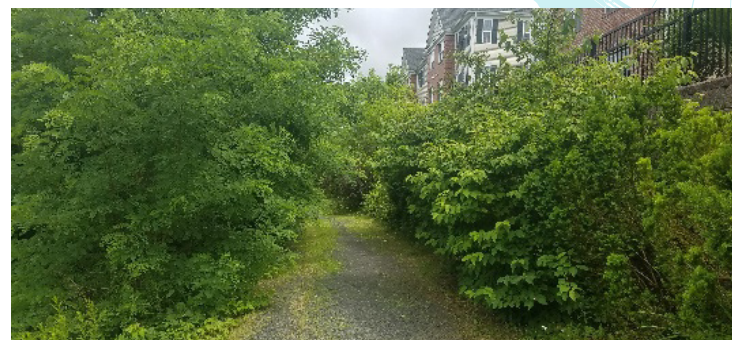
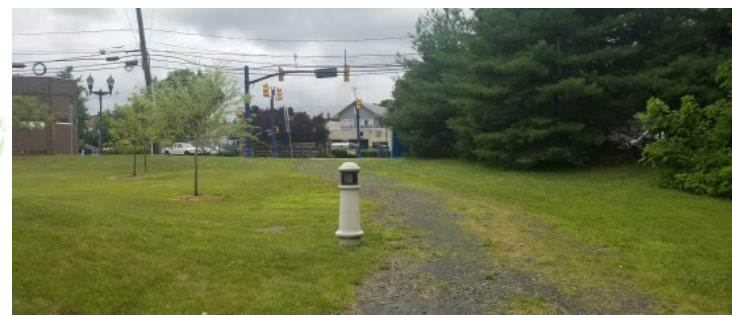
Canal Path in SBB

The canal path off Main Street is an enjoyable walk with nice natural features, however, it feels like visitors are unwanted due to the lack of signage, poor trail upkeep and lack of foliage maintenance.

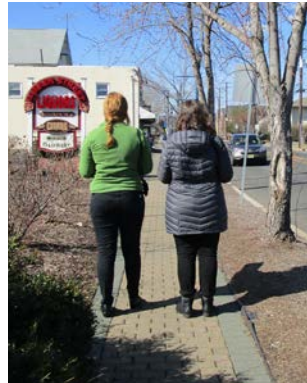
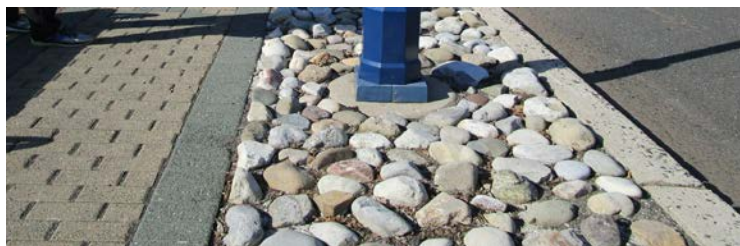
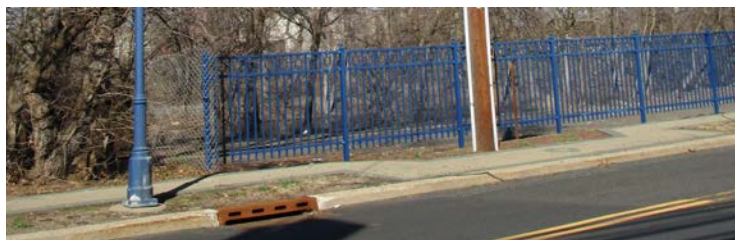
Narrow and Bumpy Sidewalks

Sidewalks along Main St. are narrower than standard and barely accommodates two pedestrians walking side-by-side. Although decorative brick pavers can provide an attractive aesthetic, they are discouraging for use by seniors, parents with strollers, and people with disabilities due to the bumpy surface. In addition, property owners have added other materials like stones in the buffer zones that further narrow the walking areas and decrease ADA compatibility.

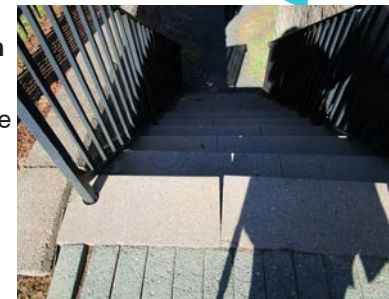
Exclusive Design of Access to Canal Path

The access to the canal path near the swing bridge does not have directional or informational signs which note it is a public area. The stairway to river through the new development is steep and in poor repair.

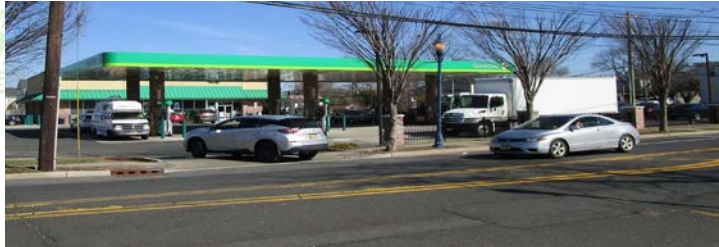
Lack of Pedestrian Access at Commercial Sites

Even though pedestrians have the right-of-way on sidewalks, people walking in front of QuickChek face fast turning vehicles and lack of better defined pedestrian space.

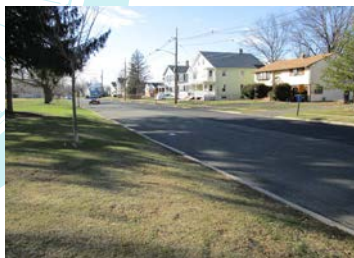
Lack of Pedestrian Access around school

Several sides of Memorial Park, near Robert Morris School, lack sidewalks

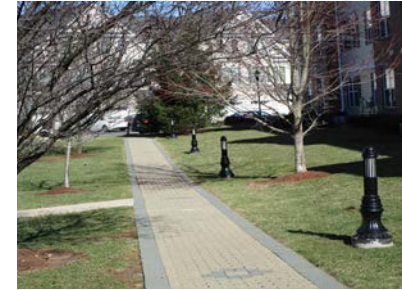
Walkway Lighting

Walkway lighting is provided along a pathway accessing the canal trail.

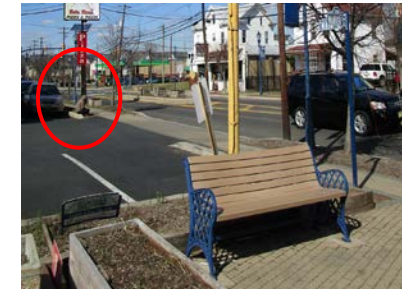
Isolated Benches, Need for Shade

Placement of benches are often not close enough to shopping facilities. [See woman sitting on the curb instead of using bench.] Benches are often lacking shade which would encourage pedestrians to linger and enjoy the area. Additional street trees would enhance aesthetics and provide needed shade.

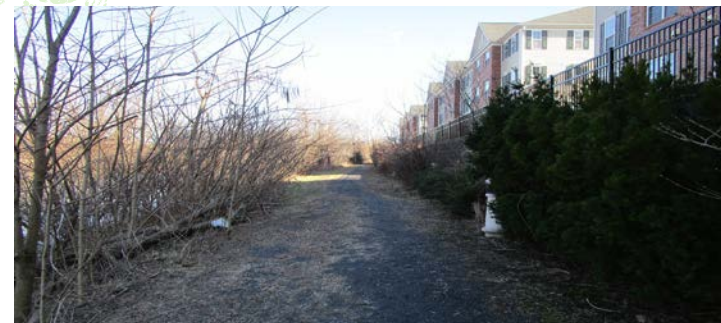
Lifeless Canal Front

Canal pathway needs seating, garbage cans, and upkeep. This is a potential location for improved placemaking.

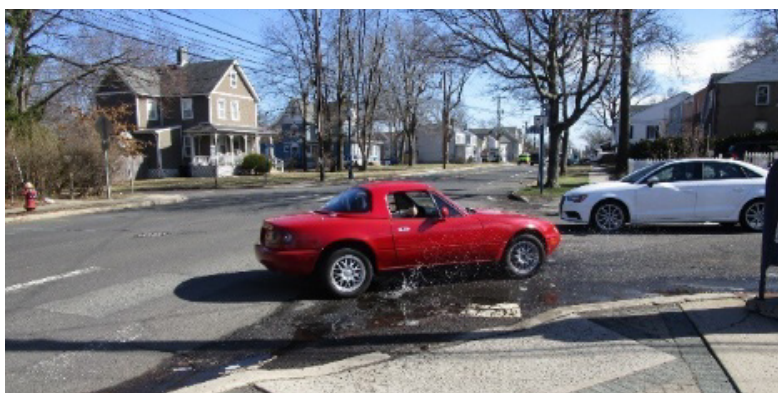
Wide Corner Radius

Vehicles turn at high speeds at the intersection of Main Street and Maple Avenue due to the wide curb radius. Poor crosswalk, curb cut and pavement conditions are also visible. Water pools at the intersection and turning vehicles will splash waiting pedestrians.

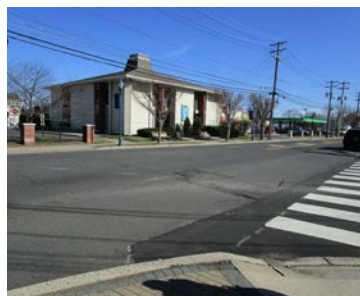
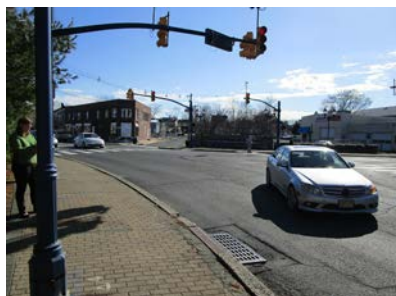
Extremely wide turning radii off Main Street leads to higher vehicle turning speeds which creates increased risk for pedestrians and a longer crossing distance.

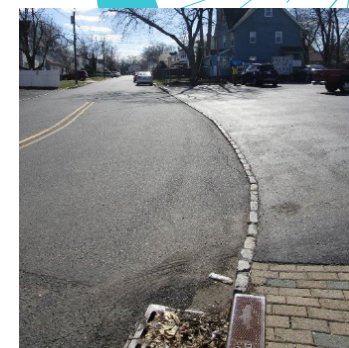
Excessive driveway width on Warren St. to the commercial plaza off of Main Street puts pedestrians at risk due to turning vehicles and many conflict points.

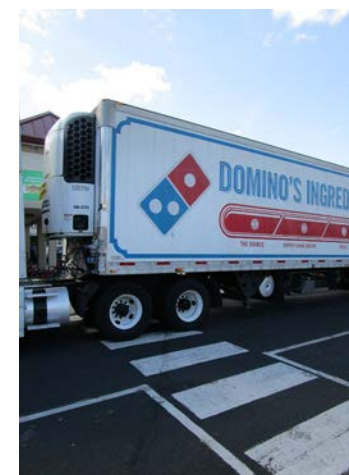
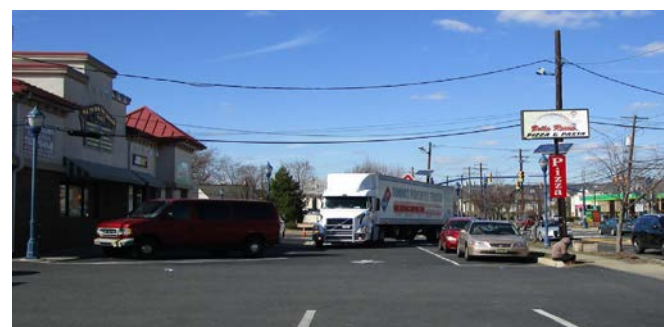
Pedestrian Unfriendly Parking lot

Large trucks create an unfriendly environment for both vehicles and pedestrians. Many trucks parked in crosswalks in the downtown corridor.

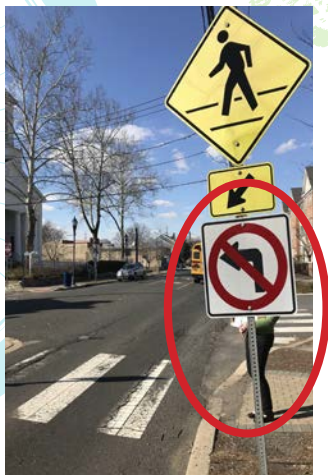
Decorative Street Light Obscures Pedestrians from Drivers

While aesthetically pleasing, the decorative street lights are not at pedestrian scale and obstructs the visibility of pedestrians crossing Main Street at Canal Walk.

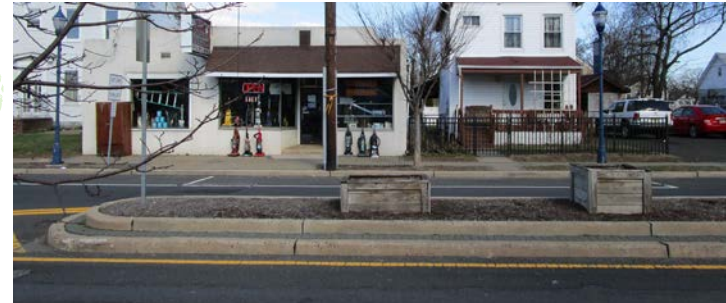
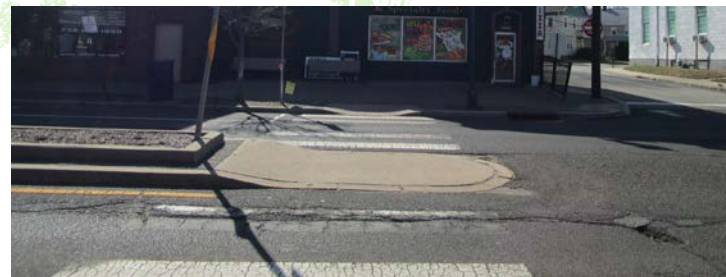
Traffic-Calming Island

Main Street includes a nice island that provides space for flowers. Adding trees and year-round plantings to this area would be helpful to create boulevard feel and encourage slower speeds. There is also an opportunity to extend the island to create protected pedestrian refuge areas. Incorporating storm water management through green infrastructure can be explored.

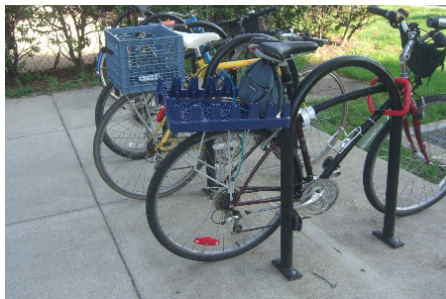
Bike Parking on Main Street

Adding inverted U-shaped bike racks to Main Street is recommended to improve bike access and reduce vehicle parking needs.

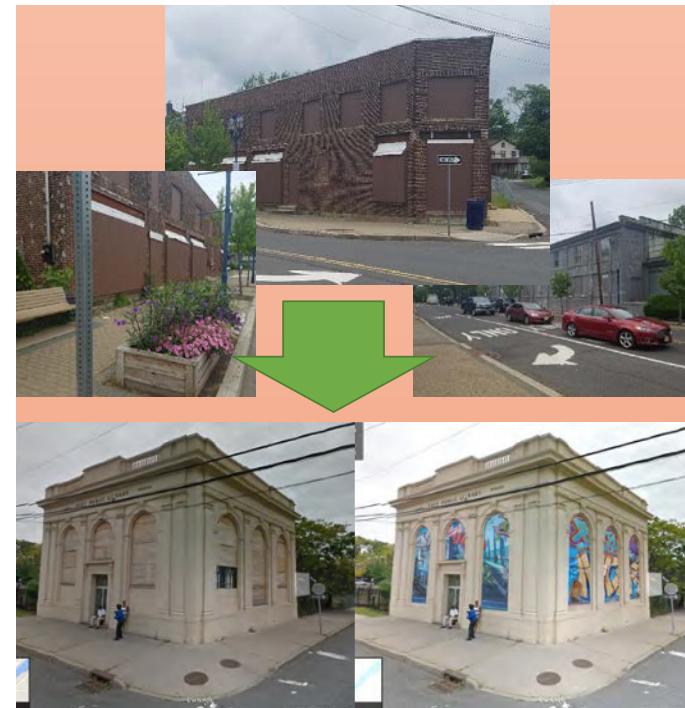
Abandoned Buildings at Gateway

Sadly, there are abandoned buildings causing an unsightly entrance to an otherwise pretty town. Vacant and broken buildings contribute to unfriendly walking environments, especially for children and seniors. Renovation and reuse of these buildings is paramount to further economic growth in the community. However, they provide an opportunity for interim improvements that can reflect positively on the neighborhood and be part of larger cultural programming through adding artwork, murals and wayfinding highlighting the history of the town. These murals can be designed by the community or commissioned by a local artist. See Crime Prevention Through Environmental Design chapter.

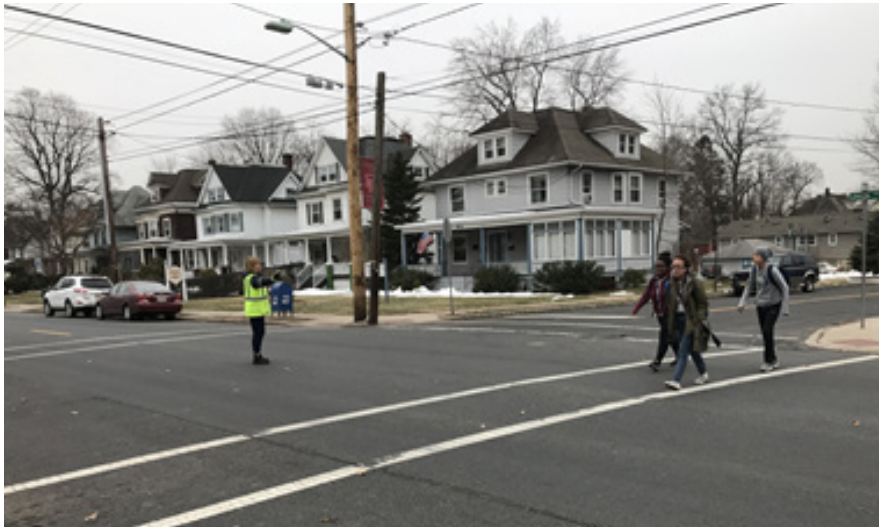
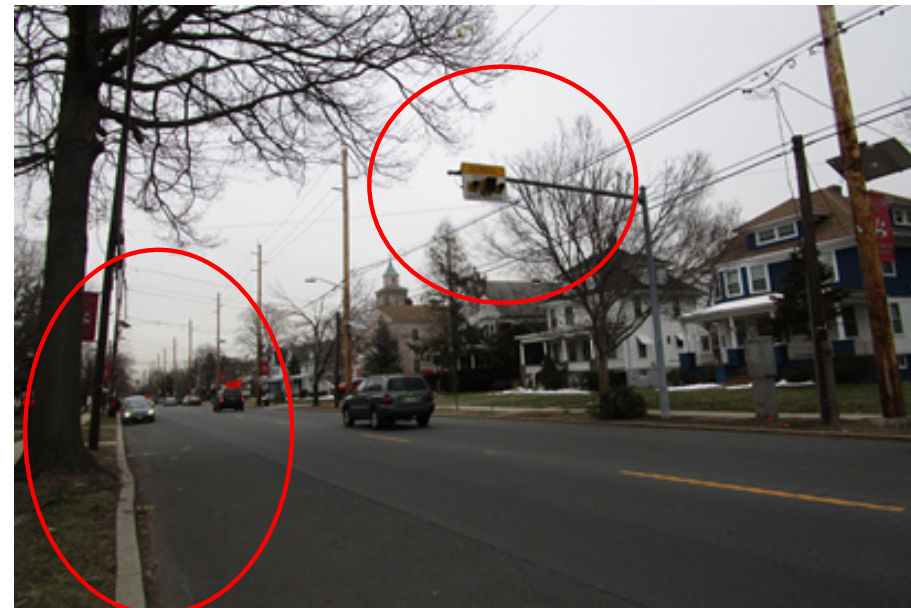
NJ-28 in front of Bound Brook High School

This is a wide busy street with a long crossing that serves as a transit corridor. Middle Earth students noted this as one of the most difficult crossings in Bound Brook.

- Higher traffic volume
- Long, difficult crossings
- Speeding vehicles
- Wide travel lanes
- No bicycle infrastructure (e.g. racks, lanes, bicycle compatible shoulders)
- Lack of school zone markings & incorrect placement of school zone signage

- Upgrade school zone flashing beacons (larger & MUTCD compliant, correct placement & updated tech)
- Add radar feedback signs
- Add "School Zone" & hi-viz crosswalk markings in street
- Improve Transit bus pull out areas
- Enforce no parking during school day
- Narrow travel lanes to add bike friendly shoulders/NJT bus pull outs
- Use curb extensions, bollards, or pedestrian refuge islands to shorten the crossing.

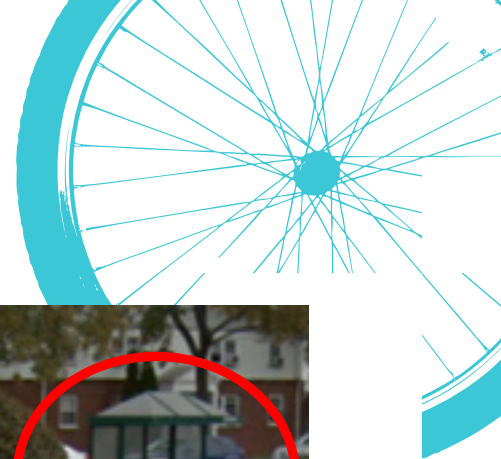
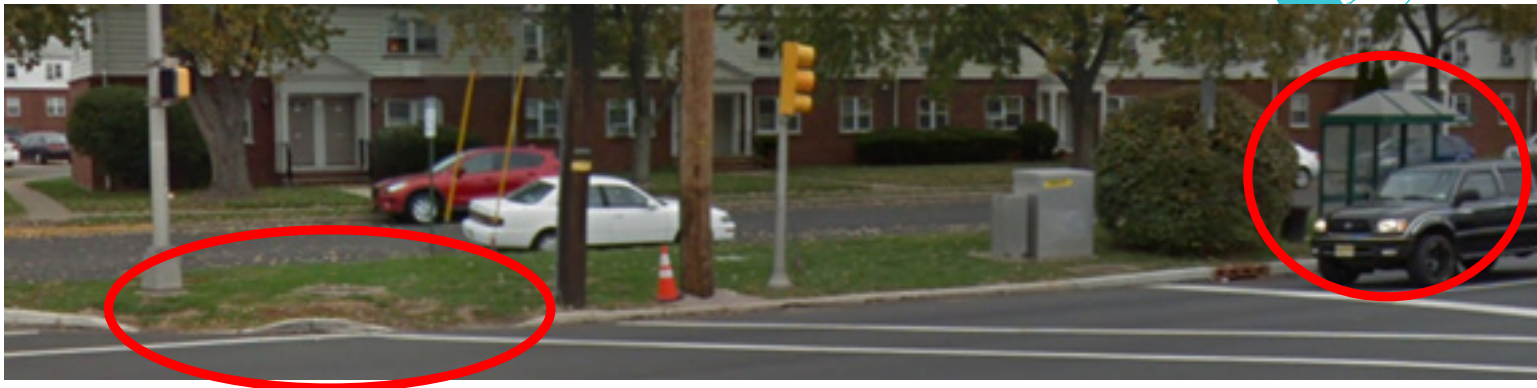
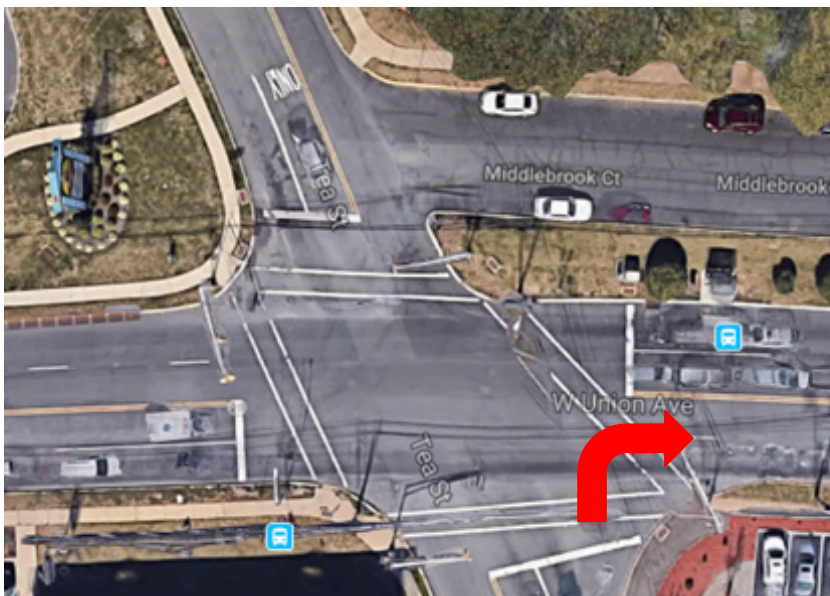
Intersection of NJ-28 and Tea Street

Though a difficult bicycle and pedestrian environment, this intersection is surrounded by trip attractors such as shops, restaurants, medical offices, and commercial businesses that are likely to generate bicycle and pedestrian travel.

- Relatively high pedestrian and cyclist crashes from empirical data
- Long crossings
- Missing sidewalk at crossing and to reach bus stop
- Wide curb radius

- Add sidewalk to the island and connect bus shelter
- Add crosswalk between the island and residential blocks
- Make all crosswalks high visibility
- Shorten crossings by reducing curb radii
- Upgrade Ped crossing times to MUTCD standards
- Update infrastructure for ADA compliance (detectable warning surfaces and curb cuts)

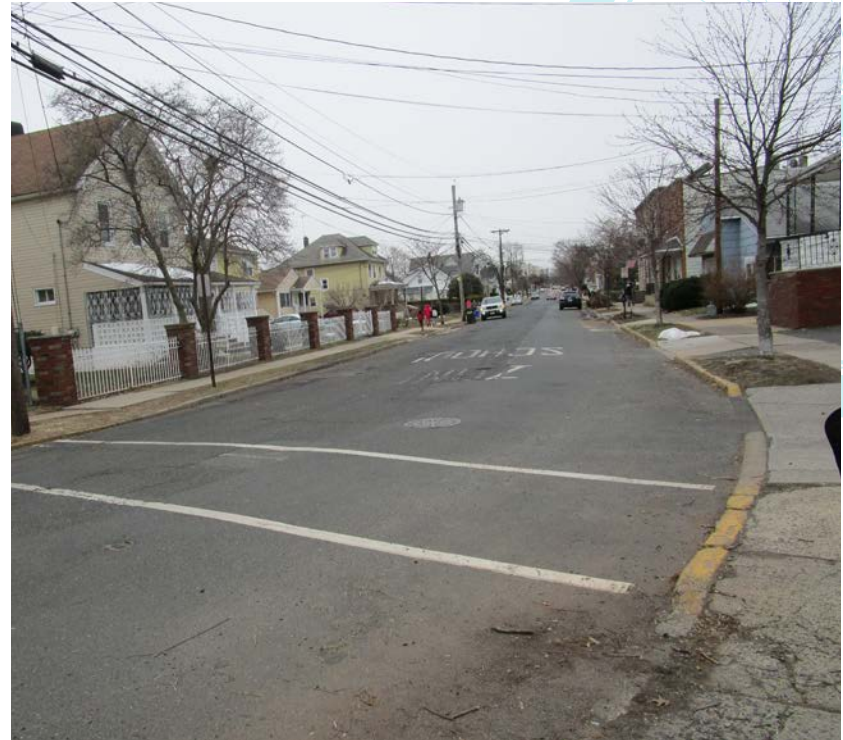
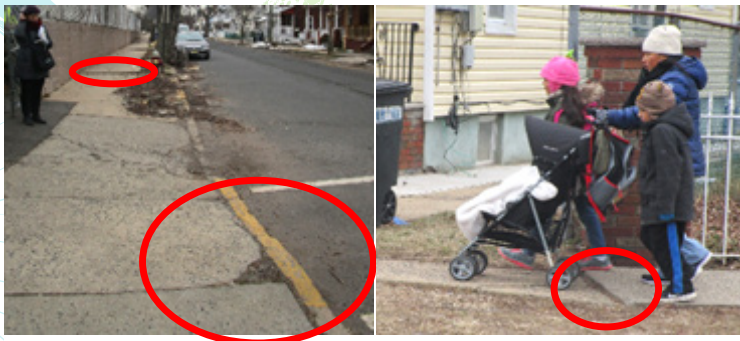
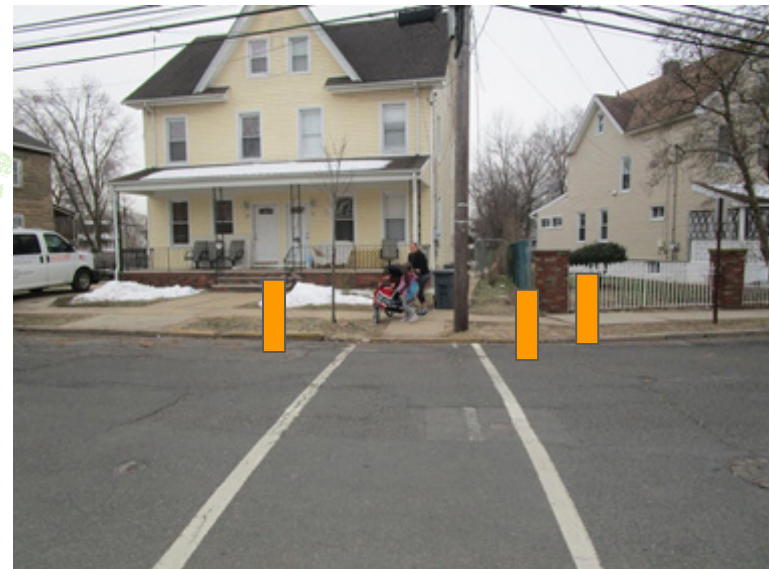
Behind Lafayette Elementary School (2nd Street)

- Cracked and uneven sidewalks
- No "School Crossing" signs
- Missing curb cuts and ADA detectable warning surfaces
- Not a highly visible crossing
- Parent pick-up/drop-off too close to crosswalk

- Repair broken sidewalk
- Improve crosswalk with high visibility crosswalk painting, ADA compliant curb ramps with detectable warning surfaces, and school crossing signage
- Use bollards or curb extensions to keep parents from parking too close to the crossing

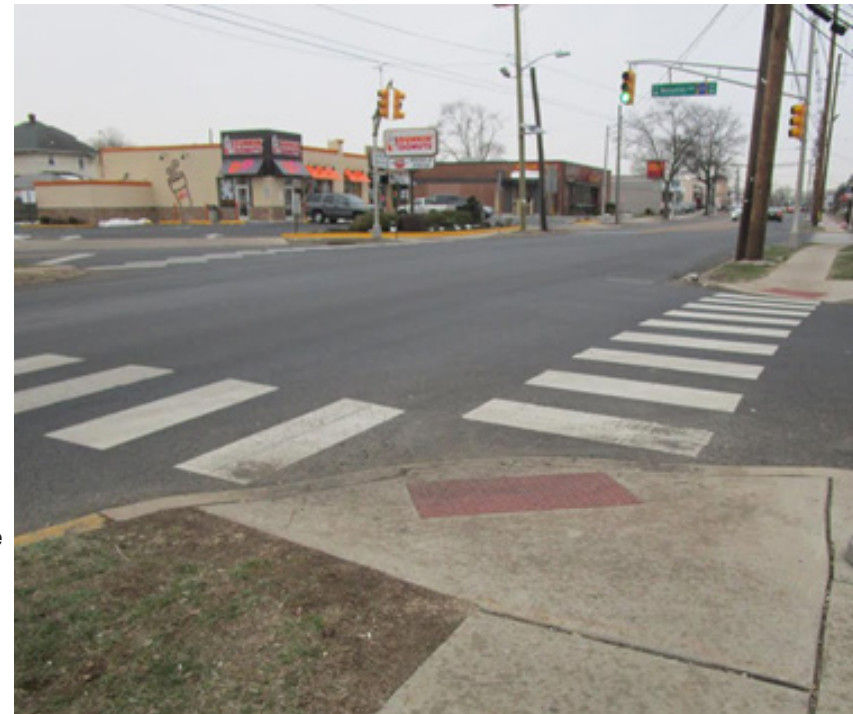
W. Union Ave & Vosseller Ave

This long and difficult crossing is located within close proximity to the high school and shops and restaurants that serves as bicycle and pedestrian trip, generators.

- Extend painted median to create pedestrian refuge
- Add countdown pedestrian signals and increase crossing time to new MUTCD standards
- Tighten curb radii to shorten crossings, especially by Memorial and Dunkin Donuts

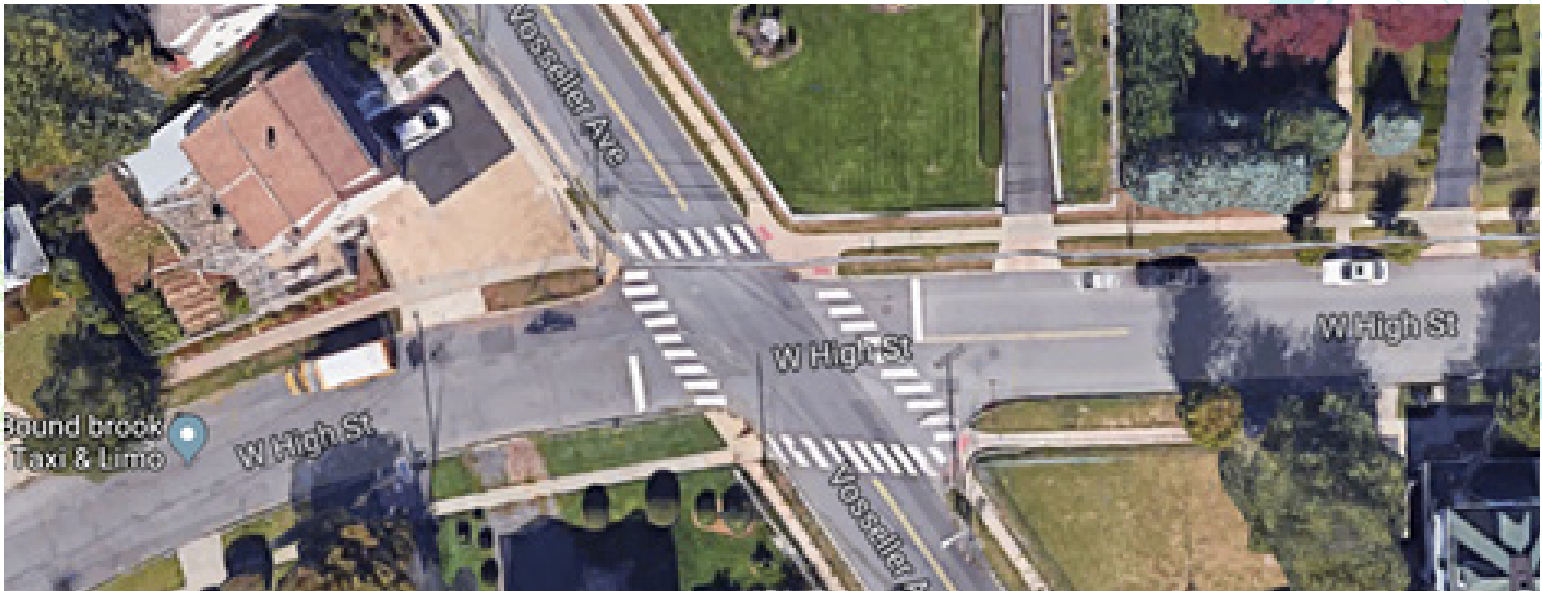
Vosseller Ave & West High Street

Speeding was observed along this long, straight section of Vosseller Ave.

- Add mini roundabout using simple markings or a raised island with plantings using "green street" storm water management designs
- Add radar feedback signs

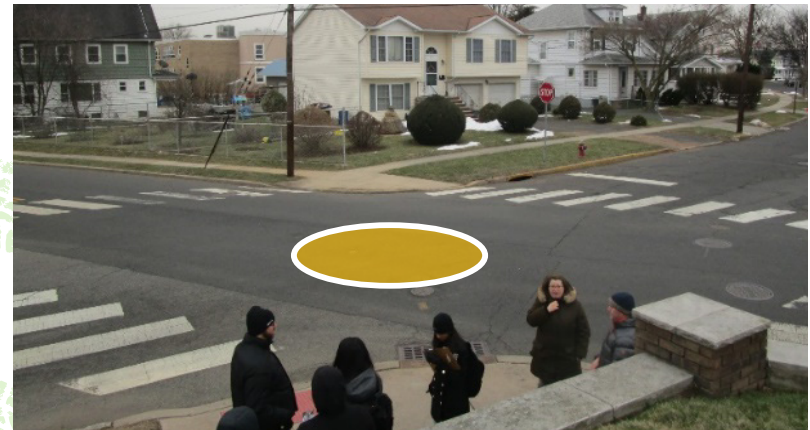
- Speeding

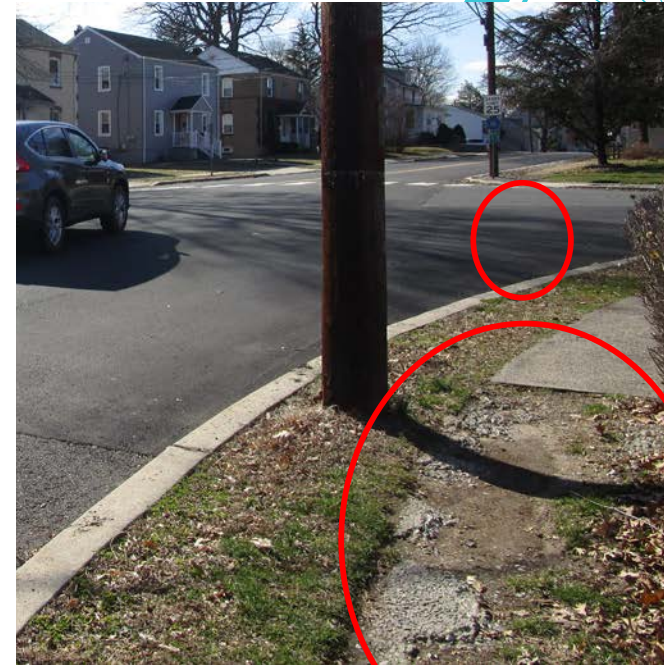
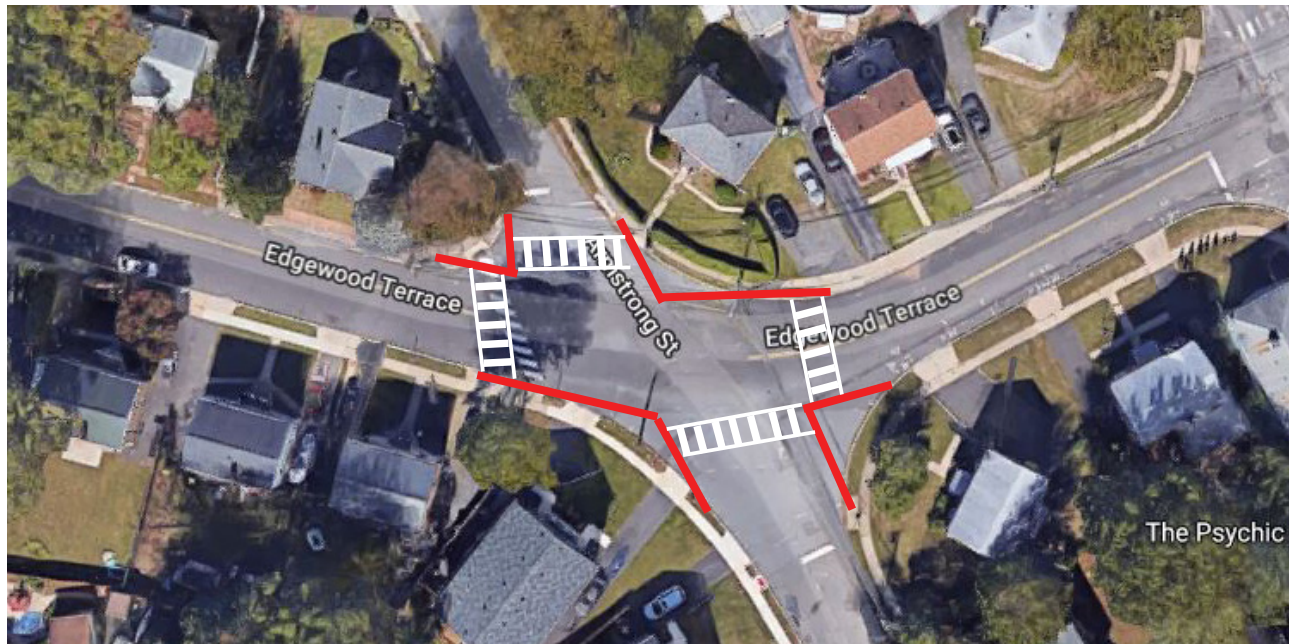
Edgewood Terrace & Armstrong Street

This extremely wide intersection was noted as an especially difficult place to cross by a Middle Earth student from South Bound Brook.

- Poor quality or missing crosswalks and sidewalks (ADA compliant curb ramps will be installed by Somerset County in 2018/2019)
- High motor vehicle speeds
- Wide curb radii

- Sidewalk repair
- Shorten crossing distances and reduce width of pavement through use of paint and flexible bollards or curb extensions
- Add additional crosswalks

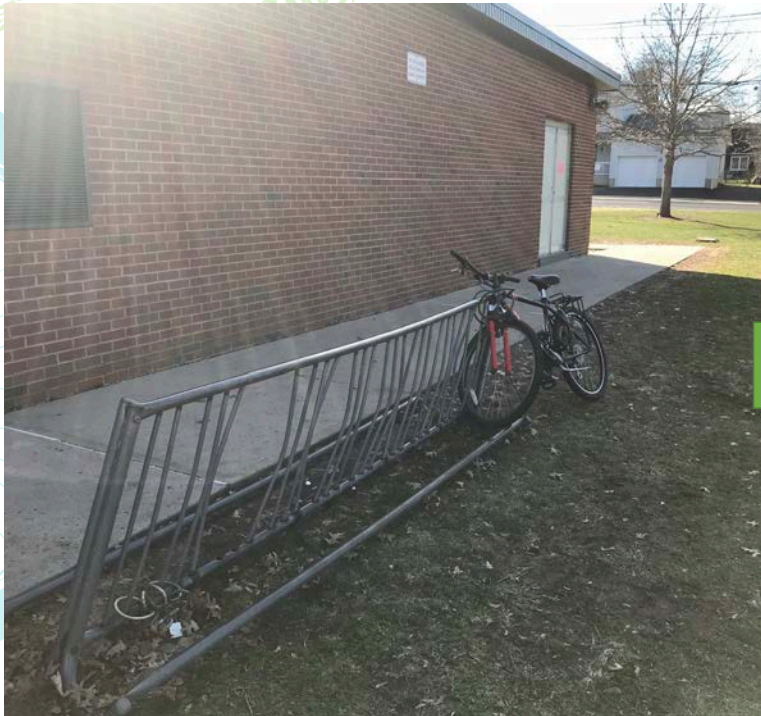
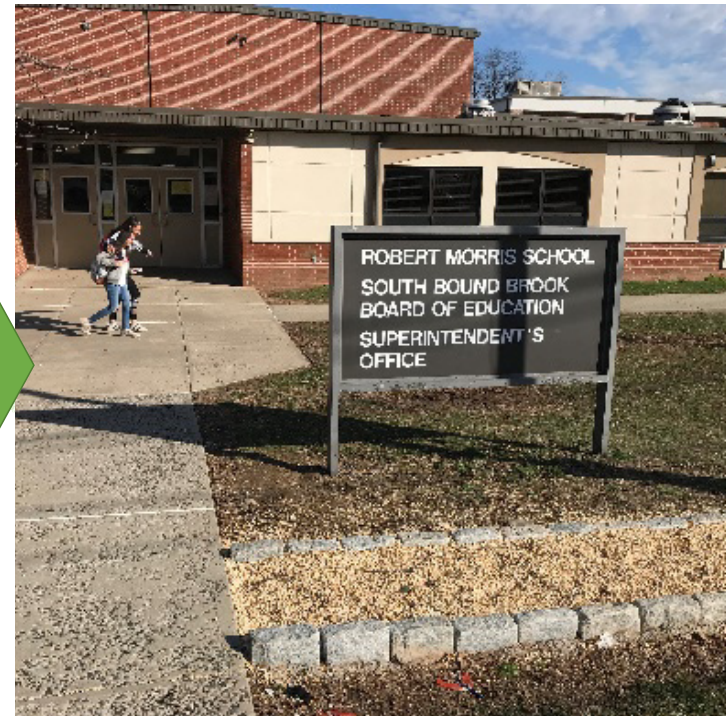
Robert Morris School

- Lack of bicycle facilities
- Current bike rack is poorly placed and in poor condition

- Install new back rack to a more convenient location visible from inside the school.
- Consider additional bicycle parking
- See NJ School Bike Parking Guide, www.saferoutesnj.com
