Highland Park School Bike Assessment

February 2017

Highland Park Bike Assessment

Keep Middlesex Moving, Inc.

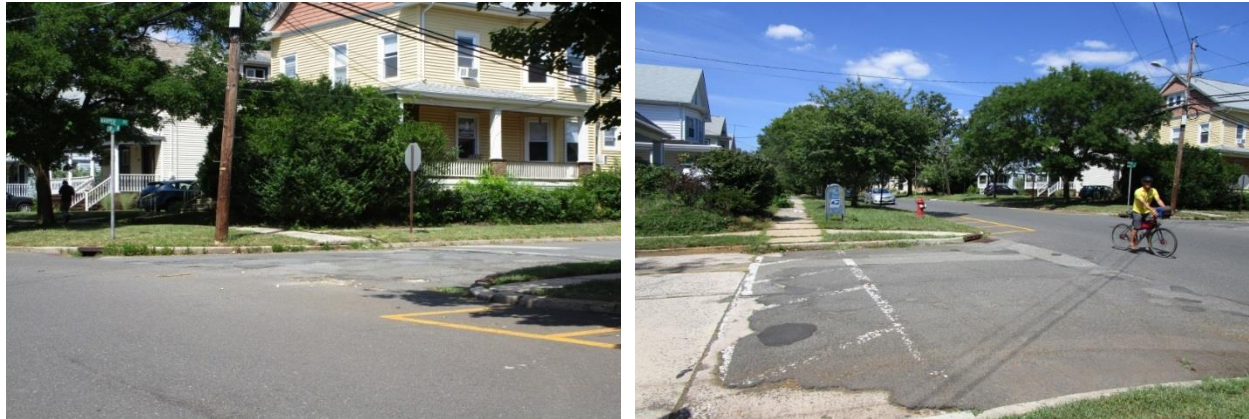
Figure 3 and Figure 4 illustrate common conditions on the Blue Route. Pavement wear, potholes, and patching provide uneven conditions at some intersections. Crosswalk striping is worn, and several intersections lack sidewalk curb ramps. This may present a challenge for pedestrians, child cyclists, and families with strollers. Some sidewalk approaches had steps to reach the street level, as shown in Figure 4.

Figure 3 - Poor pavement condition and lack of sidewalk curb ramps at Harper Pl. & S. 3rd Ave.

Deficiency/Opportunity	Potential Action	Responsible Org.
Maintenance		
Faded crosswalks	Restriping	Borough
Pavement condition	Patching and repaving as budget and grant opportunities allow	Borough
Vegetation	Code enforcement of planting maintenance by property owners	Borough
Sewer grates	Repair or replace damaged and substandard storm sewer grates	Borough
River Rd. bike path buckling	Repair	County
Irving bike rack placement	Relocate bike rack closer to main entrance	School District
Infrastructure investment		
Missing sidewalk curb ramps	Install curb ramps as budget and grant opportunities allow	Borough
Missing sidewalk segments	Install sidewalks as budget and grant opportunities allow	Borough
Missing sidewalks on Woodbridge Ave.	Install sidewalks as budget and grant opportunities allow	County
River Rd. crosswalk warning signs	Investigate replacement/enhancement	Borough/County

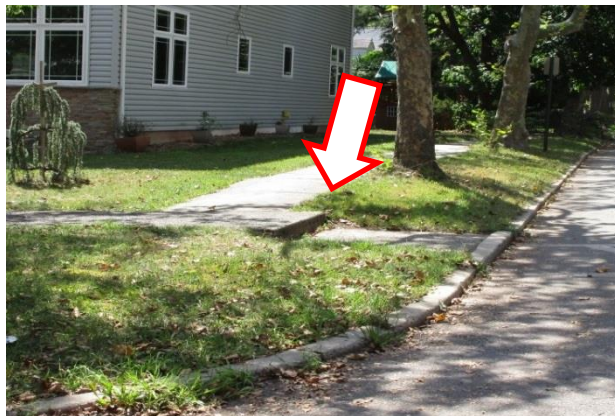
Figure 4 - Step on sidewalk on Donaldson St. & S. 3rd Ave.

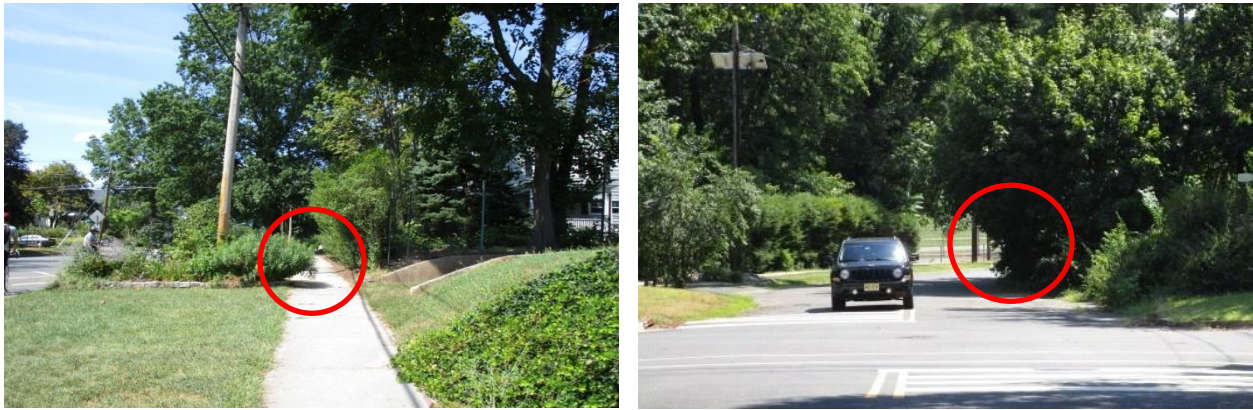
The assessment team noted trees and bushes obstructing the sidewalk along the route, as seen in Figure 5 (left). In addition, they noted overgrown trees on the S. 3rd Ave. entrance to Donaldson Park that limited pavement width and visibility, visible in Figure 5 (right).

Figure 5 - Overgrown vegetation obstructs a sidewalk on S. 2nd Ave. (left) and S. 3rd Ave. at Valentine St. (right).

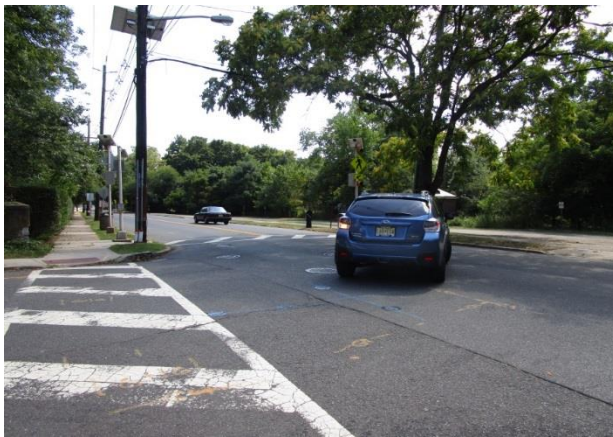
River Road, a two lane county highway, connects the majority of the Borough to a residential neighborhood on the other side of a railroad Right of Way barrier. This road was observed to have traffic speeds and volumes that are unsuitable for youth bicyclists. In addition, the road passes through a tunnel under a railroad trestle with no shoulder and insufficient width for shared riding. A paved multi-use path parallels the road before entering Johnson Park, a county park. Accessing the path requires crossing River Rd., which is facilitated by illuminated yield-to-pedestrian warning signs and striped crosswalks at three locations (Figure 6). Unfortunately, the warning signs were found to be partially obstructed by utility poles and trees, limiting their visibility to drivers. In addition, they are illuminated

Figure 6 - Flashing crosswalk lights not visible on all sides on Harrison Ave. & River Rd.

by low-intensity amber lights. Replacement with rapid-flash strobe lights in a less obstructed location may improve visibility and yield compliance at these crosswalks.

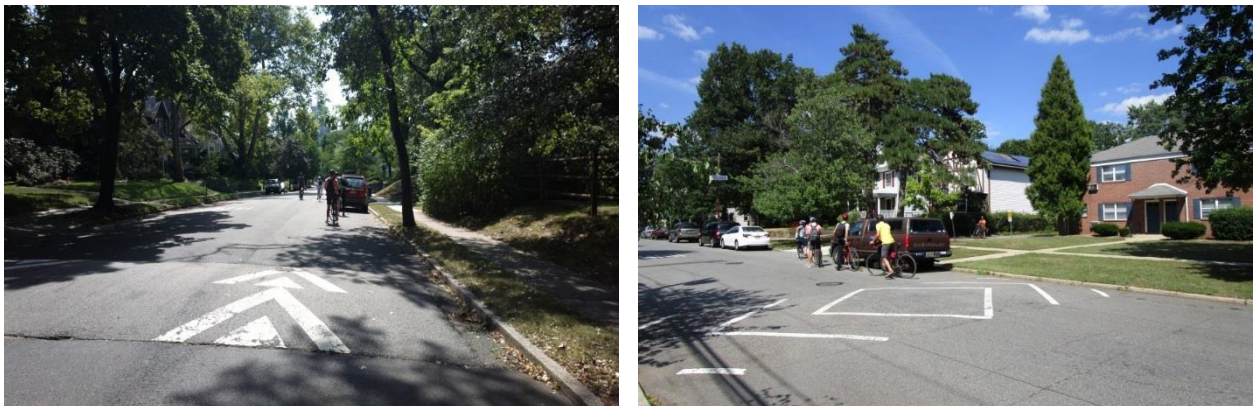
Speed humps on North and South 2nd Ave. and Harrison St. may moderate motor vehicle traffic on these streets.

Figure 7 - Speed hump on Harrison Ave. (left) and S. 2nd Ave. (right).

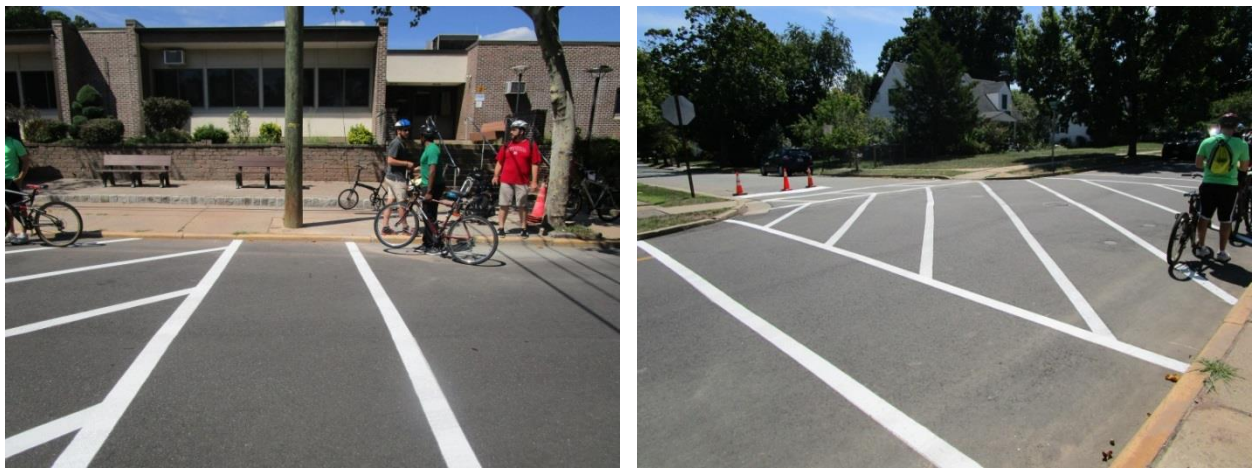
Faded crosswalks, missing curb ramps, missing truncated domes, and in some cases missing crosswalks were observed throughout the Red Route. While the crosswalks were recently repainted in front of Bartle Elementary on Mansfield St., curb ramps and truncated domes are missing from the crossing directly in front of the school. To further complicate the crossing, one of the crosswalks leads pedestrians into a utility pole. A faded crosswalk was also observed at South Adelaide Ave. and Johnson Street. Though curb ramps are present, truncated domes are missing. At Harper St. and Felton Ave. the crosswalk that is present is faded. There is no crosswalk across Felton Ave. There are also no curb ramps and no truncated domes at this location. At S.1st Ave. and Magnolia St. there are two faded crosswalks crossing South First Ave. with no curb ramps or truncated domes present. Both of the crosswalks crossing South First Ave. lead pedestrians to bad connections to the sidewalk with one leading directly into a telephone pole.

Figure 9 - Freshly painted crosswalks at Bartle School entrance, but lack of curbcuts

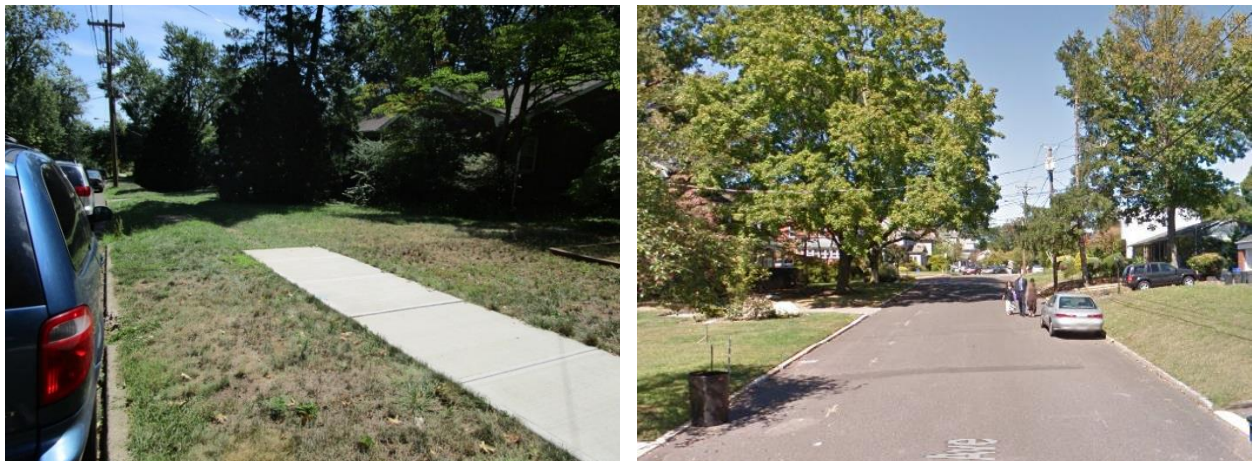
Several gaps in the sidewalk network were observed along the Red Route. On South 4th Ave., the sidewalk abruptly ends along one side of the street mid-block between Mansfield St. and Becker St. Sidewalk starts up again at the Corner of Becker Street, but sidewalk along South 4th Ave. ends on both sides at Graham Street. There is no sidewalk on either side along Donaldson St. and it is missing along one side of Valentine St. until just before South 2nd Ave. Continuing along Valentine, sidewalks again end on one side at South 1st Ave. There are no sidewalks at the end of Cedar Ave. past Donaldson St. One side of Skyview Ter. has sidewalks, but all sidewalks end at the intersection with South Adelaide Ave. There are no sidewalks on the end of South Adelaide Ave. until they start midblock after Elbert Ct. Sidewalks are again missing along South Adelaide Ave. in front of one home located near the intersection of South Adelaide Ave. and Valley Pl.

Figure 10 - Discontinuous or absent sidewalk on S. 4th Ave. (left) and S. Adelaide Ave. (right)

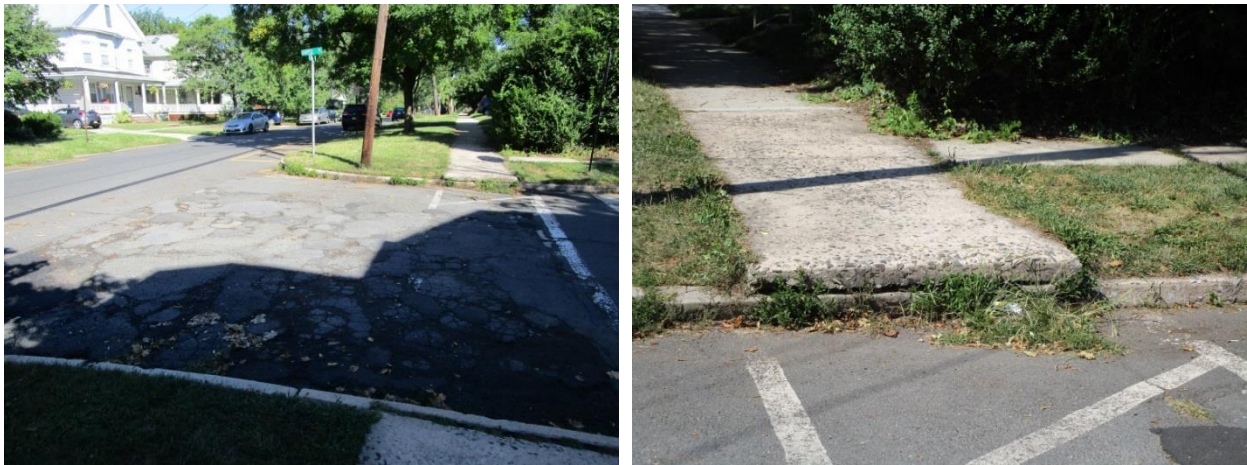
The intersections of South 3rd Ave., Harper St., and Harper Pl. present a variety of issues. The crosswalks on Harper St. and Harper Place are faded and do not have curb ramps or truncated domes. Additionally,

Figure 11 - Poor pavement condition and high curb at S. 3rd Ave. at Harper Pl.

there is an extremely high curb on one side of the crossing of Harper Place. The road surface of both Harper St. and Harper Place approaching each crossing is rough, creating a hazard for bicyclists. There is also no crosswalk at this intersection that crosses South 3rd Ave., a busy road connecting to Raritan Ave.

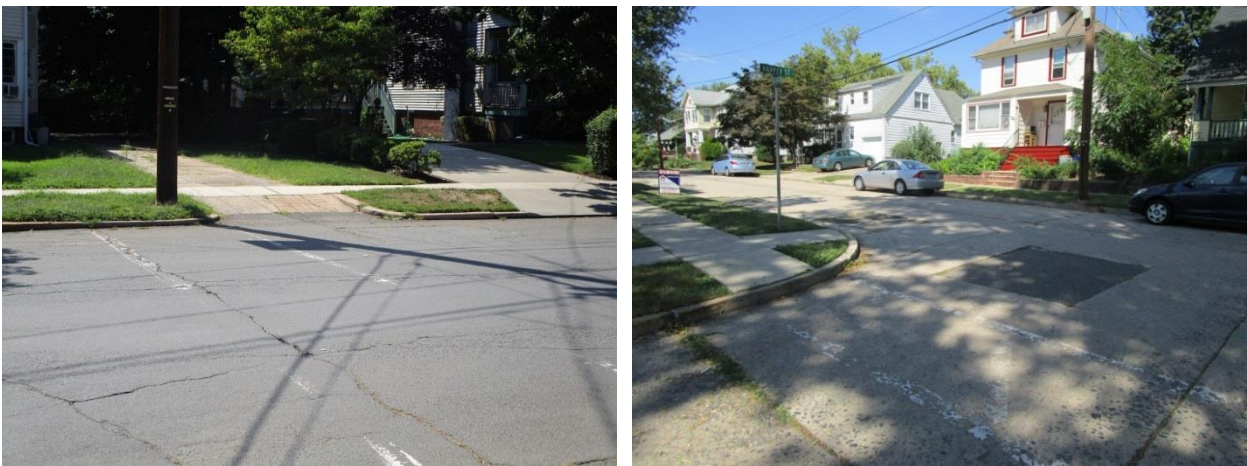
Figure 12 - Faded crosswalks and lack of curb ramps at S. 1st Ave. at Magnolia St. (left) and Felton St. at Harper Ave. (right)

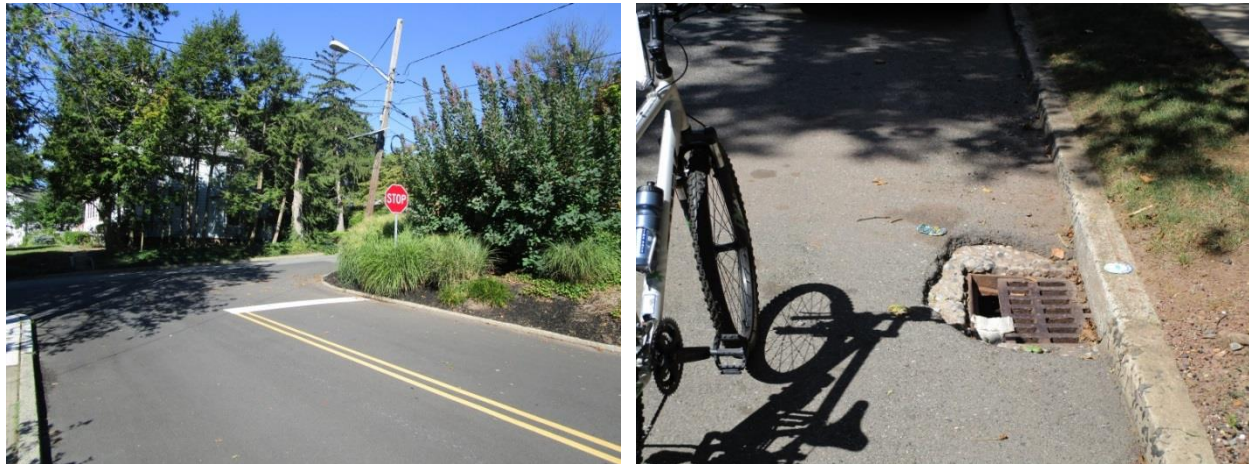
Other issues noted along the Red Route included a problematic sight obstruction and a broken sewer grate. At the Intersection of Valentine St. and Cedar Ave. overgrown vegetation makes it difficult to see oncoming traffic. On South Adelaide Ave. in front of the Highlander building, an old sewer grate that sits below the street surface has shifted and resulted in an open hole in the street surface. It was also noted that there was no stop sign at the intersection of Donaldson St. and Braun Ave.

Figure 13 - Plantings obstruct views at Valentine St. & Cedar Ave. (left), broken sewer grate on S. Adelaide Ave.

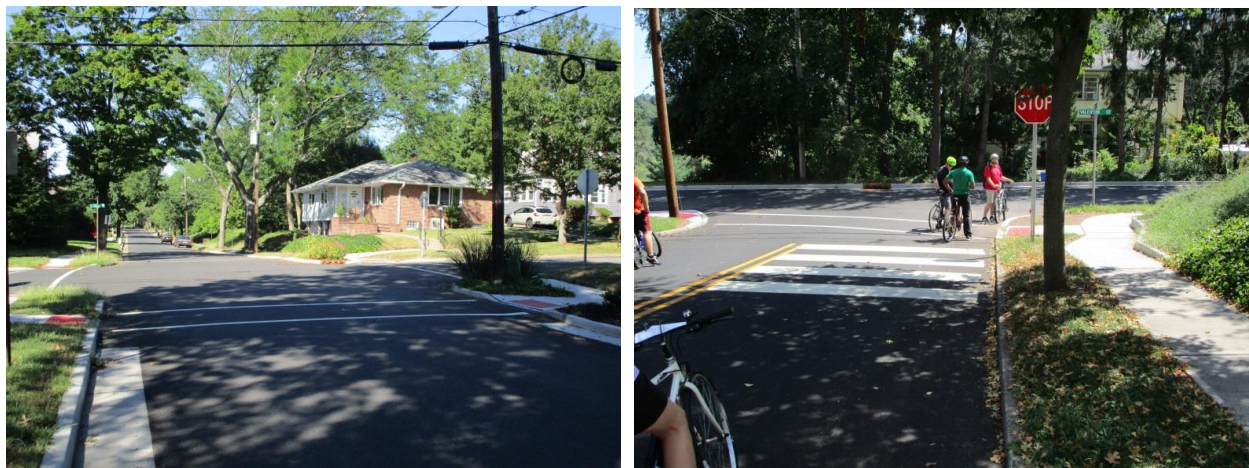
Figure 14 - Recent paving, striping, and curb ramps on Valentine St.

Riders on the Red Route also noted a lot of good infrastructure already in place that helps to make bicycling easier within Highland Park. Valentine St. was recently repaved, providing a smooth path of travel for bicyclists. Riders on the Red Route also appreciated that the Stop signs along Valentine St. stopped north/south traffic, providing a stop free east/west path of travel for a good portion of the south side of town. Riders also felt more secure noting that many of these stops along Valentine Street had enhanced stop bars, enhancing visibility and indicating to drivers that there is an upcoming stop. Riders on the Red Route also enjoyed their ride along South 1st Ave., noting that it was one of the widest streets in town and provided room for parking, two way vehicle travel, and bicyclists comfortably. The

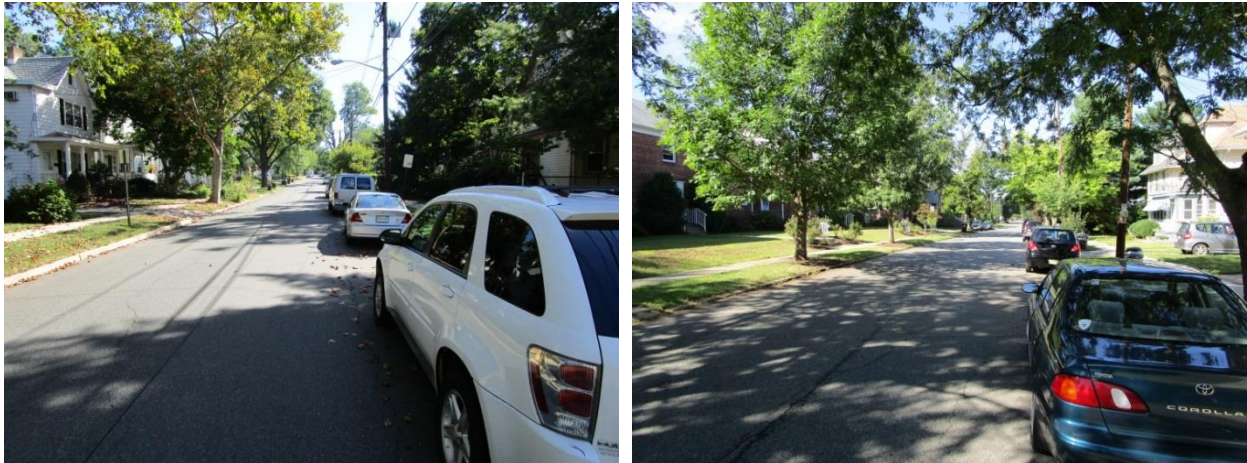
The Red Route traveled down to parallel streets traveling west to east on the south side of Highland Park, Magnolia St. and Benner St. Both streets accommodate on street parking and two way traffic but felt quite narrow when being traveled by bicycle. Riders of the Red Route felt that exploring options to make these streets each one way in opposite directions could make them more comfortable for bicycling.

Figure 15 - Assessment riders felt uncomfortable sharing the road on Benner St. (left) and Magnolia St. (right)

Magnolia St. and Benner St.	Investigate converting to a one-way pair with bike facility	Borough
Bicycle lanes	Investigate routing	Borough
River Rd. under Amtrak	Investigate alternative bicycle routes	Borough/County/NJDOT
Columbia St., Cherry St., and Parker Rd.	Investigate traffic engineering changes to improve safety for motor vehicles, bicyclist, and pedestrians	Borough

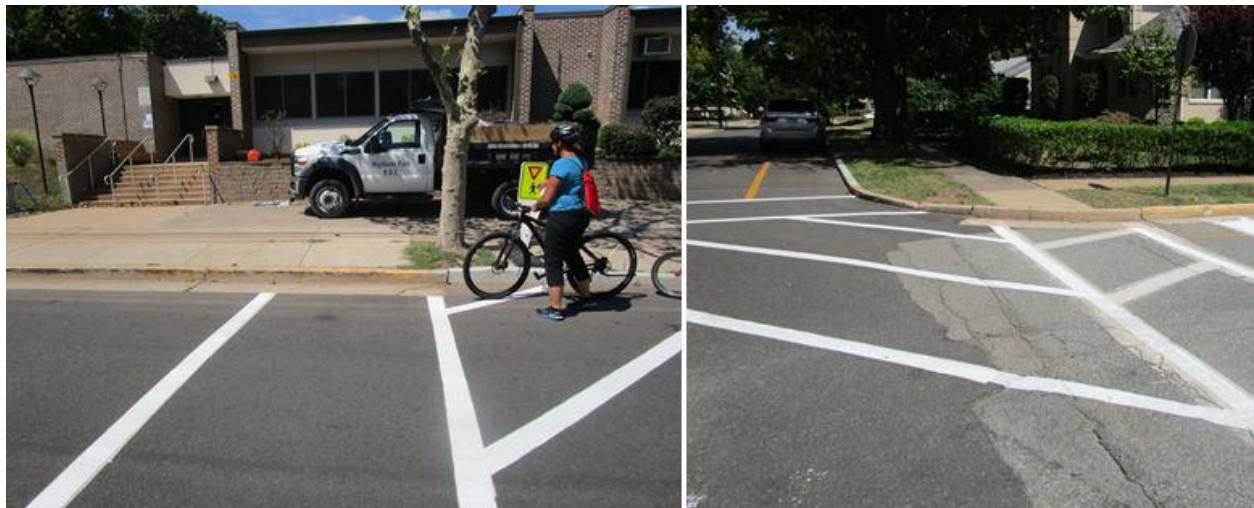
Beginning with Bartle School, there are freshly painted crosswalks on the corner of Grove St. and Mansfield St., however there are no curb ramps and one crosswalk is obstructed by a utility pole. The Borough was in the process of re-painting crosswalks throughout the town in time for school to begin in September.

Figure 17 - Freshly painted crosswalks but no curb ramps at the Bartle School entrance on Mansfield St.

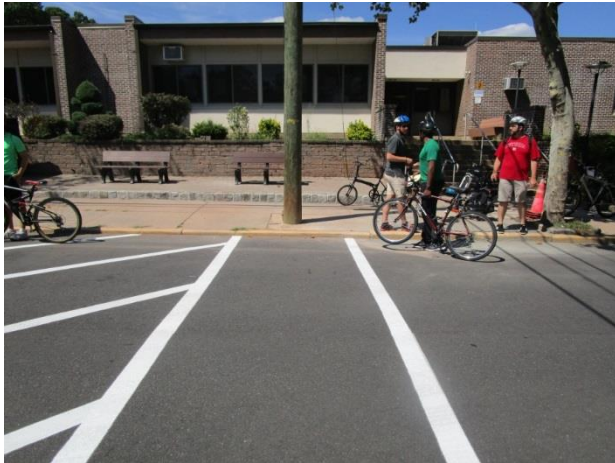
Figure 18 – A utility pole obstructs a crosswalk on Mansfield St. at Grove St.

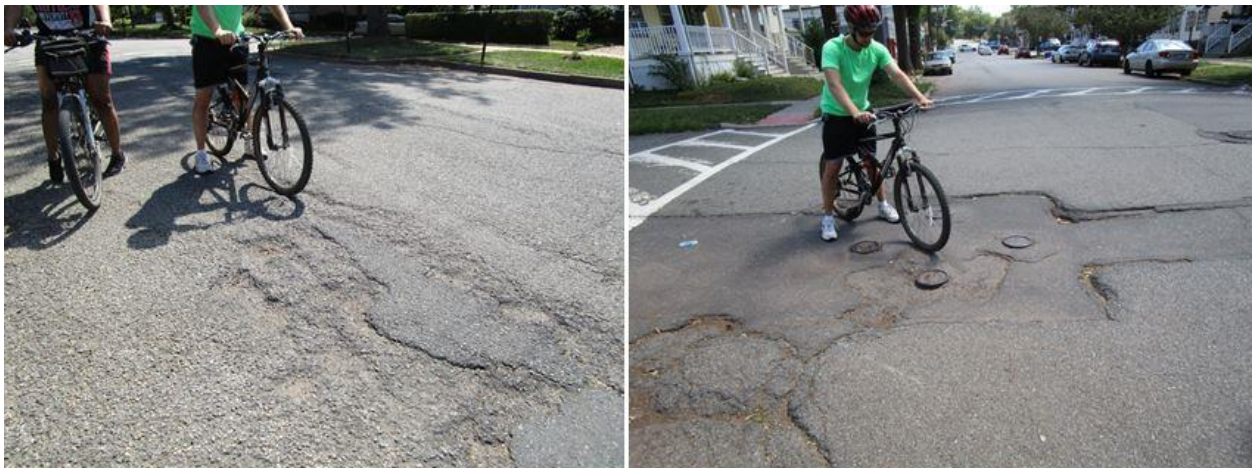
Throughout the silver route, instances of poor pavement condition due to potholes and patching may make street riding challenging for young bicyclists.

Figure 19 - Poor pavement condition from potholes and patching.

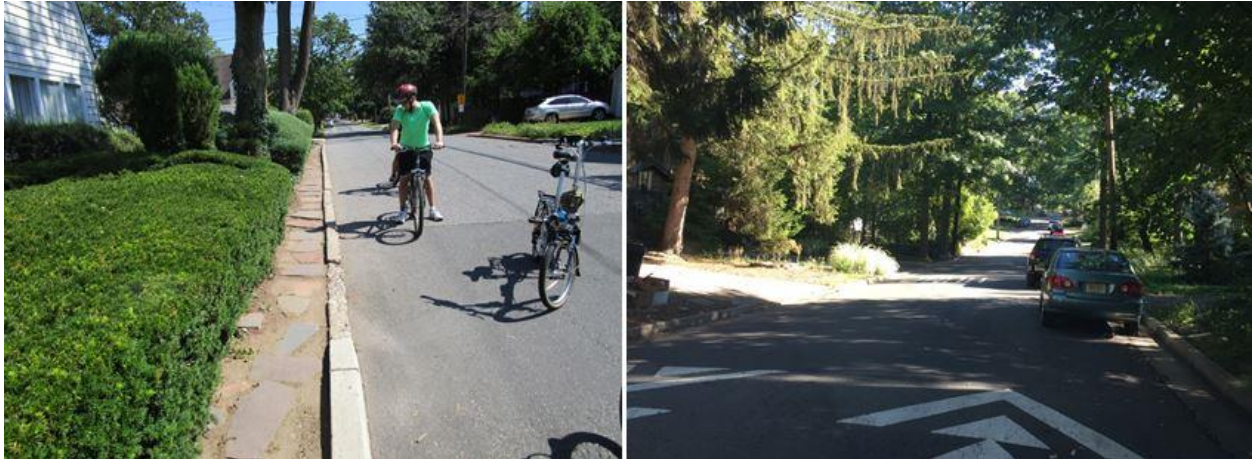
Sidewalks were generally in good condition on the north side of State Highway 27, except for some overgrown shrubs, trees, and plants obstructing the sidewalks. Several streets were lacking continuous sidewalks.

Figure 20 – Non-standard path on Madison Ave. (left) and lack of sidewalks on Harrison Ave. (right)

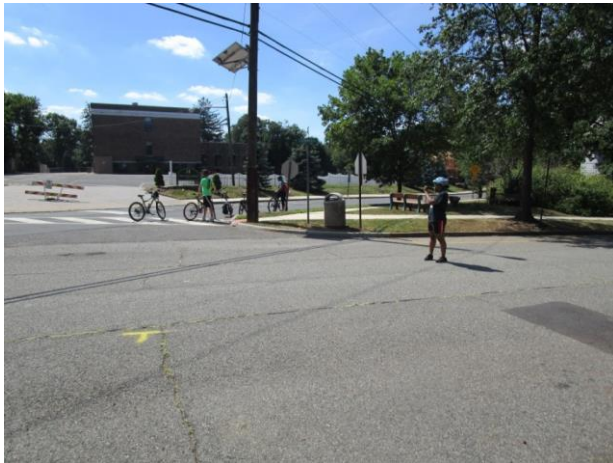
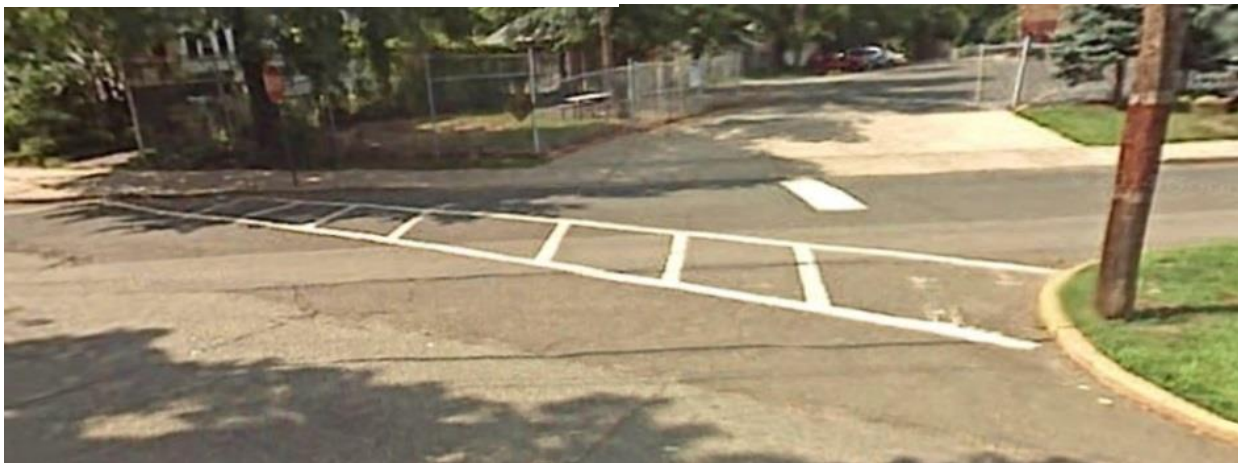
Figure 21 - Intersection of Madison Ave. & N. 4th Ave.

The intersection of Madison and N. 4th Ave. at the Center School (a private school, currently vacant), within a block of the Middle School, is has a long crosswalk that lacks curb ramps and ends at utility pole.

N. 4 th Ave. and Madison Ave.	Investigate alternative crossings	Borough
Turf field bike racks	Install bike racks as budget and grant opportunities allow	Borough/County
Further Study

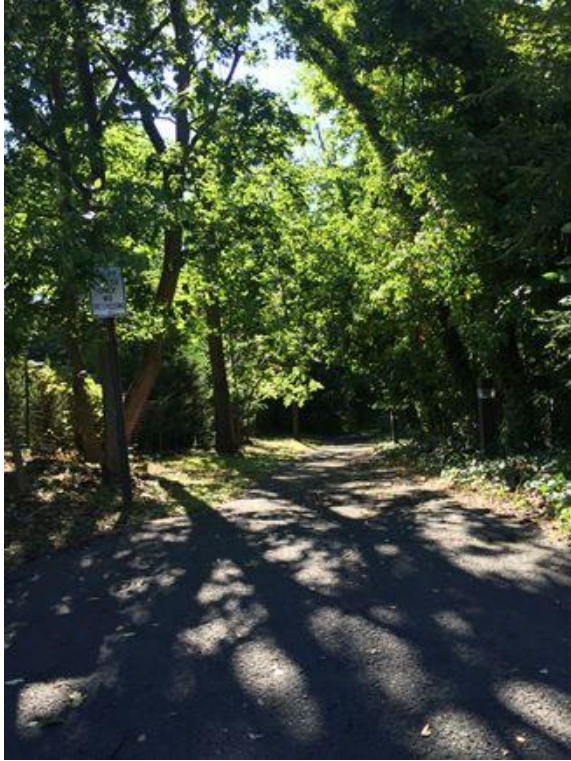
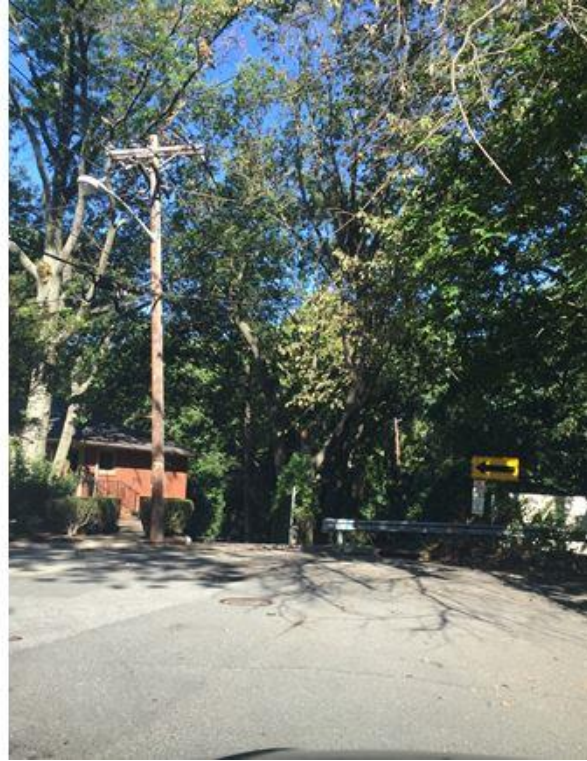
Figure 24 - Multi-use path between Harrison Ave. & N. 5th Ave.

An unsigned, illuminated multi-use path connects Harrison Ave. and N. 5th Ave.

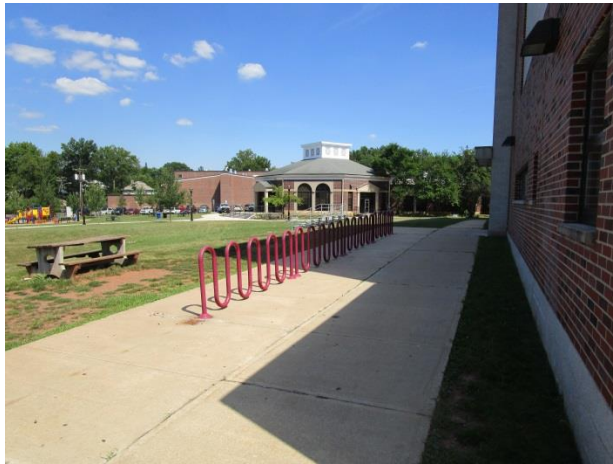
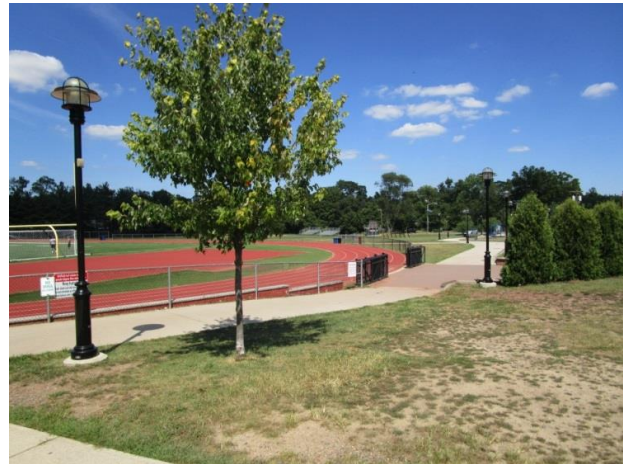
Figure 23 - Middle School bike rack (left) and adjacent turf field (right)

A large bike rack is located on the side of Highland Park Middle School, near the entrance. An assessment participant suggested the installation of an additional bicycle rack at the adjacent turf field, which is heavily used by students and local sports clubs after school and on weekends.

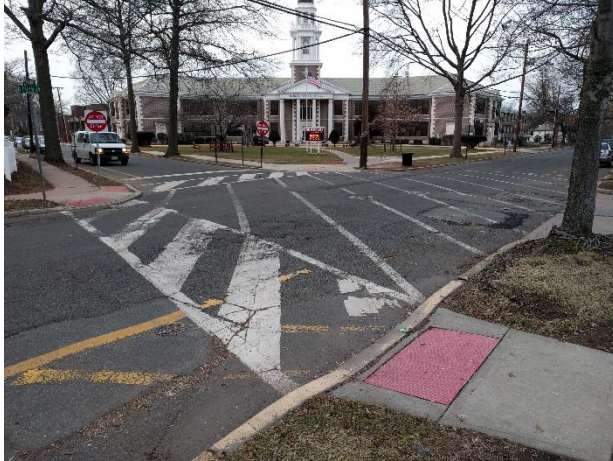
At the intersection of N. 5th Ave. and Montgomery St., directly in front of the High School and public library, the Borough has recently restriped crosswalks and added diagonal stripes across the intersection to warn drivers of frequent pedestrian crossings. A participant noted that students walk diagonally across the intersection during school arrival and dismissal.

Figure 25 - N. 5th Ave. & Montgomery St. crosswalk and diagonal striping

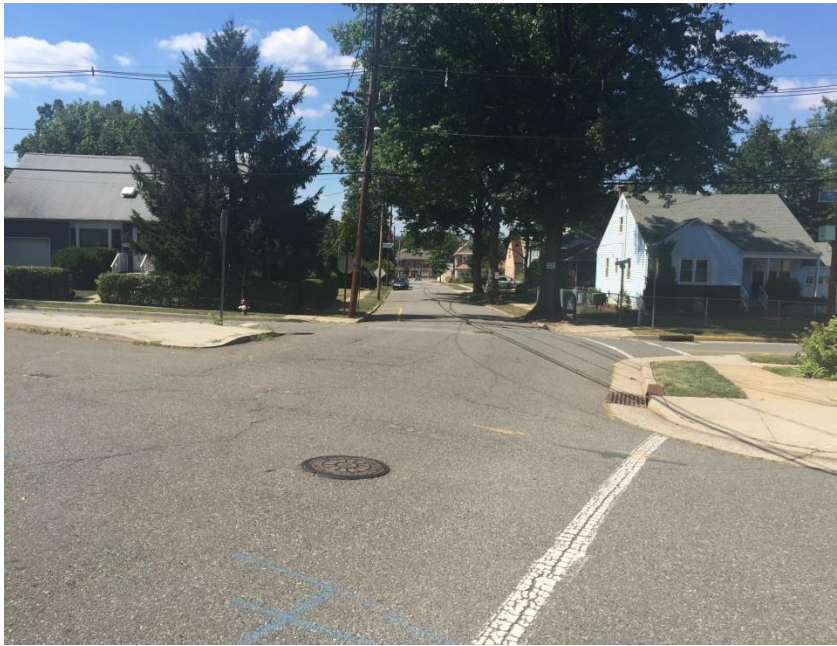
Assessment participants noted the three-way intersection of Columbia St., Cherry St., and Parker Rd. as a concern. A sign on Columbia St. warns about the upcoming “dangerous” intersection, and residents have added their own “slow down” signs. The lack of crosswalks at this intersection may make it difficult for children and adults to cross.

Figure 28 - Intersection of Columbia St., Cherry St., and Parker Rd.

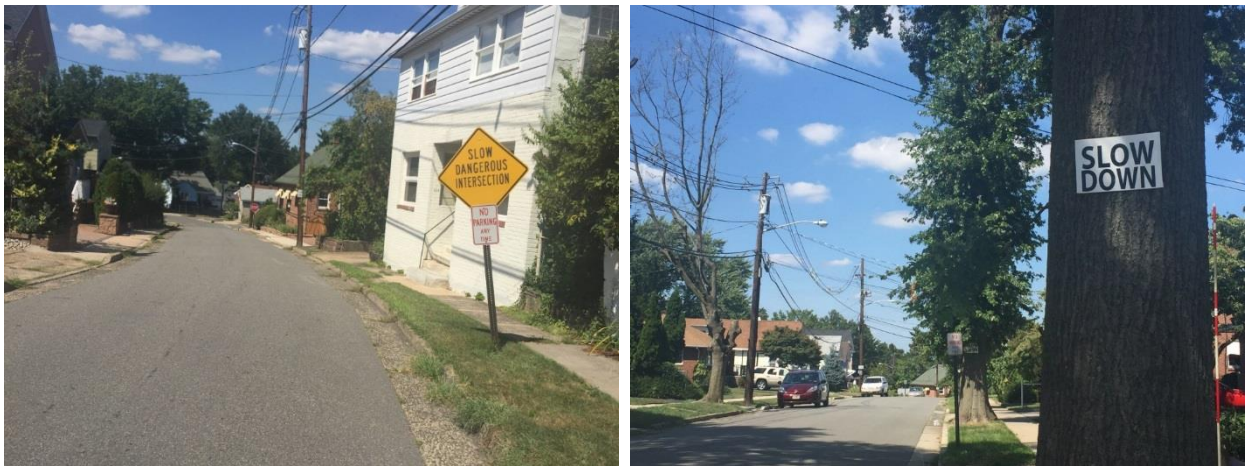
Figure 27 - Official and homemade warning signs on the Columbia St. approach to Cherry St.

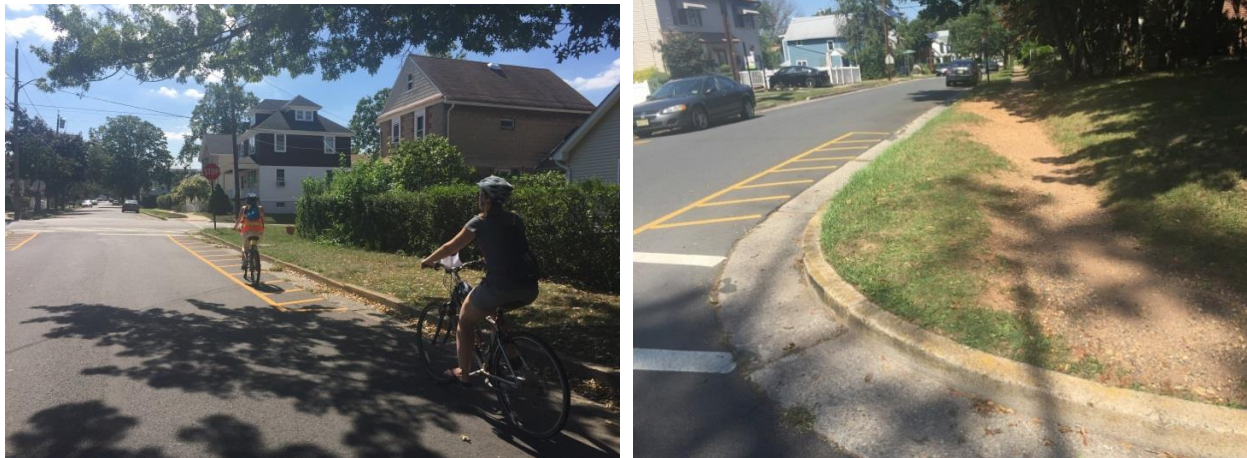
Participants noted a lack of sidewalks in some neighborhoods. A worn path on Central Ave. at Merilind Ave. by the Irving School shows the amount of pedestrian activity in the area.

Figure 29 - No sidewalk on Columbia Ave. & Central Ave. (left) and dirt path at Central Ave. & Merilind Ave. (right)

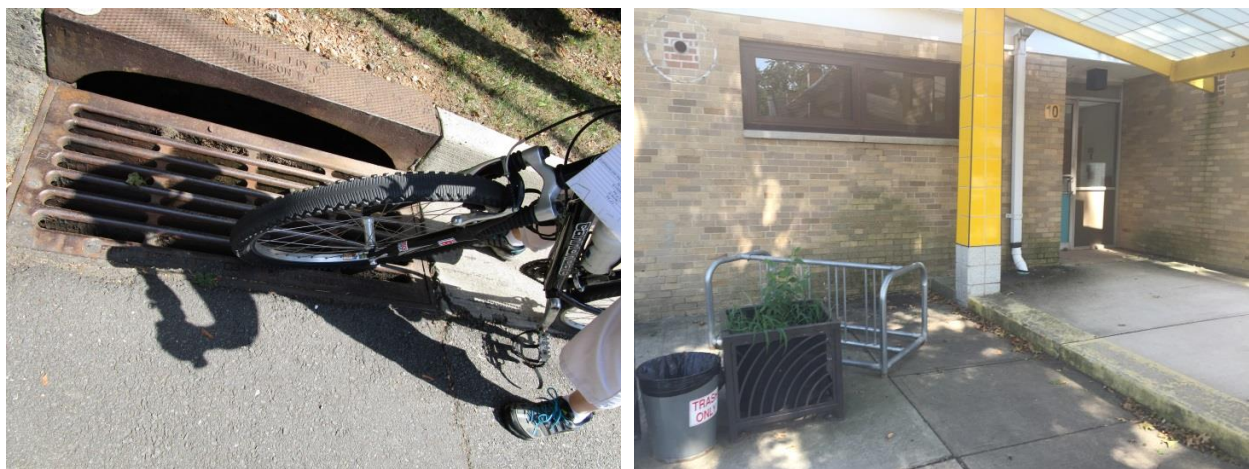
Other issues noted along the Black Route include a storm sewer grate at Crowell's Rd. and Aurora St. with wide slits where a child's bike wheel could get stuck and potentially cause injury. Irving School has a traditional comb-style rack near the gymnasium. The rack was recently relocated from the main entrance because bicycles were obstructing the accessible doors. While it is encouraging that the school has a bike rack for students to use, the awkward placement limits the rack's usability.

Figure 30 -Wide grate on Crowells Rd. & Aurora St. (left) and comb-style bike rack at Irving School (right)

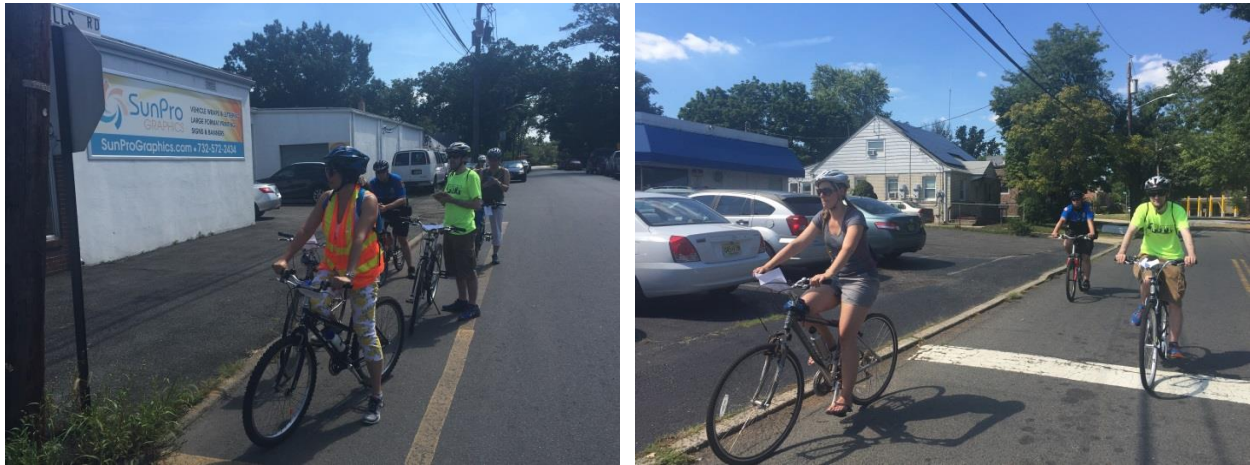
Where the Black Route crossed Woodbridge Ave., assessment participants noted that some Woodbridge Ave. businesses have parking lots that extend to the curb, with no sidewalk. In addition, wide driveway cuts are present. At the corner of Crowells Rd. and Woodbridge Ave. vehicles in the parking lot were located up to the curb, leaving no space for pedestrians. Across from the Irving School, a business at the corner of South 11th Ave. and Woodbridge Ave. had wide driveways and a parking lot to the curb. While cars were parked to leave enough room for pedestrians to walk next to the curb, there is no delineation or barrier between the parked cars and the pedestrians who cross an open driveway.

Figure 31 - Lack of sidewalks and wide driveway cuts on Crowells Rd. (left) and S. 11th Ave. (right)

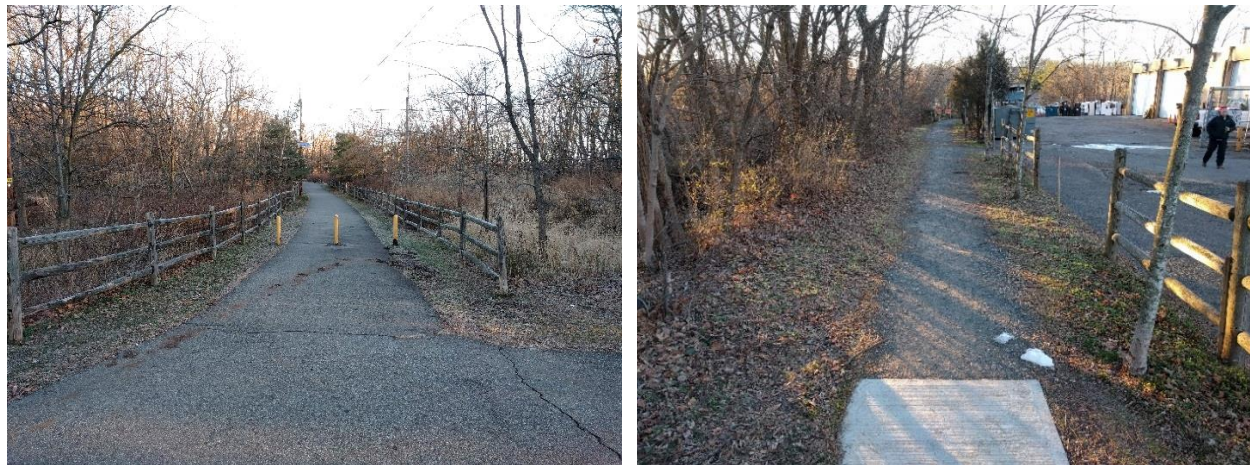
Riders on the Black Route noted a multi-use path and access road that connects the base of S. 7th Ave. at Donaldson St. with the base of S. 5th Ave. at Valentine St. This connection may facilitate a walking or biking connection from the Donaldson Park Apartments to Bartle Elementary School. This pathway is illuminated by “cobra head” street lamps. Riders also noted a crushed stone pathway that begins at the corner of S. 5th Ave. and Valentine St. and connects to Donaldson County Park. Paving of this pathway would provide a bike and ADA accessible route to the northern end of Donaldson County Park.

Figure 32 - Multi-use pathway from S. 5th Ave. (left) and crushed stone path to Donaldson Park (right)
